A HYDRAULIC AND FISHERIES BASED POST-PROJECT APPRAISAL OF THE INCHEWAN BURN RESTORATION PROJECT, BIRNAM, SCOTLAND

David Gilvear, Colin Bull, Stuart Hugh, Heather Bryson, Lewis Lowe, Ross Paterson, Iain Prescott, Andrew Rossi

Biological and Environmental Sciences
University of Stirling

River Restoration Centre conference
April 2010

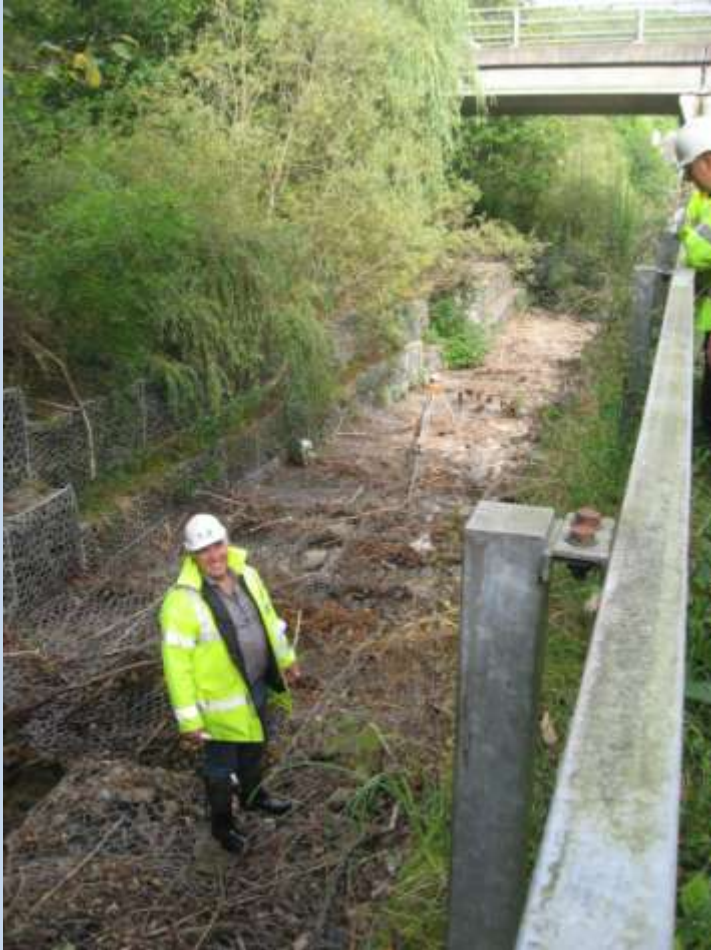
Before

Inchewan Burn encased in gabions during upgrading of A9 Road (1970s).

Dewatered burn and prevented fish passage

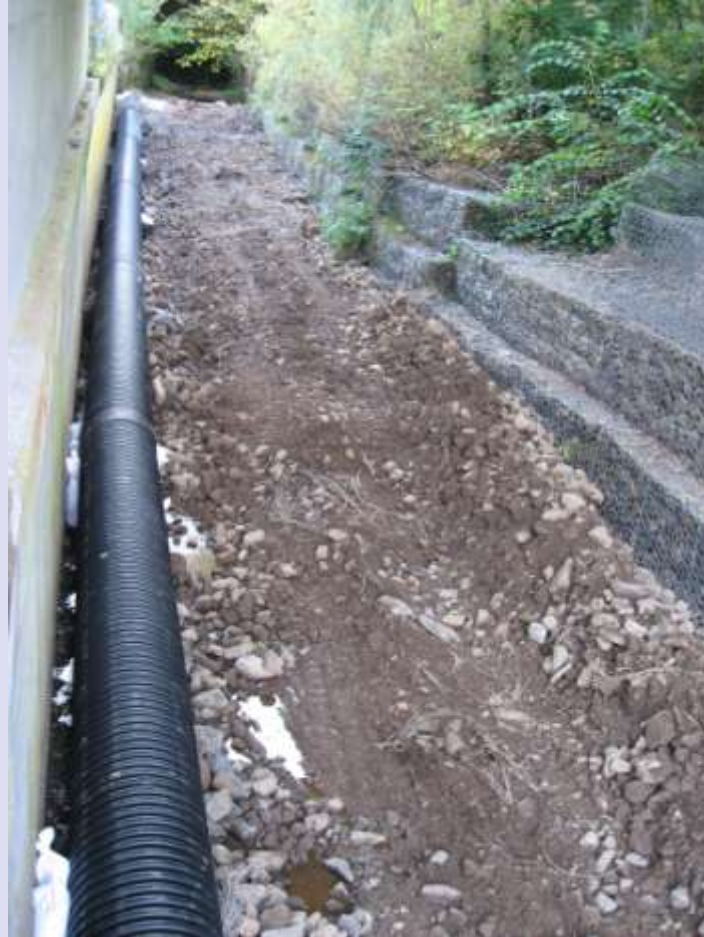
During

Physical works undertaken in 2008 and improvement of upstream habitat (conifer removal from burn margins)

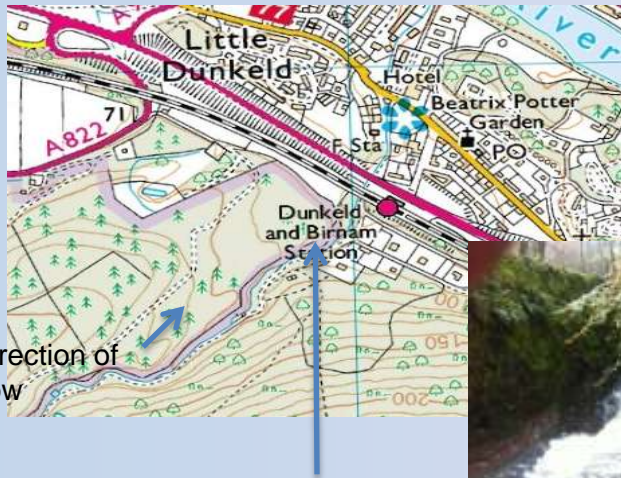
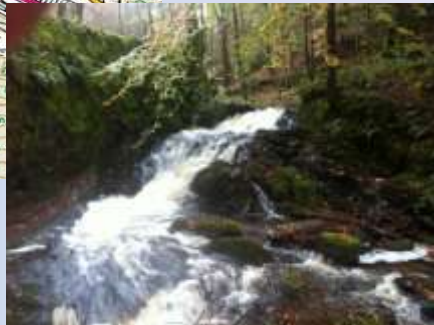
- 4 species encountered (trout, salmon, eel, stoneloach)
- Trout found at all sites
- Eels present upstream from restored section
- Juvenile salmon present in the short restored section and downstream in similar numbers.
- Masonry-culvert beneath railway line possible impairment to migratory fish
- The presence of natural waterfall provides impairment to migratory salmonids

- Successfully restored hydraulic habitat
- Salmonids colonising restored reach
- Salmon passage upstream impaired
- Post-project appraisal critical
- Need for adaptive management
- Need for application of fish passage porosity tool for waterfall/railway culvert and possible “works” (e.g. boulder placement/baffles)
- Value of “citizen” (student) science in post-project appraisal
