#### DAY-LIGHTING OF A CULVERTED CHANNEL IN DYCE, ABERDEEN

River Restoration Centre Conference, University of Nottingham, 19<sup>th</sup> April, 2012

Dr. Hamish Moir, Dr. Chris Bowles, Mr. Sam Diaz

### Case study of 'constrained process restoration'

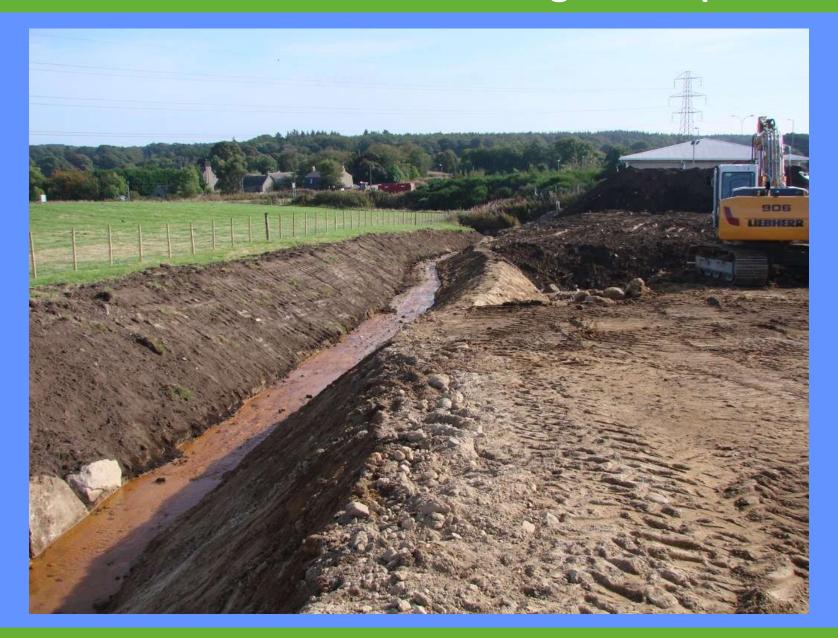
### The site with initial channel realignment (NOT us!)

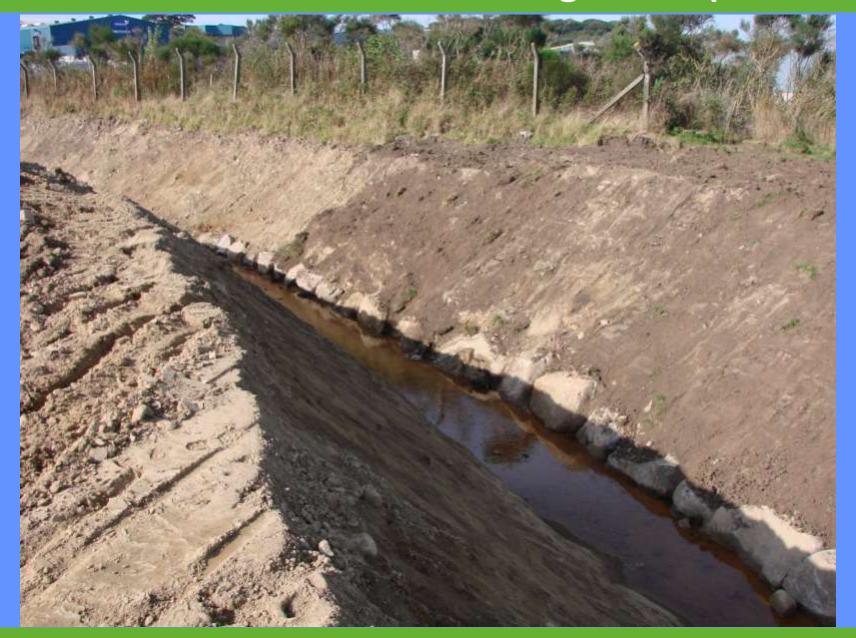
## The site with initial channel realignment (NOT us!)

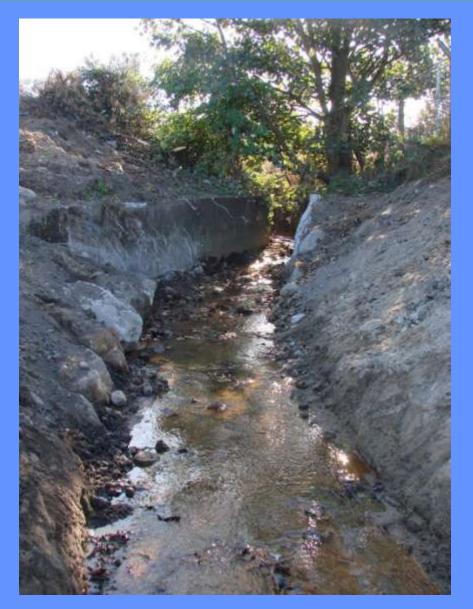
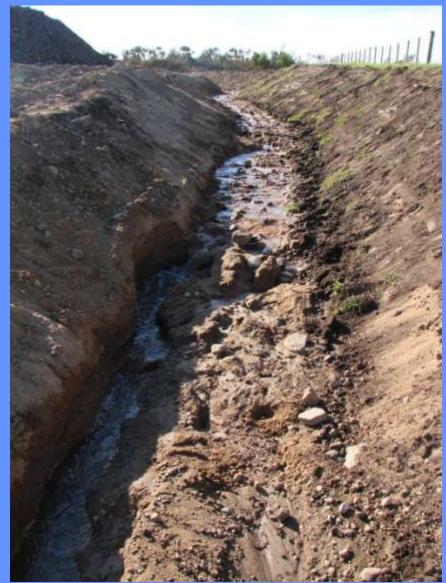
### The site with initial channel realignment (NOT us!)

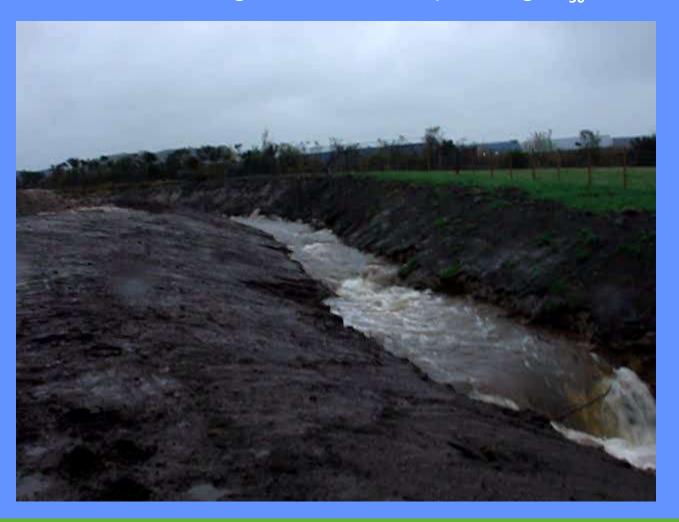
### High flow events prior to further analysis

Two flood events occurred on 31<sup>st</sup> Oct and 5<sup>th</sup> Nov 2009

Nearby gauge on mainstem River Don indicated magnitudes of ~10 year return interval

Site estimate indicated discharge of 2.0 – 2.5 m<sup>3</sup>s<sup>-1</sup> (i.e., design Q<sub>50</sub> underestimated)

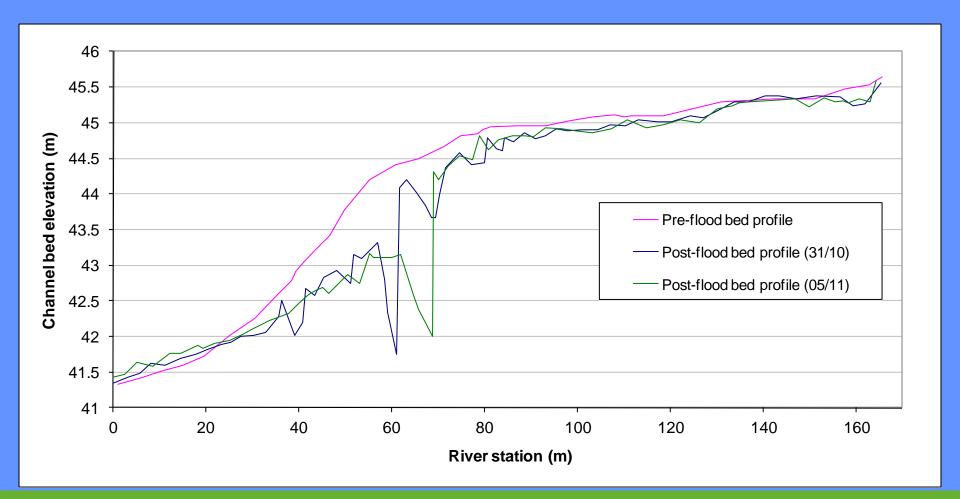
- Incision of the channel bed of up to 2.7 m
- Upstream head-cut migration of 7.5 m due to 05/11/09 event
- Total cut of 539 m<sup>3</sup> of material

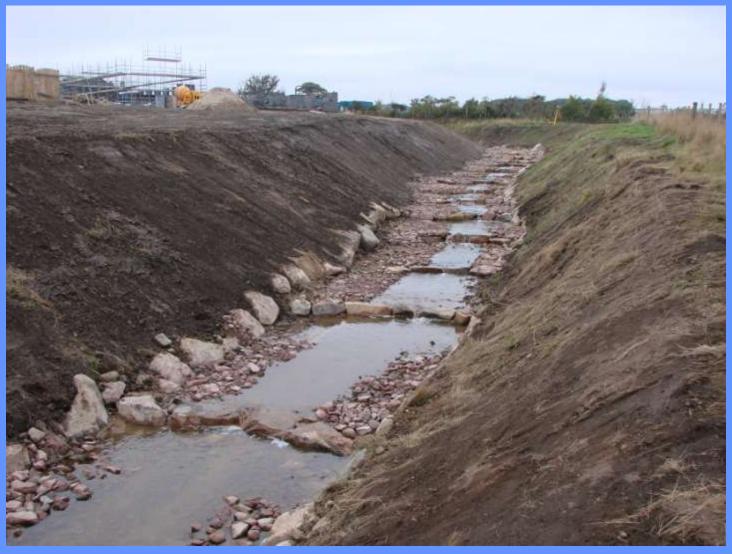
#### 1. Newly completed

#### **Post-construction**

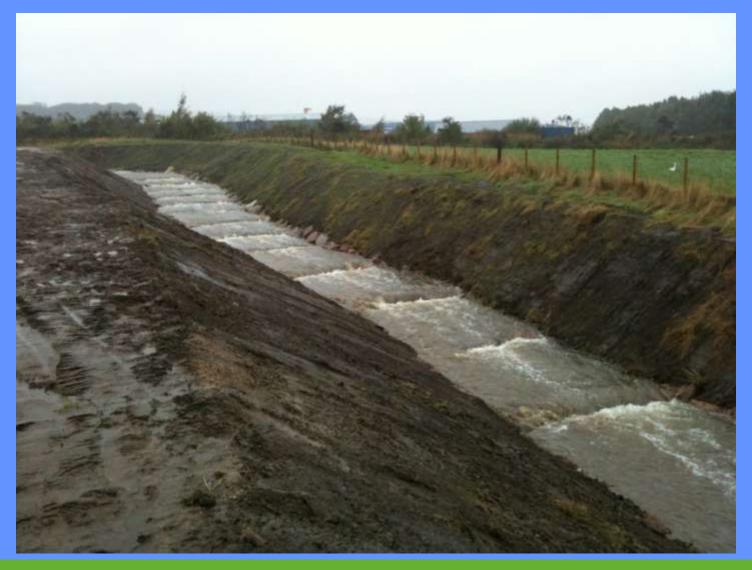
### 2. Under high flow

#### **Post-construction**

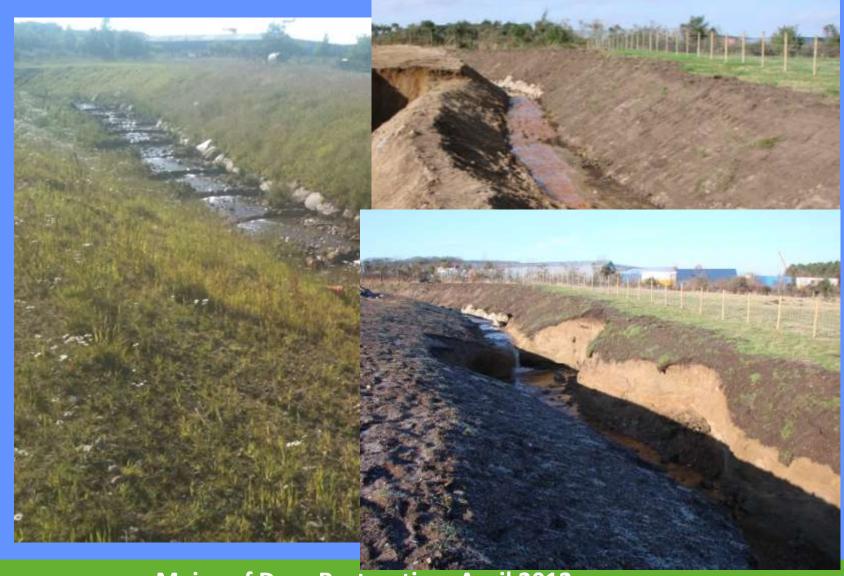
### 4. Ten months after construction

#### **Post-construction**
