A HYDRAULIC AND FISHERIES BASED POST-PROJECT APPRAISAL OF THE INCHEWAN BURN RESTORATION PROJECT, BIRNAM, SCOTLAND

David Gilvear, Colin Bull, Stuart Hugh, Heather Bryson, Lewis Lowe, Ross Paterson, Iain Prescott, Andrew Rossi

River Restoration Centre conference
April 2010

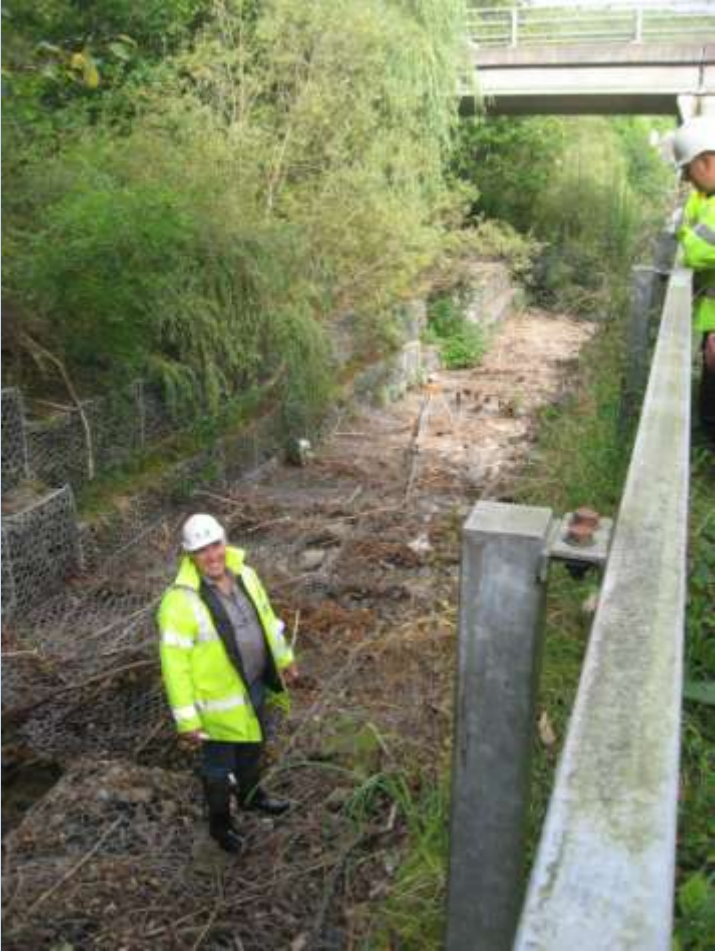
Before

Inchewan Burn encased in gabions during upgrading of A9 Road (1970s).

Dewatered burn and prevented fish passage

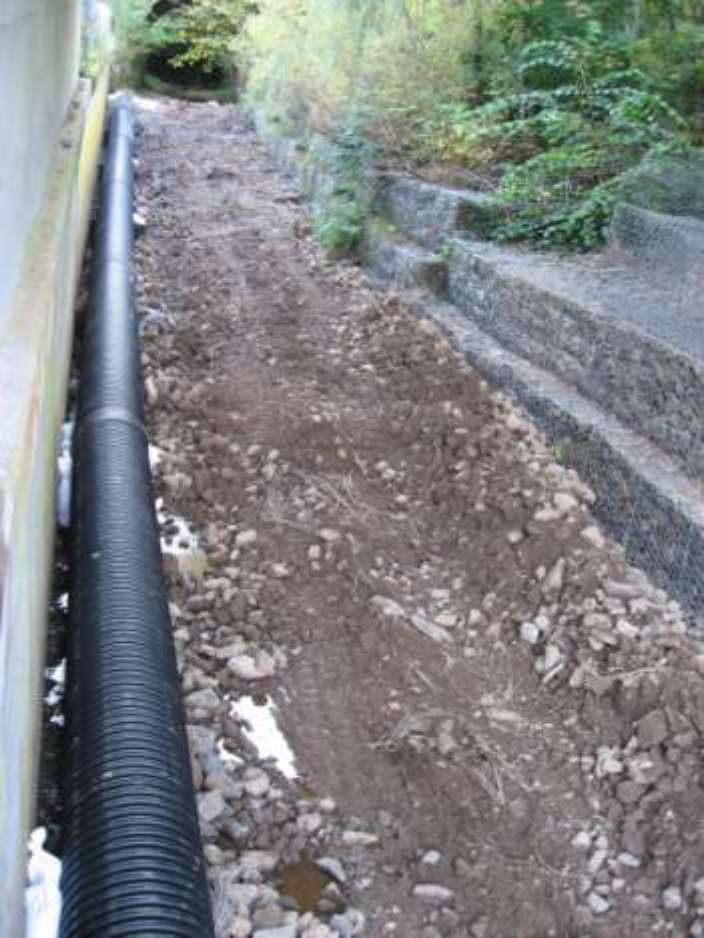
During

Physical works undertaken in 2008 and improvement of upstream habitat (conifer removal from burn margins)

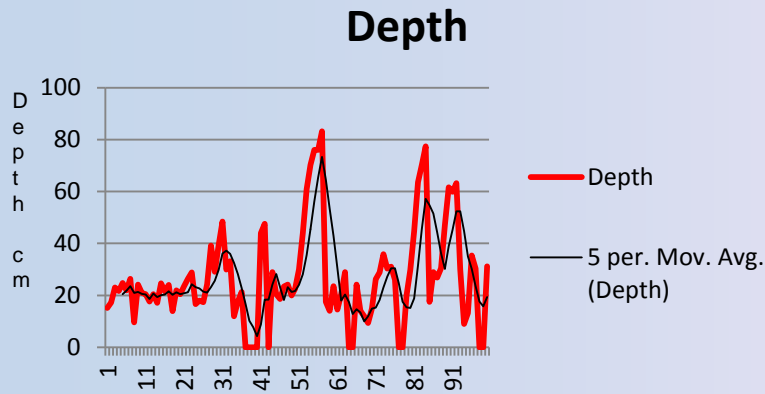
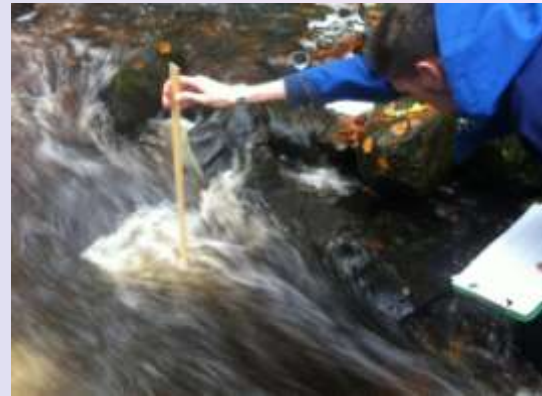
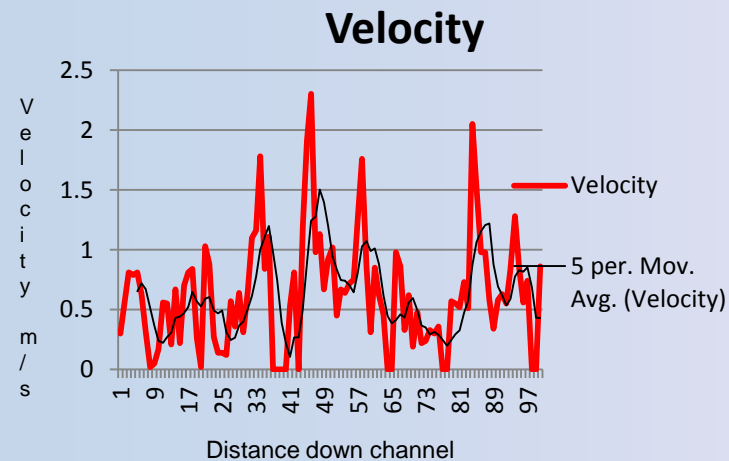
Restored reach

- Depths at low flow - 0-80cm
- Water Velocities - 0.15-2.5 ms⁻¹
- Step-pool morphology

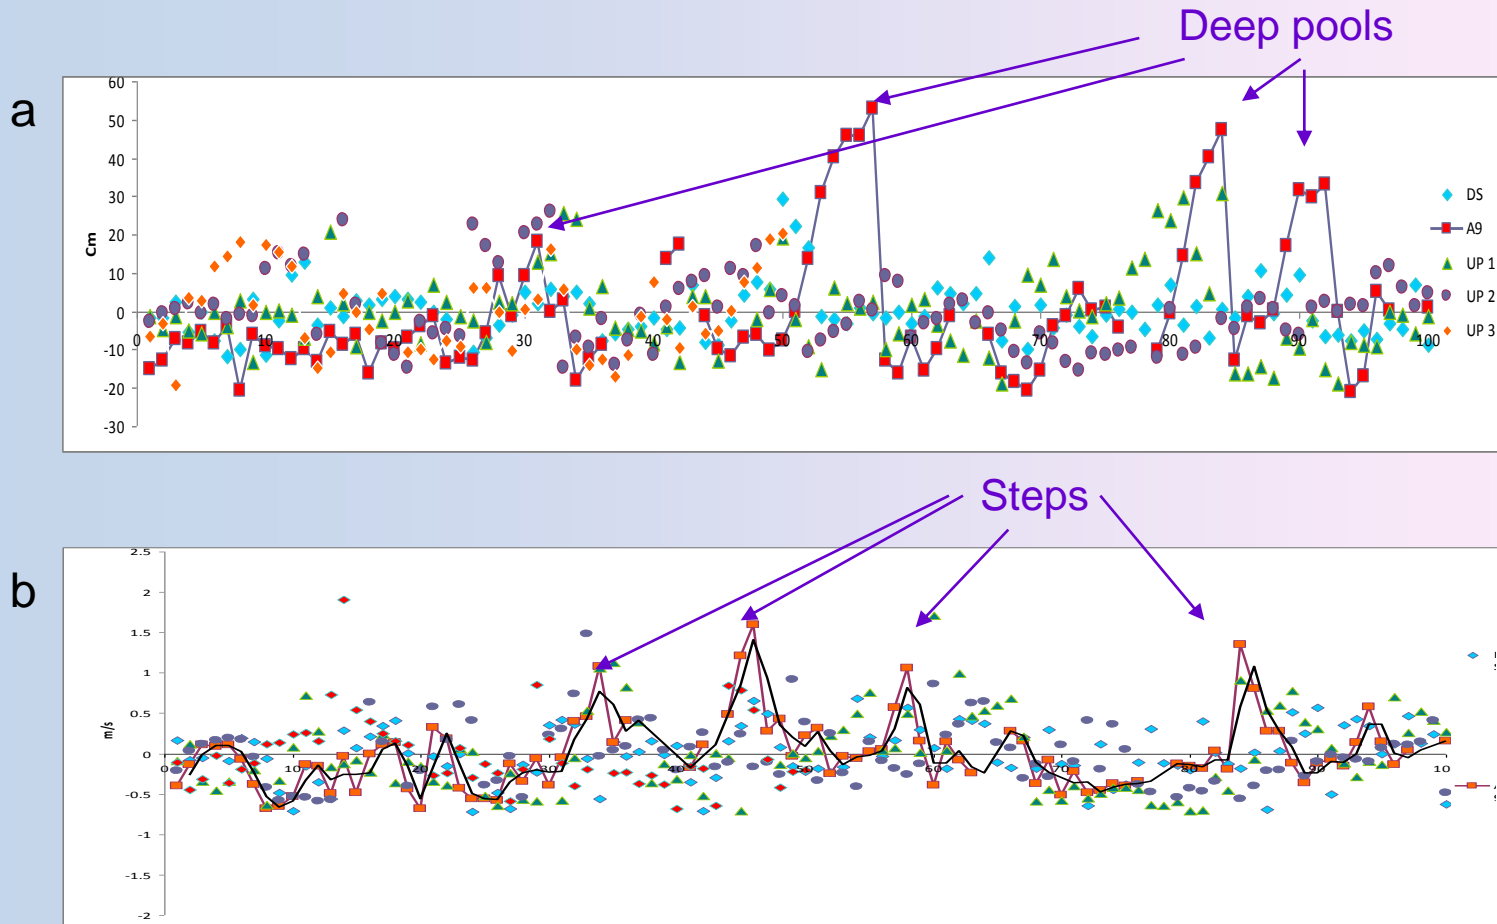
Residuals around average depth (a) and velocity (b)

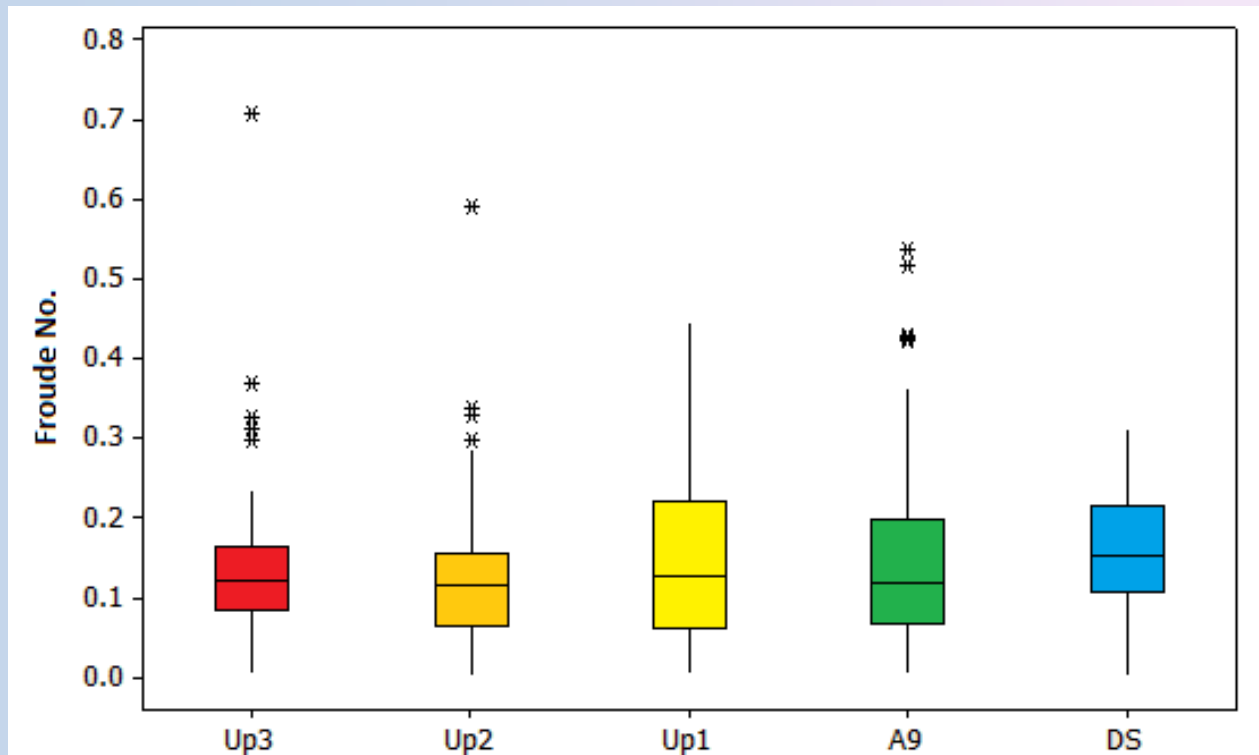
Froude No – integrates velocity and depth and measure of flow type

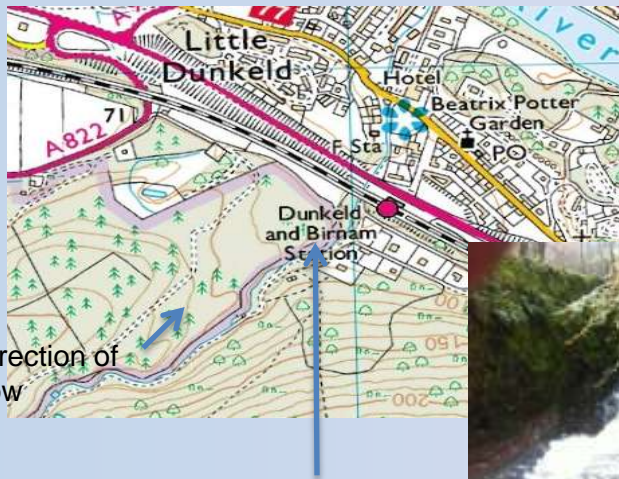
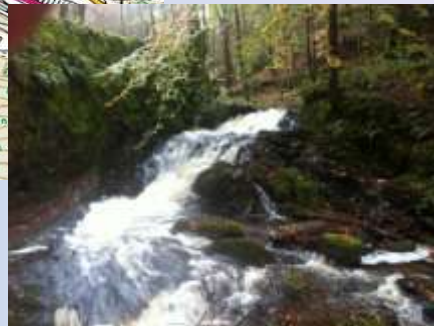
- 4 species encountered (trout, salmon, eel, stoneloach)
- Trout found at all sites
- Eels present upstream from restored section
- Juvenile salmon present in the short restored section and downstream in similar numbers.
- Masonry-culvert beneath railway line possible impairment to migratory fish
- The presence of natural waterfall provides impairment to migratory salmonids

- Successfully restored hydraulic habitat
- Salmonids colonising restored reach
- Salmon passage upstream impaired
- Post-project appraisal critical
- Need for adaptive management
- Need for application of fish passage porosity tool for waterfall/railway culvert and possible “works” (e.g. boulder placement/baffles)
- Value of “citizen” (student) science in post-project appraisal
