# Restoring Meanders to Straightened Rivers

## 1.11 Returning a woodland stream to its former sinuous course

### HIGHLAND WATER AT WARWICKSLADE CUTTING

LOCATION - NEW FOREST, 3KM SOUTH WEST OF LYNDHURST, SU273055

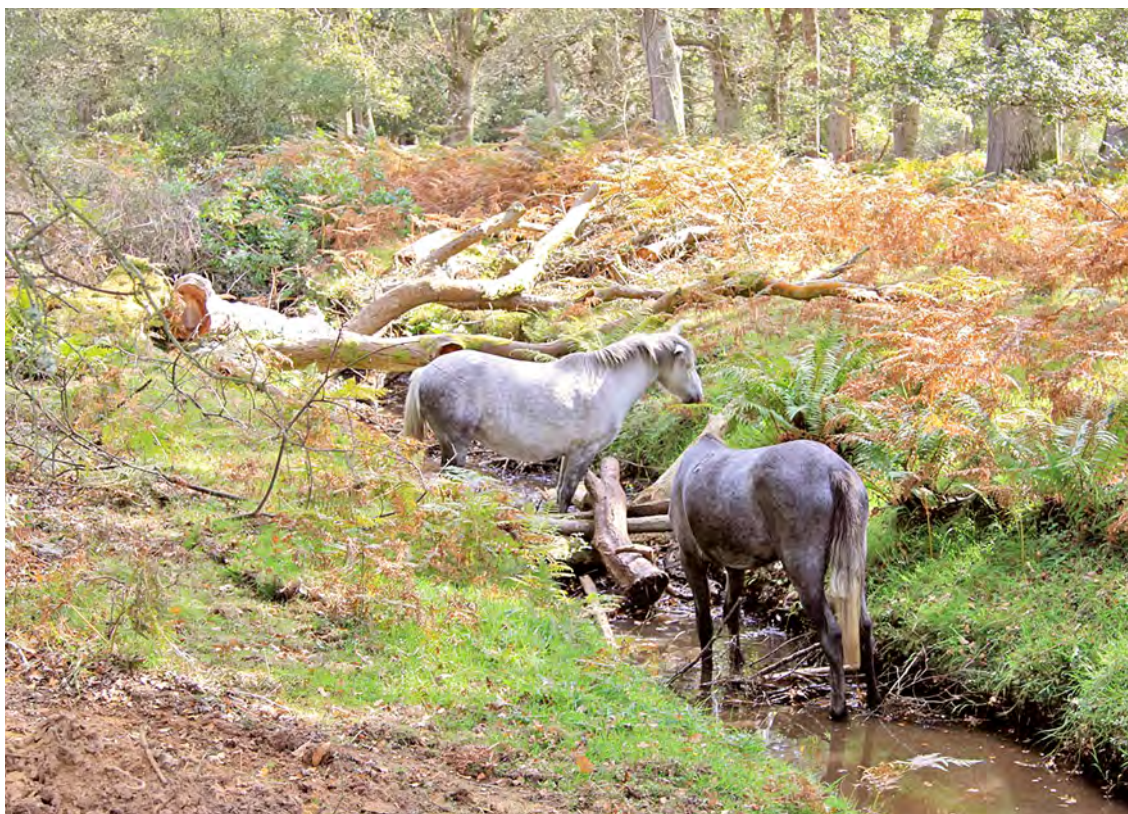
One example of this degradation is on Highland Water, a small headwater sub-catchment (4.9km<sup>2</sup>) of the Lymington River. Prior to restoration the channel was up to 1.2m deep and 4m wide restricting the natural seasonal flooding of the surrounding forest. The previously wet woodland and mire habitat had dried out and the increased channel size presented a barrier to the freely roaming forest animals.

The degraded channel was restricting both natural river processes and easy access across the forest for roaming animals – 2009

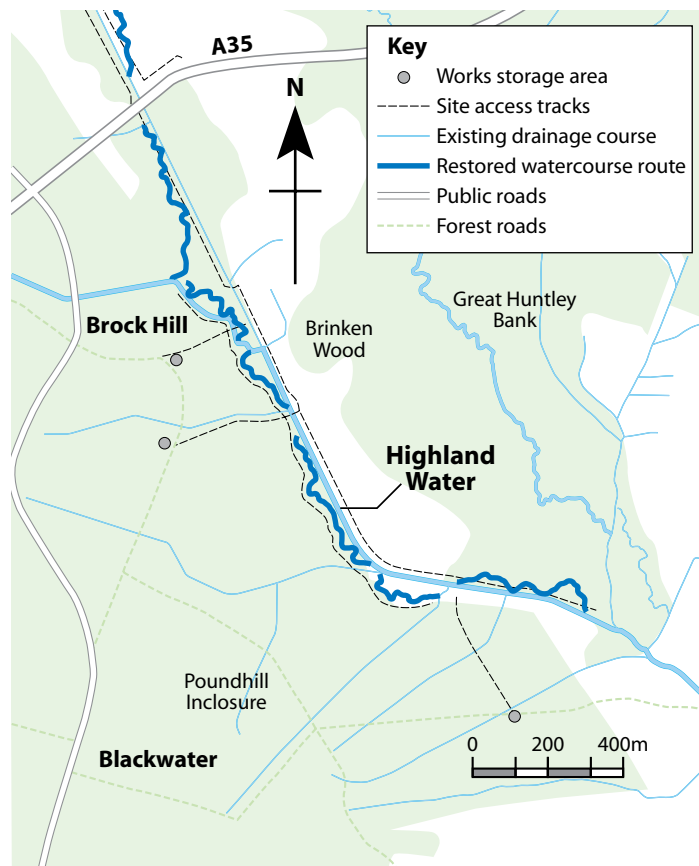
**Figure 1.11.1**

MAP SHOWING PLAN OF RESTORATION WORKS AT WARWICKSLADE

Historical maps were used to identify old or “lost” watercourses to guide the overall restoration design (See Figure 1.11.1). Where they could not be identified, the design was based on expert opinion through field assessment.

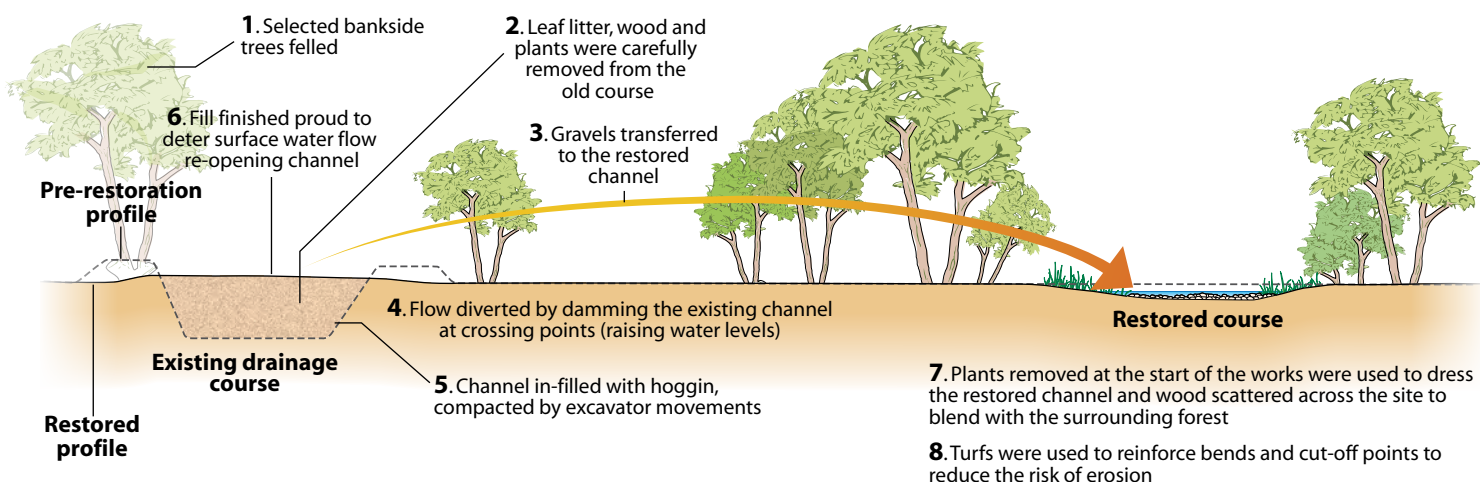
**Figure 1.11.2**

STAGES OF TECHNIQUE IMPLEMENTATION

The work was carried out in the following stages (See Figure 1.11.2):

Flow was diverted from the existing to the restored channel, section by section (See Figure 1.11.2) from one crossing point to the next moving down the reach. Adopting this phased approach enabled a controlled diversion of the flow into the new channel, reducing the risk of initial channel instability occurring.

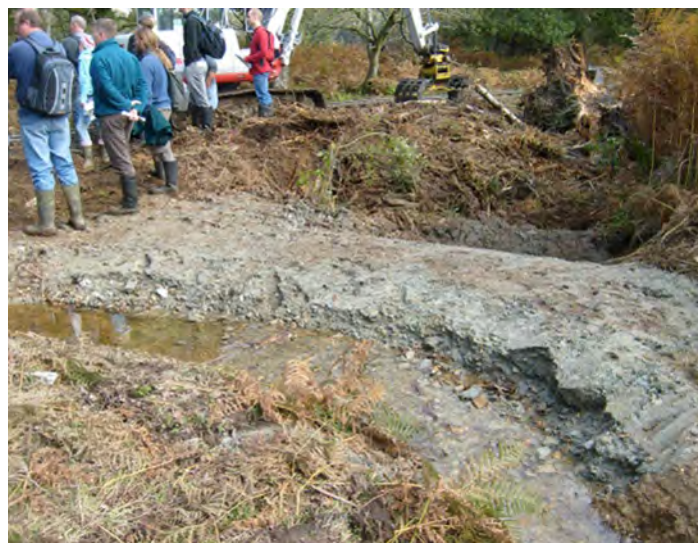
Clay infill was tightly packed at crossing points at 10 metre intervals along the channel to prevent seepage – October 2009

The clay was packed tightly at 10m intervals and at construction crossing points to prevent seepage. The rest of the channel length was then in-filled, with excavator movements helping to compact the fill as they moved across the site.

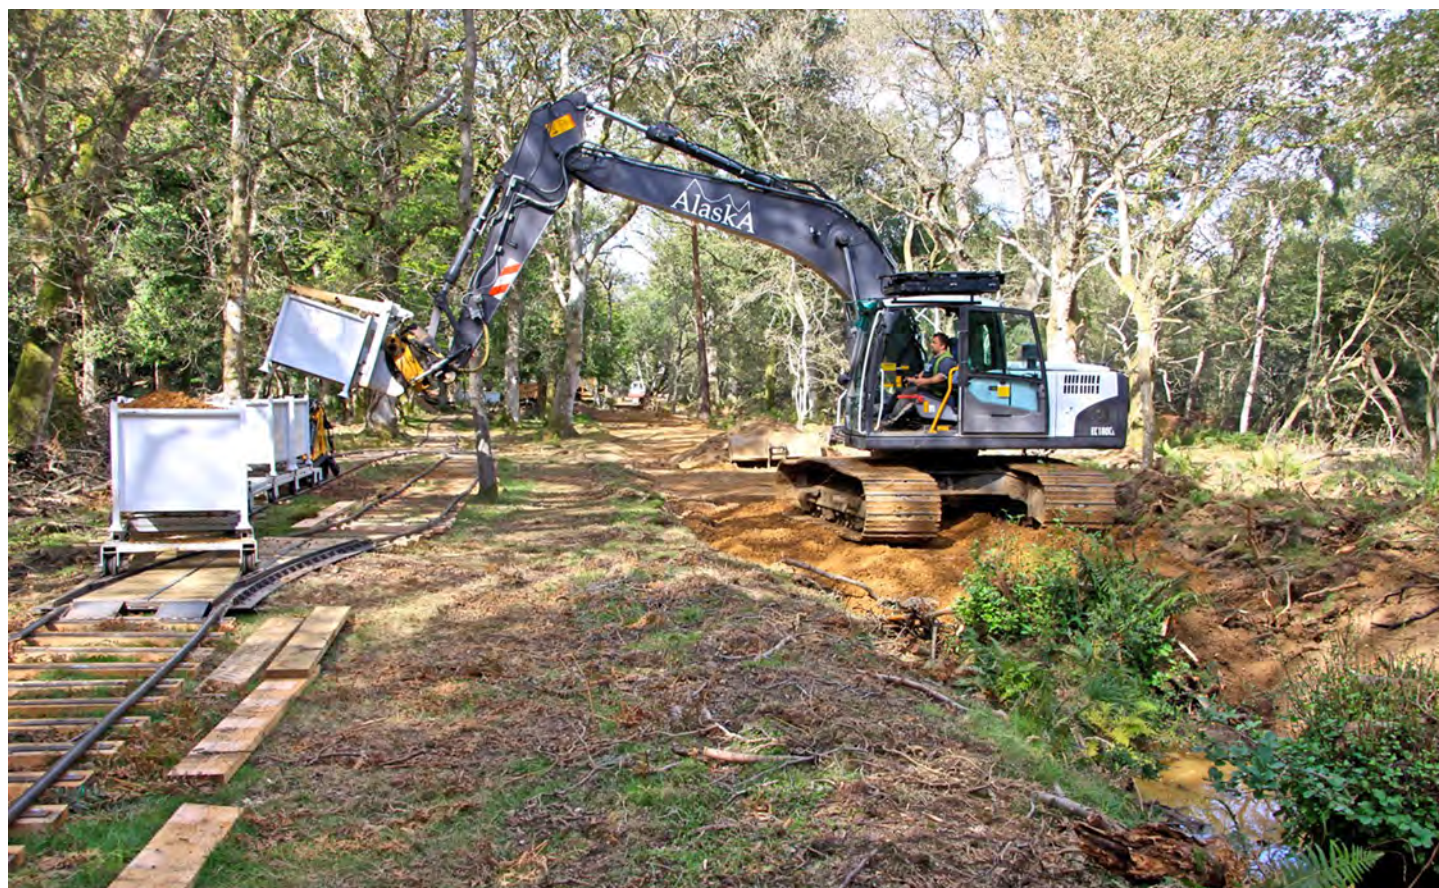
Innovative tramway designed to reduce the impact of works on the sensitive forest habitats, especially during wet site conditions – 2009

An innovative tramway system was devised to enable materials to be moved along the line of the channel, even during poor weather, with no appreciable impact on the heavily designated forest habitat.

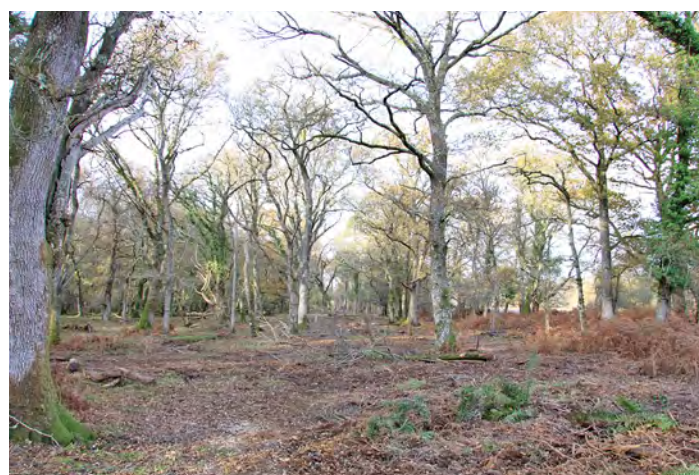
Well-placed shrubs and deadwood blend the old channel into the landscape within days – 2009

Dead wood was scattered across the site to aid the rapid recovery of the landscape and stop the route becoming a straight path for humans or grazing animals. Turfs removed from the existing course were used to reinforce bends and cut-off points to reduce the risk of erosion immediately post-construction.

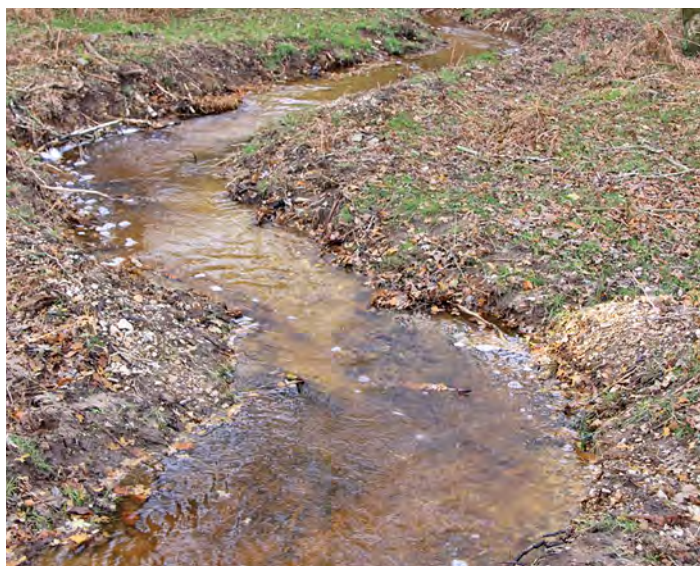
Immediately post-construction flow begins to grade materials. Pools and riffles are developing – 2009

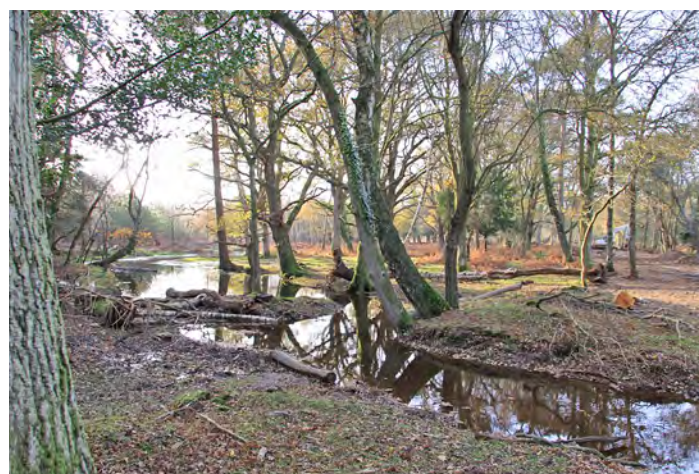
The restored course includes both narrow and wide sections – 2009
