## 12.2 Step pool cascade fish pass and culvert bed improvement

### LODGE BURN

LOCATION - COLERAINE TOWN CENTRE, N. IRELAND NW02689199

DATE OF CONSTRUCTION - APRIL/MAY 2012

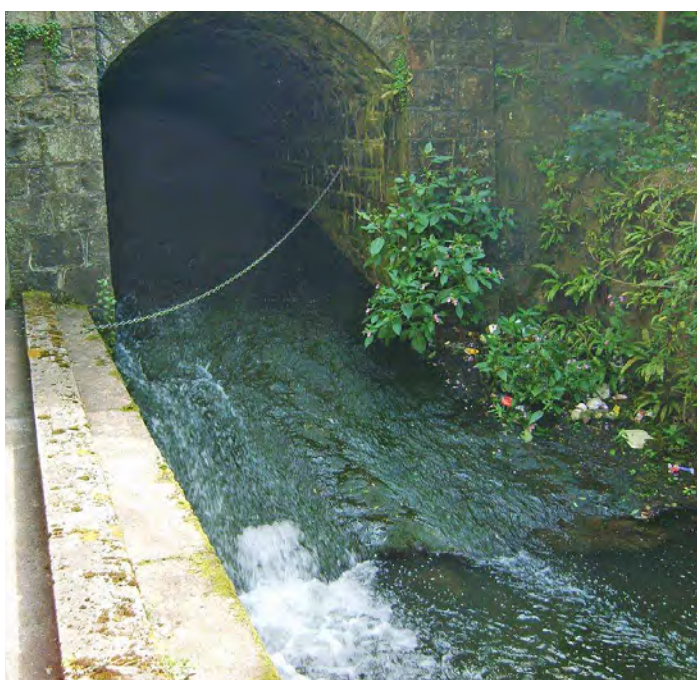
Initial scoping identified significant hydromorphological pressures within the town. The site was classified as "bad ecological status" for Water Framework Directive (WFD) in 2009. A major cause of this was identified as a perched culvert with a concrete bed and steep apron, located in the centre of Coleraine. This was

Existing culvert beneath buildings was impassable to fish due to depth, velocity and slope of the concrete bed and apron – August 2010

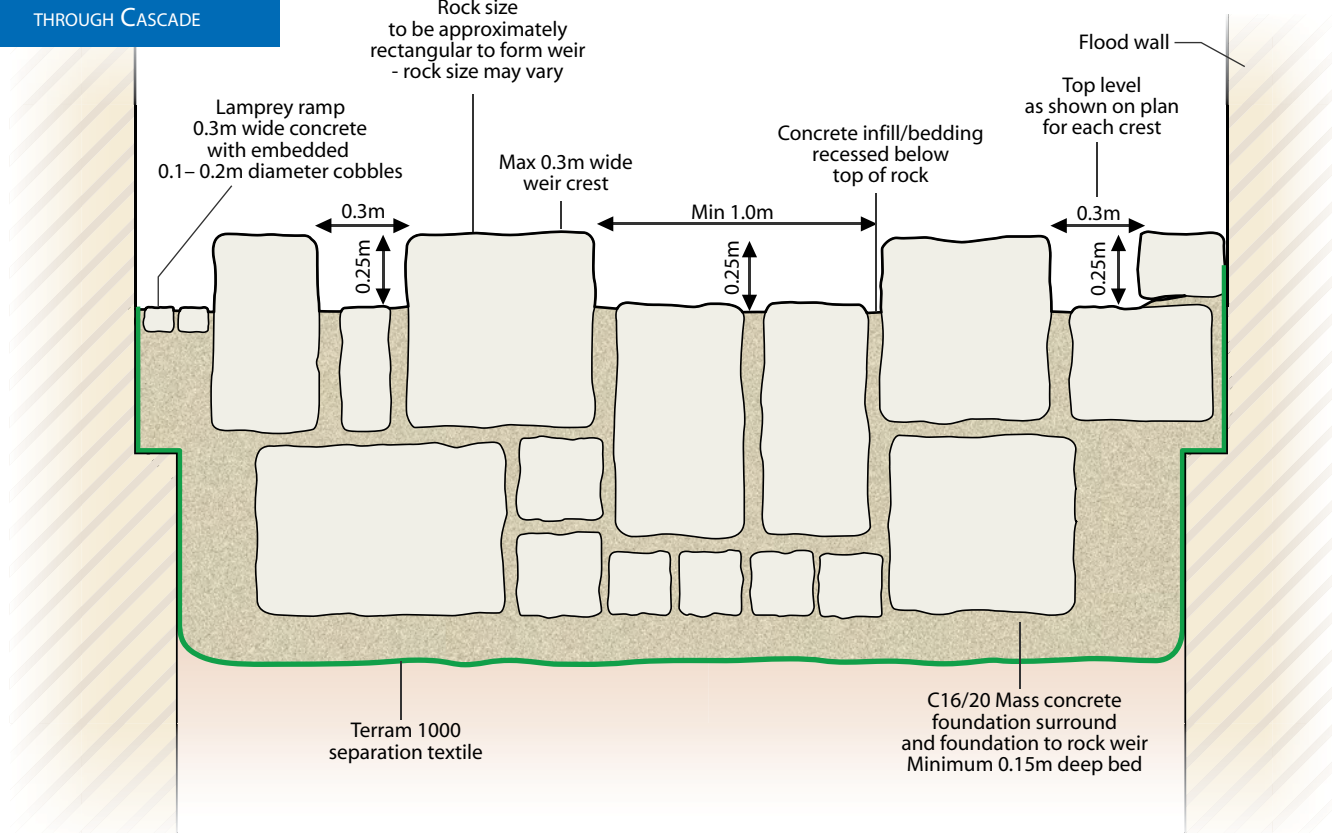
**Figure 12.2.1**  
TYPICAL CROSS-SECTION  
THROUGH CASCADE

the concrete apron was broken out creating a 1.5m drop to the channel bed. This was overcome by creating a series of six steps and pools, each with a crest 250mm lower than the previous one. The core of the first cascade was constructed with reinforced concrete as it would take the initial force of flows leaving the culvert. The remaining five were constructed of large rocks (0.5 to 1.5 tonnes) concreted in place to prevent washout (Figure 12.2.1).

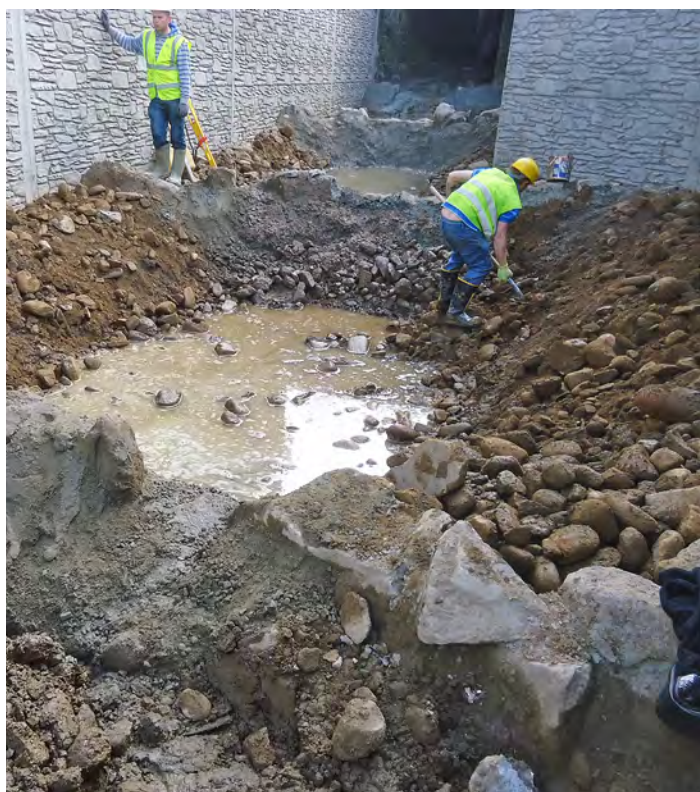
Cascade during construction – May 2012

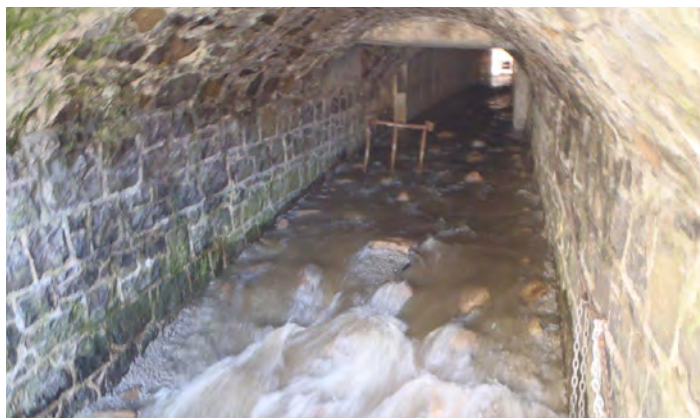
Culvert shortly after construction completed – May 2012

Flooding shortly after construction caused some damage to the face of the first cascade. Gravel and cobble washout from the culvert resulted in the infilling of pools, however this material was removed subsequently by the Rivers Agency. This initial movement highlighted the importance of incorporating sufficient self-maintaining processes in pool design (i.e. sufficient flow to maintain the pool depth), as well as the need to anticipate early wash-out of excess material. The remaining cobble bed material within the culvert is now deemed to be stable.

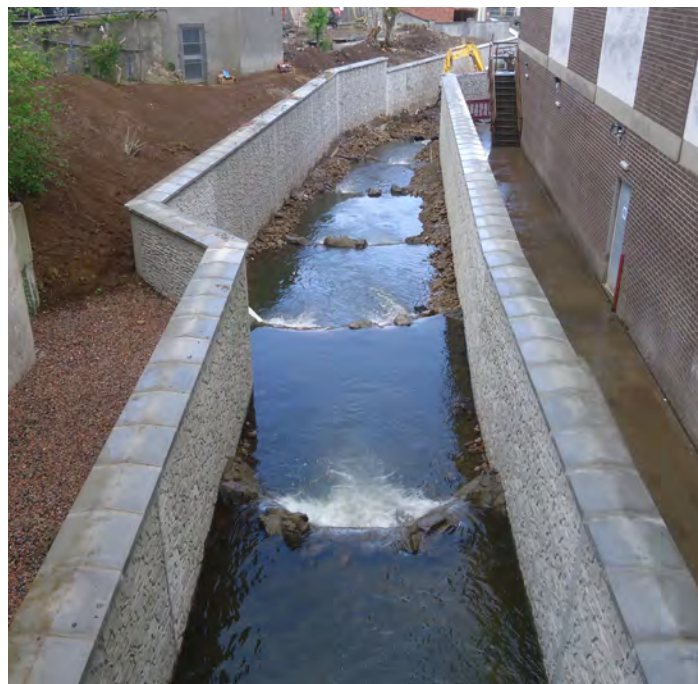
The channel post-construction during low flows – May 2012

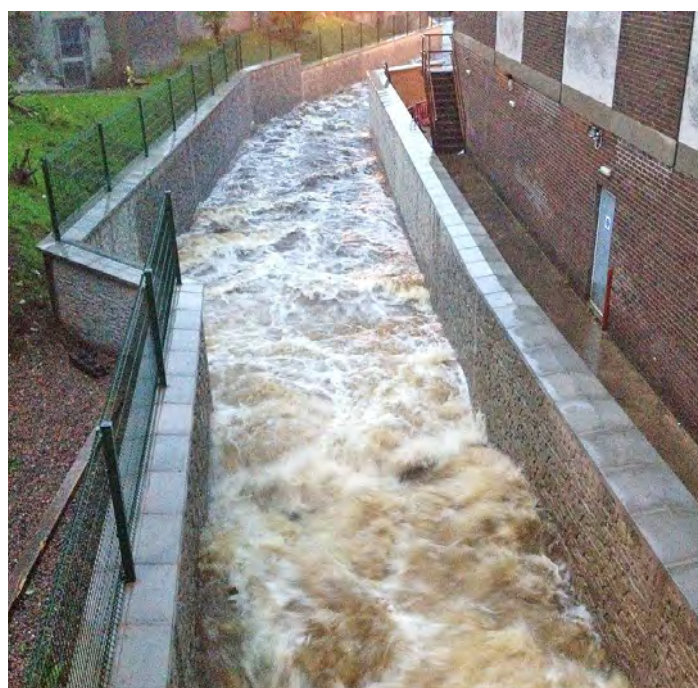
High flow event in channel demonstrating good fish passage opportunity – June 2012
