4.5 Supporting bank slips and exposed tree roots

RIVER SKERNE

LOCATION - DARLINGTON, Co DURHAM, NZ301160

DATE OF CONSTRUCTION – OCTOBER 1995 / NOVEMBER 1996

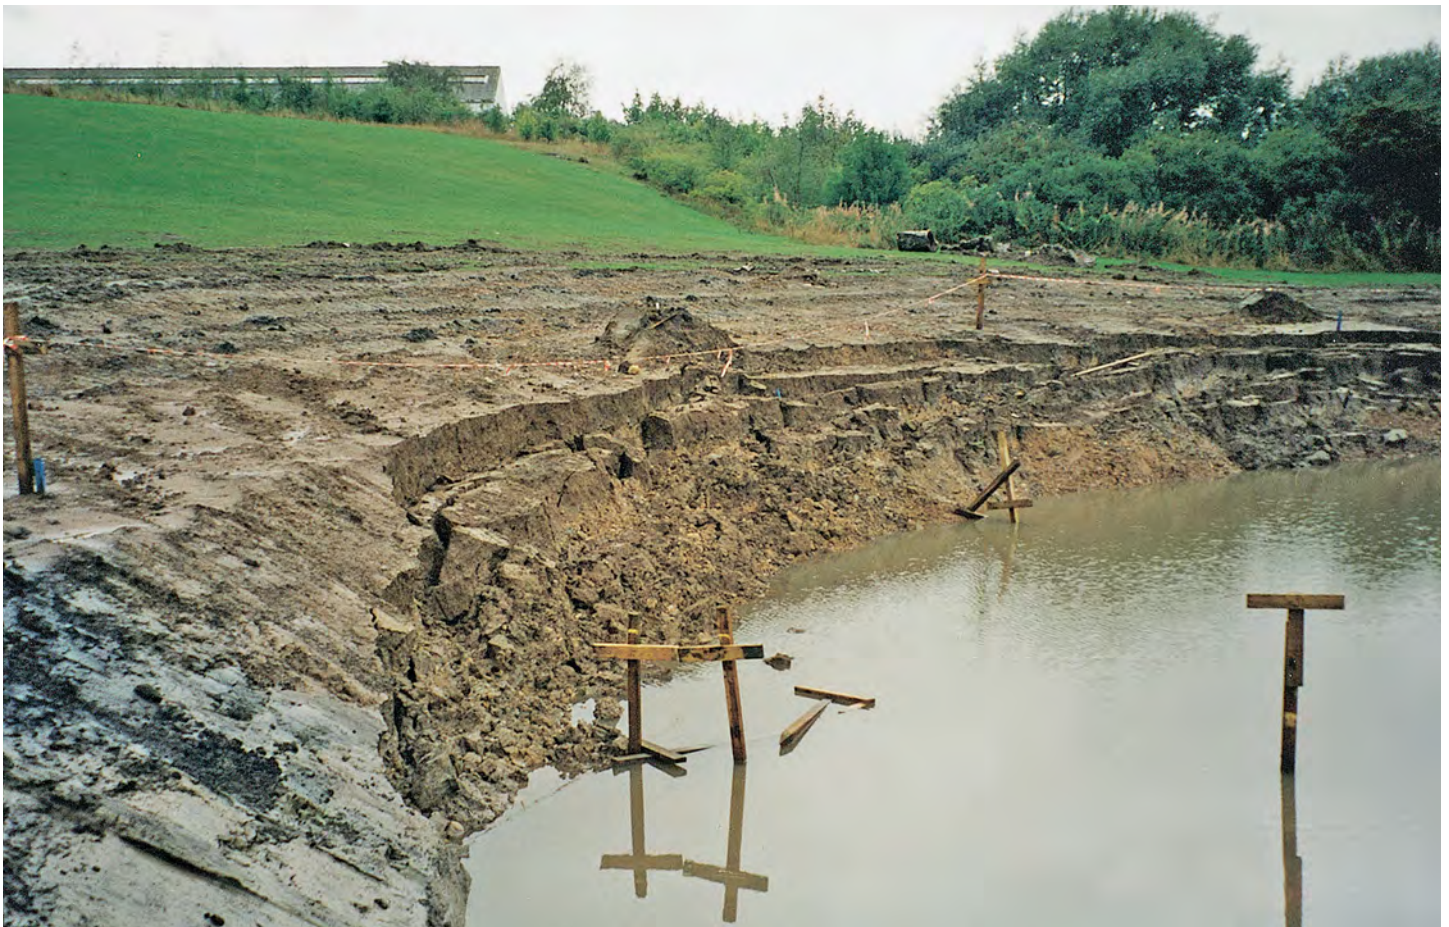
Slipped slope during work – September 1995

During works, water seepage from gravel at the bottom of a newly excavated river bank caused it to slip. As the bank was close to bunded industrial fill, repair was necessary. The route of a proposed footpath was also at risk if this bank remained unstable.

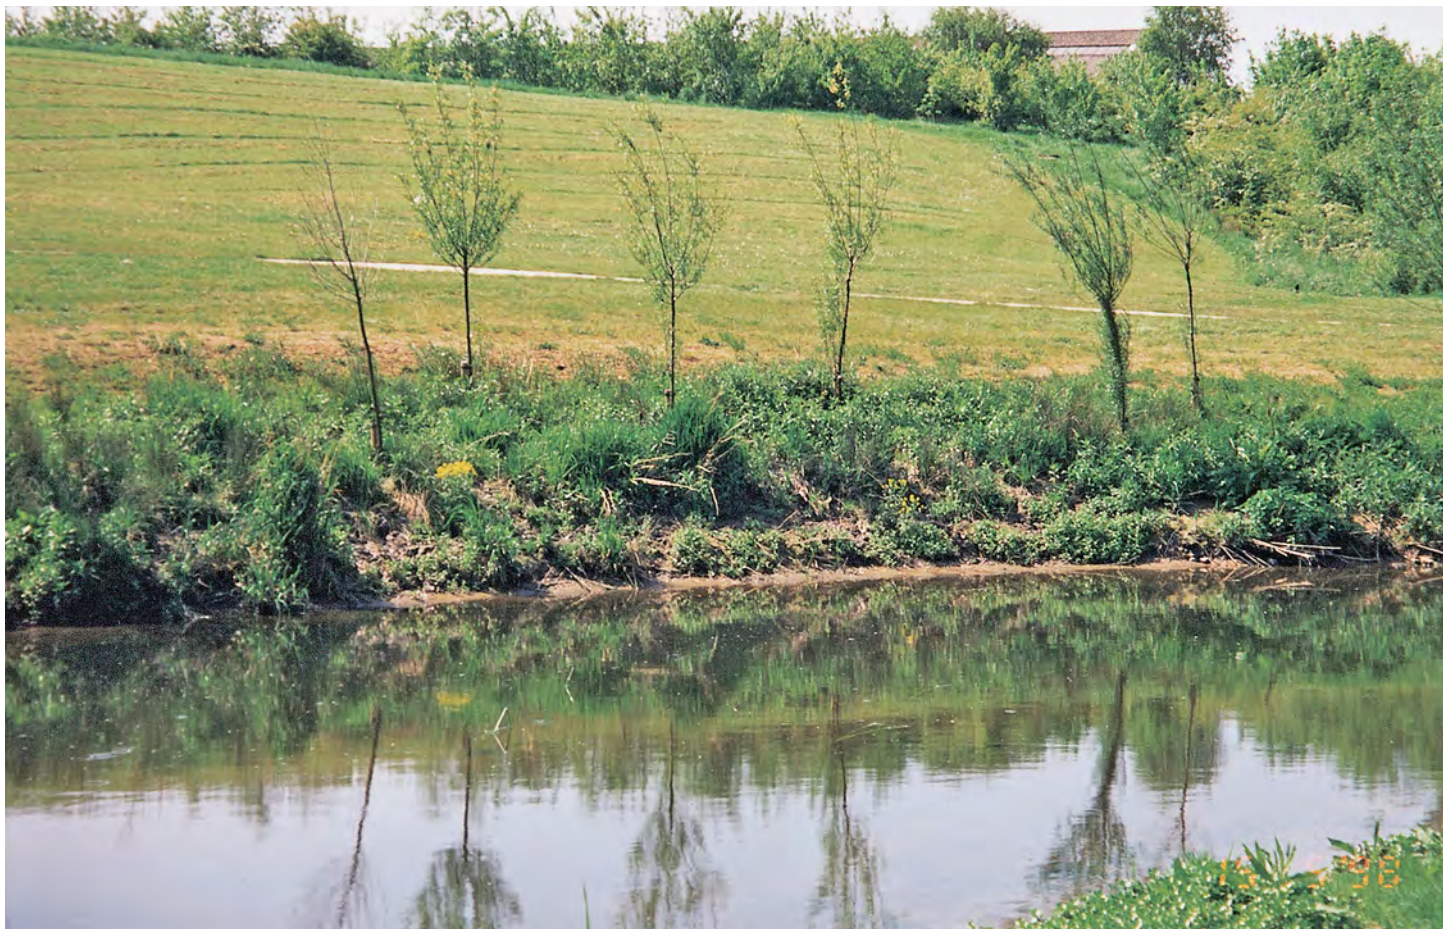
Slipped slope 2 years after repair – 1997

The bank slip has remained stable and appears natural with no visible signs of support. Water continues to seep from the bank and maintains a small wetland habitat on the ledge above river level.

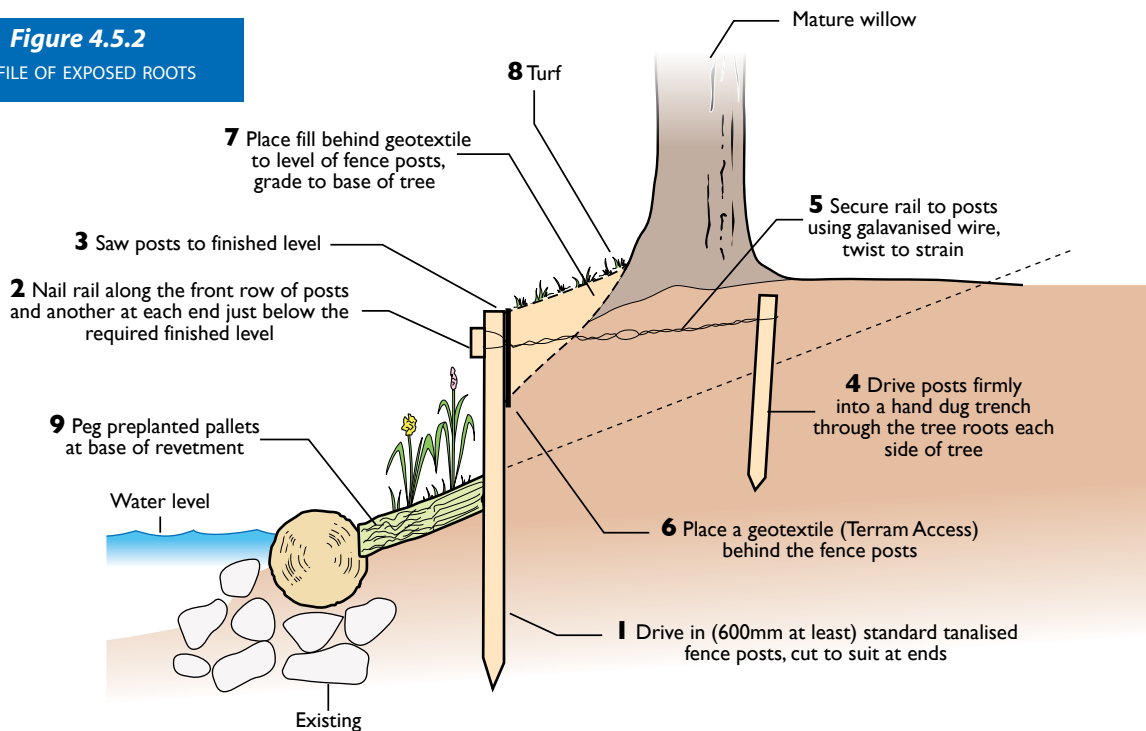
Figure 4.5.2
PROFILE OF EXPOSED ROOTS

The roots of a mature willow had been exposed during river bank re-profiling works and were being undermined by high flows and damaged by people. Although in no immediate danger, this tree had become an important resting place, providing the only shade along this bank. Positioned on the apex of a meander, it was decided to protect the roots using a simple revetment.

The design had to ensure that people could continue to use the spot without further damage. Vertical fence posts were used to revet the bank before backfilling with soil. A geotextile, 'Terram Access', was placed behind the posts to prevent soil migration. Turf was placed on the surface to achieve an instant result.

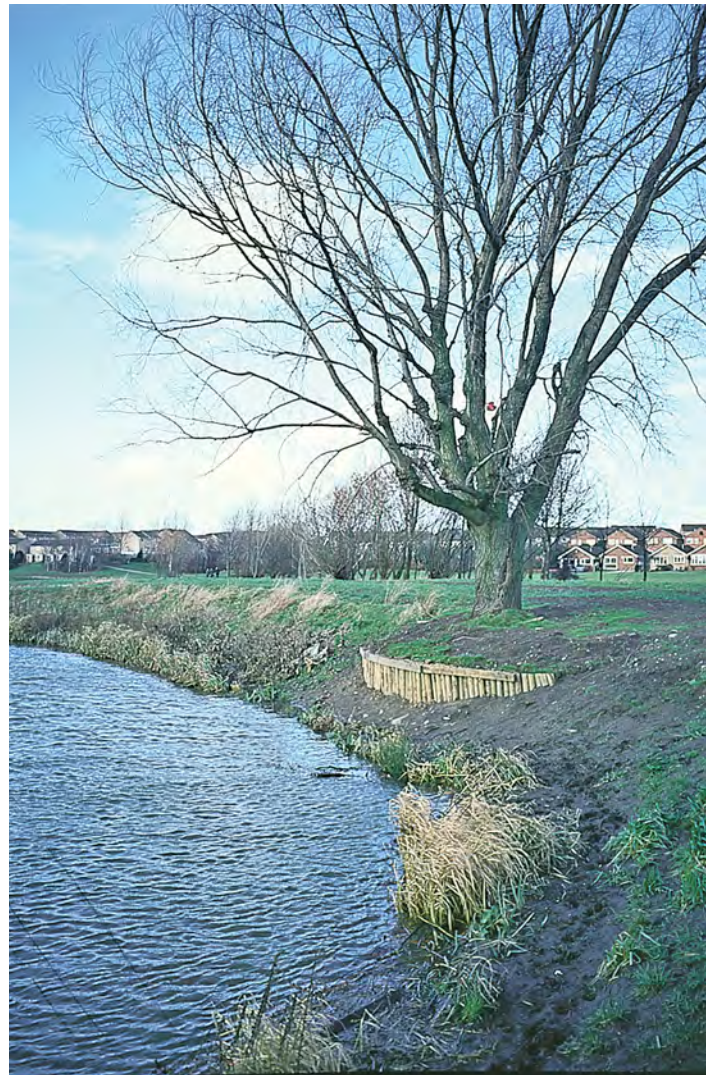
The revetment of the exposed roots has performed well, following many high flows since its construction. The roots are no longer exposed and the turf and other planting has grown to give added protection. Well used by a variety of people, the structure has become a seating area providing shade.

Vegetation establishment after 18 months
