Revetting and Supporting River Banks

4.7 Bank revetment using low steel sheet piling and coir rolls

RIVER THAMES

Location - Clifton Lock Cut, Oxfordshire SU 544944 Date of construction - September 1996 Length – 140m Cost – £45,000

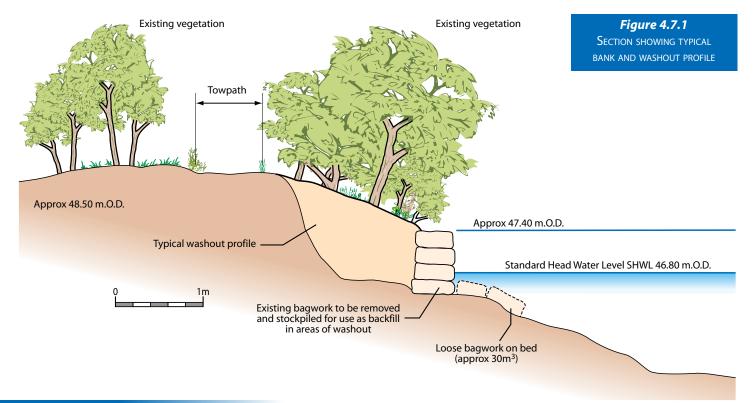
At Clifton lock cut the old concrete bagwork revetment was beginning to disintegrate and allow wash-out of the unprotected bank back towards the towpath. The reinstatement was initially

Failed section of bagwork at Clifton Lock Cut

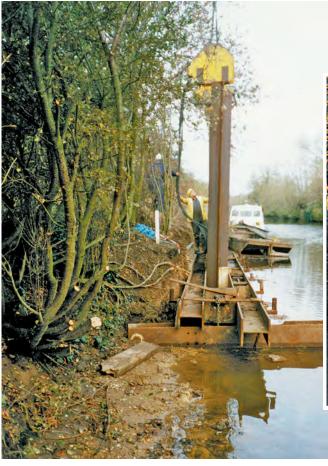
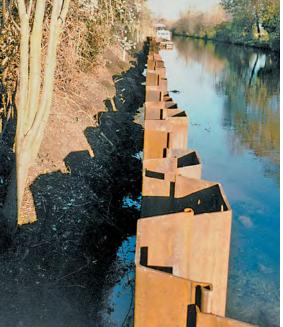
Initial sheet piling after bagwork removal, over existing trees

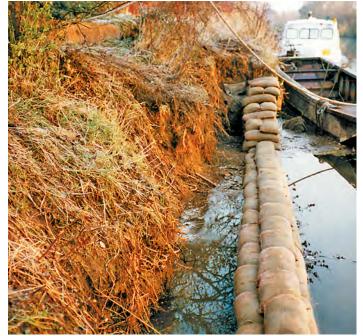
2 layer capping bagwork and tie-in to existing sheet piling

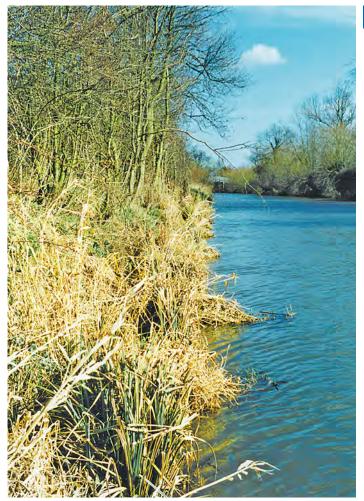
The revetted bank showed no signs of erosion and appears quite 'natural'. The emergent species planted in the reed rolls have established well, forming a dense marginal fringe.

The fibre matting protected the slope well and has since almost completely degraded allowing re-vegetation of the upper slope. In areas this has taken a number of years, possibly due to the steepness of some sections and a dry summer after completion. The growing root system of the retained shrubby vegetation helped to bind the backfilled bank and provide extra stability.

Vegetation establishment after 18 months

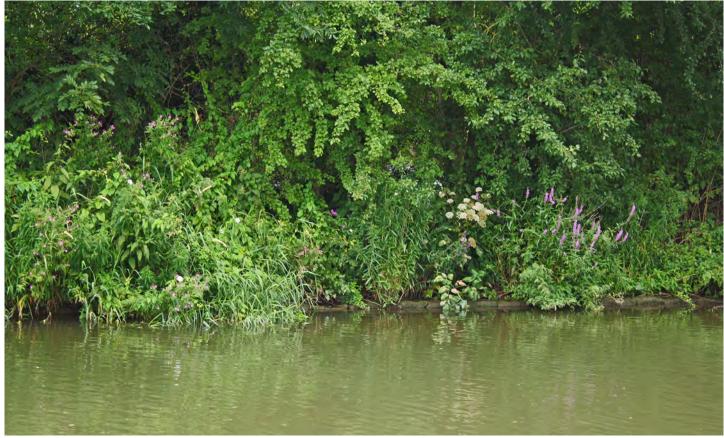
The introduced bagwork has settled (soil and silt has solidified) and is standing up well to wash caused by passing boats. Where there is sufficient light there is good vegetation growth and numerous plant species have successfully established. However, in some areas lack of maintenance means riparian vegetation has overgrown, restricting some views of the river from the towpath. The minor tree work carried out along the towpath has since ceased and it is suggested that the scheme may have benefited from a tailored tree maintenance schedule.

Vegetation growth has established and the bagwork has remained intact – August 2013
