Controlling River Bed Levels, Water Levels and Flows

5.3 River Ogwen 2013 Update

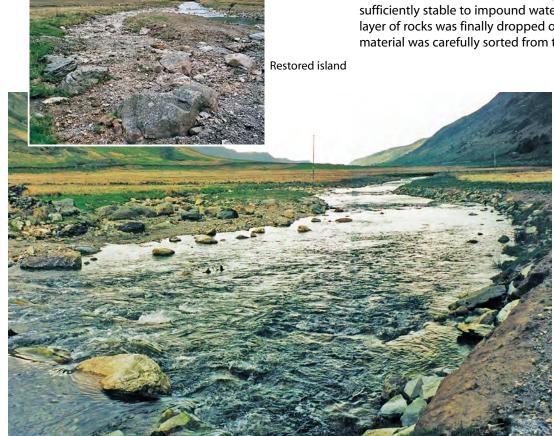
Restoration of boulder cascade, stepping stones and braided channel

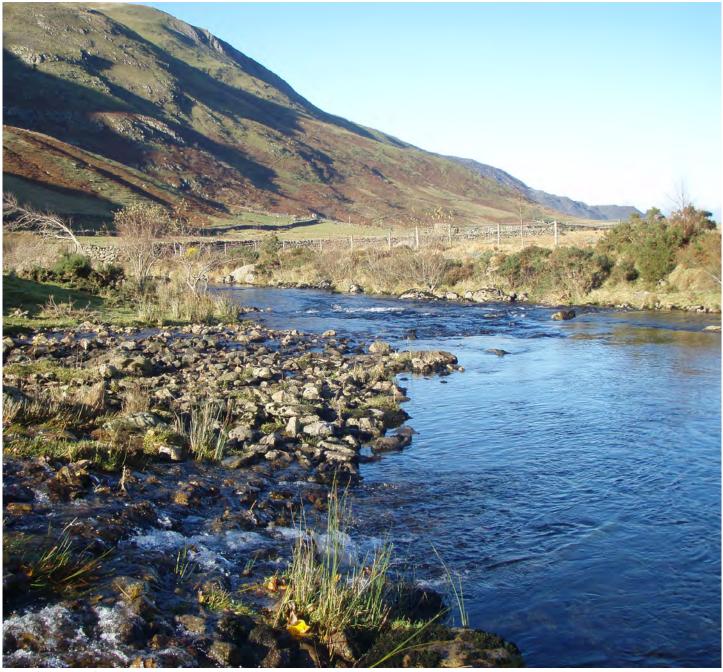
No negative consequences of raising the bed level have been observed., The longitudinal profile has remained stable with no significant morphological adjustment. A greater variation in flow diversity has been observed compared to the previously very uniform condition. Both factors indicate the success of the scheme.

Restored bed levels and bank profile. Right bank vegetated as a result of fencing. November 2012.
