## 12.6 Complete removal of a small low head weir

### RIVER GREAT OUSE

LOCATION - BUCKINGHAM, SP 69473350

DATE OF CONSTRUCTION - JUNE 2016

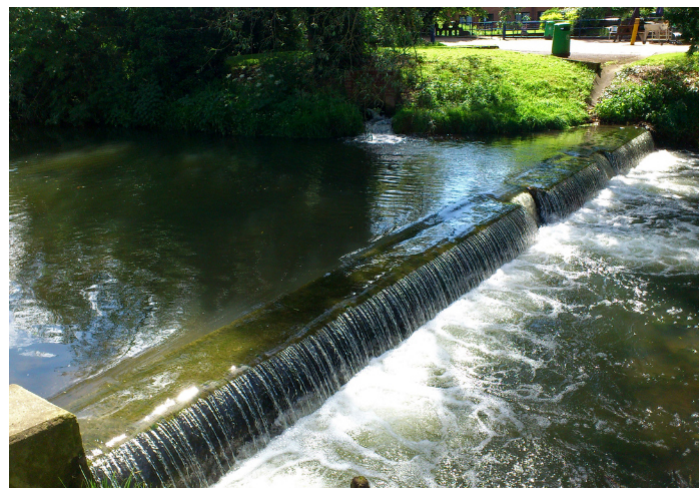
Intact 0.5m concrete weir – 2012

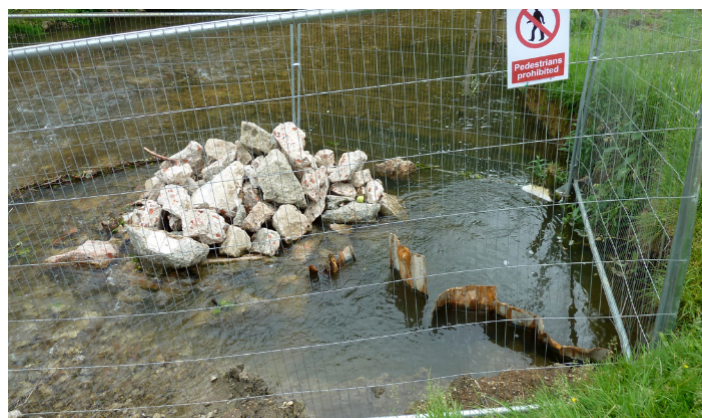
Weir concrete used to fill scour hole – June 2016

1. Working in the wet, break up and remove concrete weir using 13 tonne 360 excavator and breaker attachment.
2. Smaller concrete remnants used to infill the 2m deep scour hole. Larger concrete sections removed from site to a licensed waste facility.

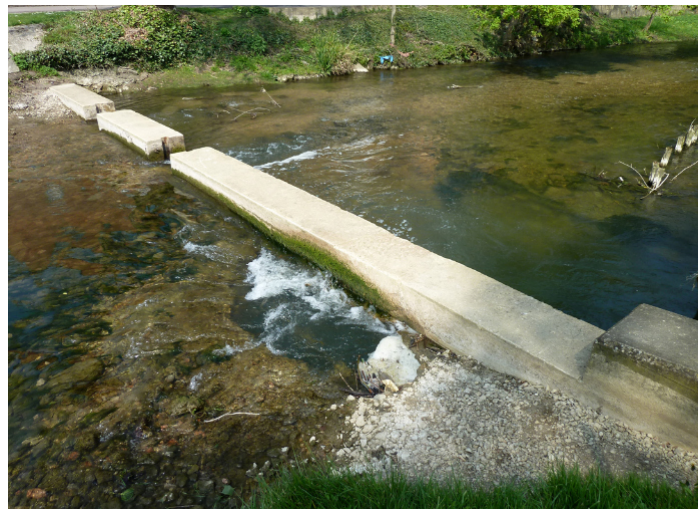
Over the next few weeks the void continued to enlarge creating a significant 2m deep scour hole on the downstream side. By May all of the low flow volume was passing under the weir, effectively making it redundant. Removal was deemed to be the most desirable and cost effective solution to restore natural processes, improve fish passage and improve public safety.

Large scour hole beneath weir – May 2016

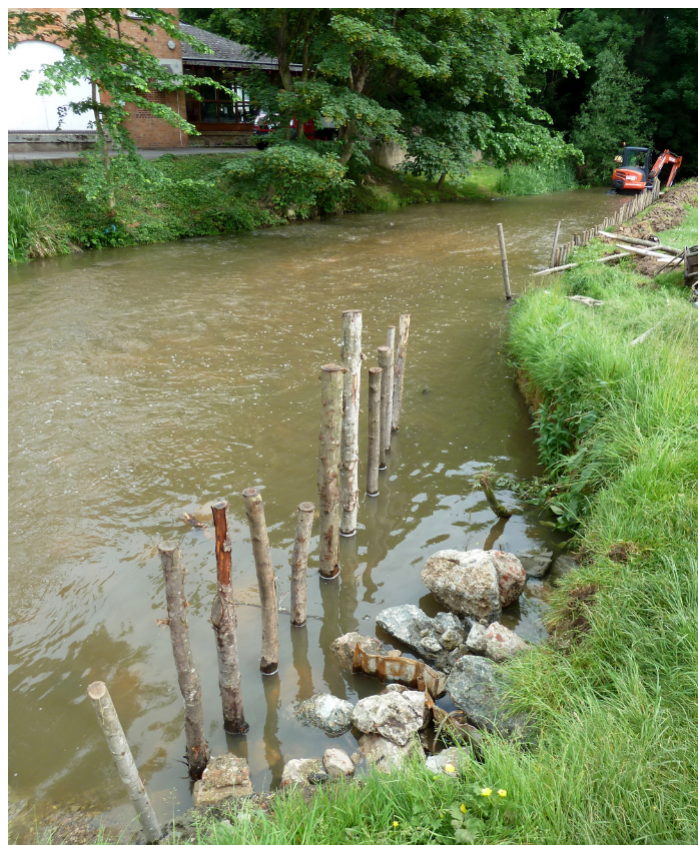
Trench sheeting and concrete fill buried behind bank revetment line – June 2016

3. Trench sheeting found beneath the weir extension. Folded over and buried in the void and bank.
4. Bank toe protected with a post and geotextile retaining line to tie in with the failed toe board replacement and regrading work.

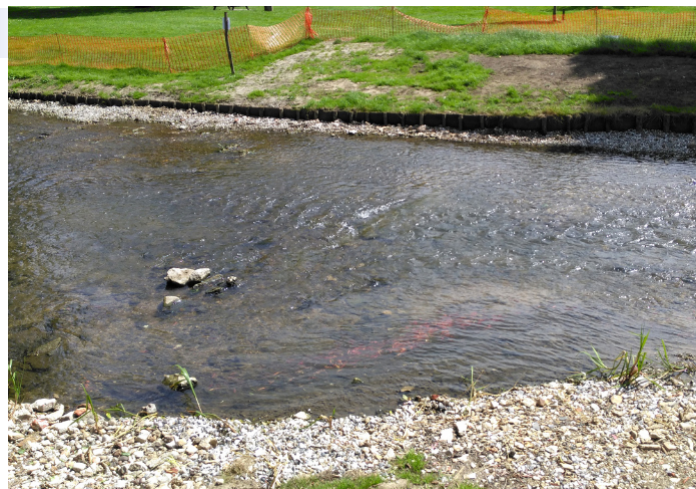
Location of removed weir after a year – July 2016

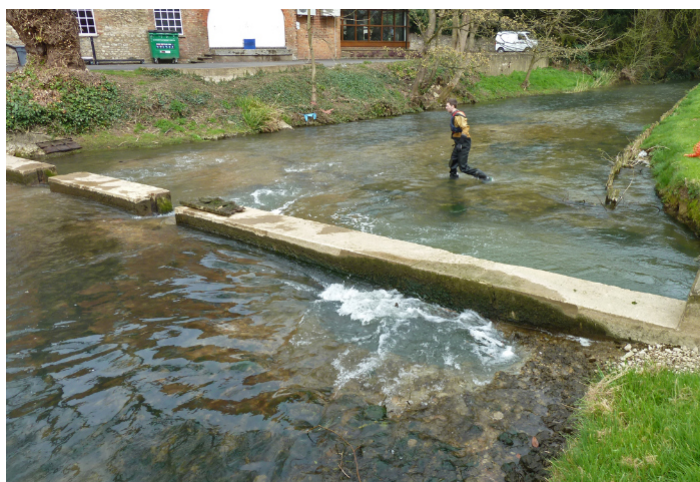
In April 2016, the weir developed a void below the previously extended section, undermining the structure and dewatering the river above. Environment Agency staff removed the two sets of wooden sluice boards to reduce the head of water and to visually assess the implication of removal on the upstream impounded levels (a weir pool, University grounds and residential gardens).

Failed weir – April 2016

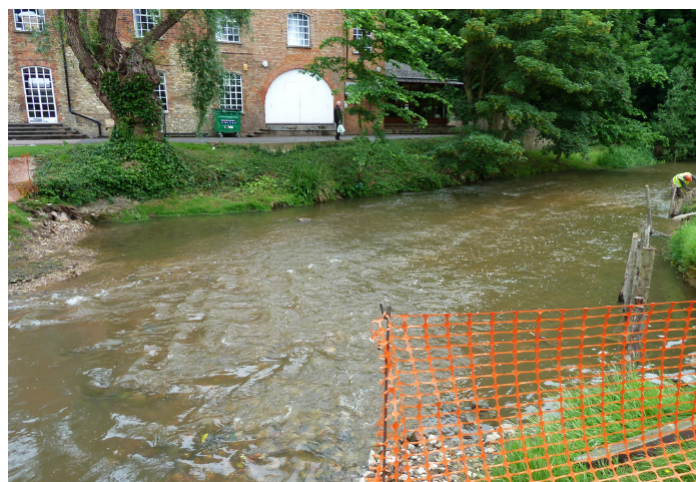
Weir removed – June 2016

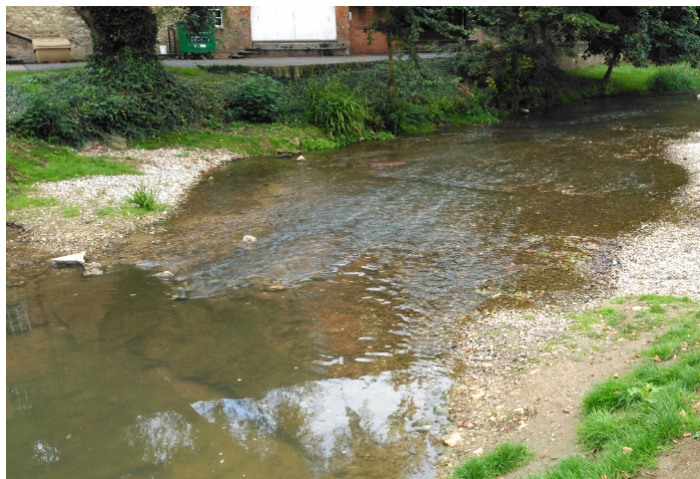
Imported gravel covering the concrete fill and creating accessible 'beaches' – Sept 2016

5. Remove the identified redundant service pipes associated with the weir.
6. Grade existing bed gravels into voids and use 20-40mm imported gravels to dress the scour hole, concrete fill and to create shallow gravel bars at both bank edges.

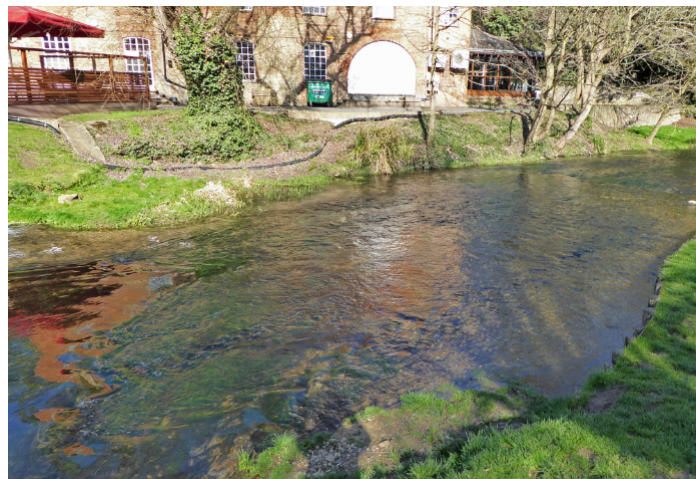
Recovery after 3 years – March 2019

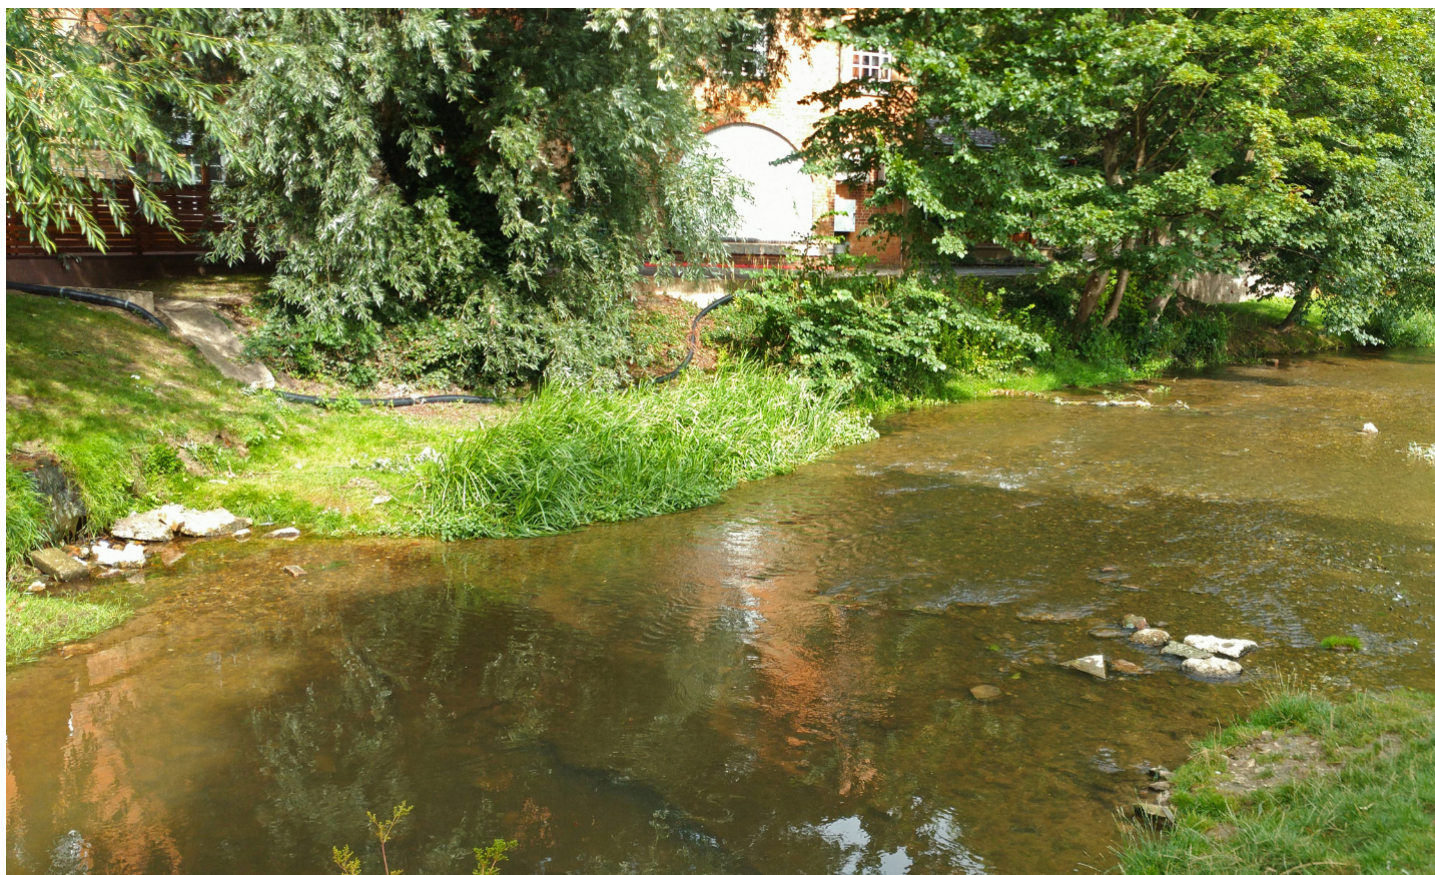
Recovery after 3 and a half years – Oct 2019
