Test & Itchen River Restoration Strategy - Appendix B Progress Report

River (& local name)	Reach Code	SSSI Units	Management Option
River Test – Southington House, Overton	T009 and T010	84	Rehabilitate N.B I think this should be a red restore due to large impounding structure.
<p>SU 50953 49769 Restoration Potential- Issues to address in Appendix B of the strategy: T009 -This reach is modified through Overton Town and impounded upstream of a sluice for around 75m. In this section the left bank is Overton sports ground and the right bank is garden. The bank is mown along both banks downstream. Channel is heavily modified through over-deepened and over-widening. It is a major silt trap with little flow diversity. A major sluice exists in the river creating a flow split by the sports ground. Previous attempts have been made to narrow the channel which have been unsuccessful due to the depth of the channel.</p> <p>T010 – Channel through Overton golf course starts at upstream end as a hatch take off from the main ponded area. Flow has been increased through the reach. The upstream end is gravel and chalk gravel but the downstream end is silted through the private grounds joining the mai

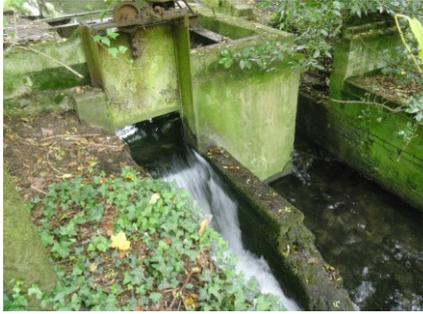
<p>Historic structure. 1m head difference</p>

<p>Restoration actions in Appendix B of the Strategy: Rehabilitate through: - De-silting - Removal or partial removal/lowering of the structure.</p>			
<p>Restoration actions carried out: 2017</p> <p>This was a major collaborative restoration in the autumn of 2017 with the owner of Southington House who's land the structure is on. Robert Bull was the contractor who carried out this technically challenging job. Downstream of the structure was restored in 2016 again by Robert Bull so this project joins the two together. The main aim of the restoration was to remove the structure and improve the silted river upstream. Due to the offtake channel upstream of the structure two low level crescent rock ramps had to be made to still provide the head height for this SSSI channel to still function. A structure had been on this site since the 15th century and a silk mill operated here in the late 18th century. Because of the historic significance of the area an archeological dig was carried out by the Overton archeological society in parallel with the restoration. All the brick work surrounding the old structure was preserved to retain the historic reference. Once removed the two rock ramps were installed upstream of the old structure and a total of 300m of river was restored through bank narrowing, the use of woody material and the introduction of some large flints around the rock ramps. There was no up or downstream fish passage when the structure was in place but once removed trout and grayling were seen swimming up and down stream immediately. Eel tiles will be retro fitted to the bed on the TRB of the brick base where the structure once stood. Instead of the normal black plastic variety these will be custom made in oak to be more aesthetically pleasing against the historic brick work.</p>

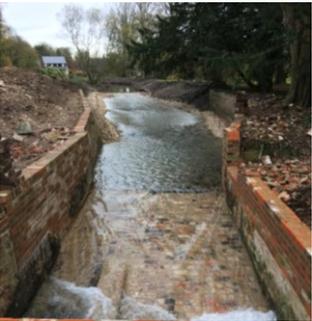
<p>Looking u/s. Structure removed, historic brick work made good. Passable for fish, upstream silt removed. 300m of channel restored.</p>

That the oak eel tiles be fitted. It has been agreed that Robert Bull the contractor will manage the site into the future. Marginal plants must be allowed to grow up to create a wide marginal fringe. Set back from the banks the area be sown with wild grass and flower mix so as to create a variety of natural habitats both in river and bankside for the benefit of the SSSI.
