Delivering River Restoration: Recipes for Success

13TH ANNUAL NETWORK CONFERENCE

RESTORATION IN TIGHT SPACES! LEGACY ENGINEERING AND RIVER NATURALISATION

G. L. Heritage, M. Schofield & S. Bentley

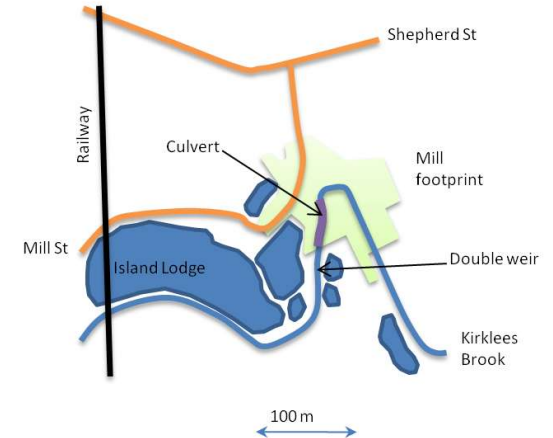
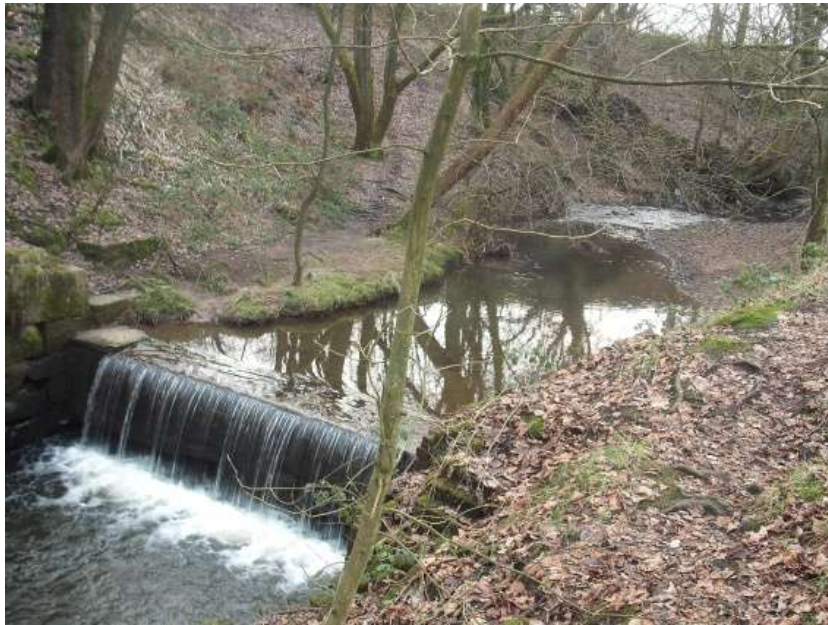
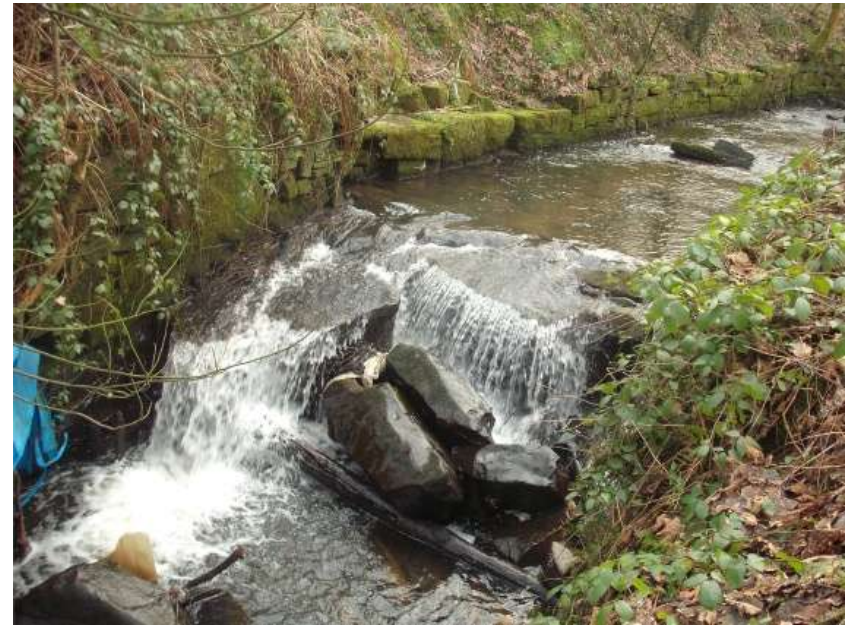
Two old weirs were preventing fish movement along the watercourse. Easement of these obstructions would open up 6 km of river to migratory fish.

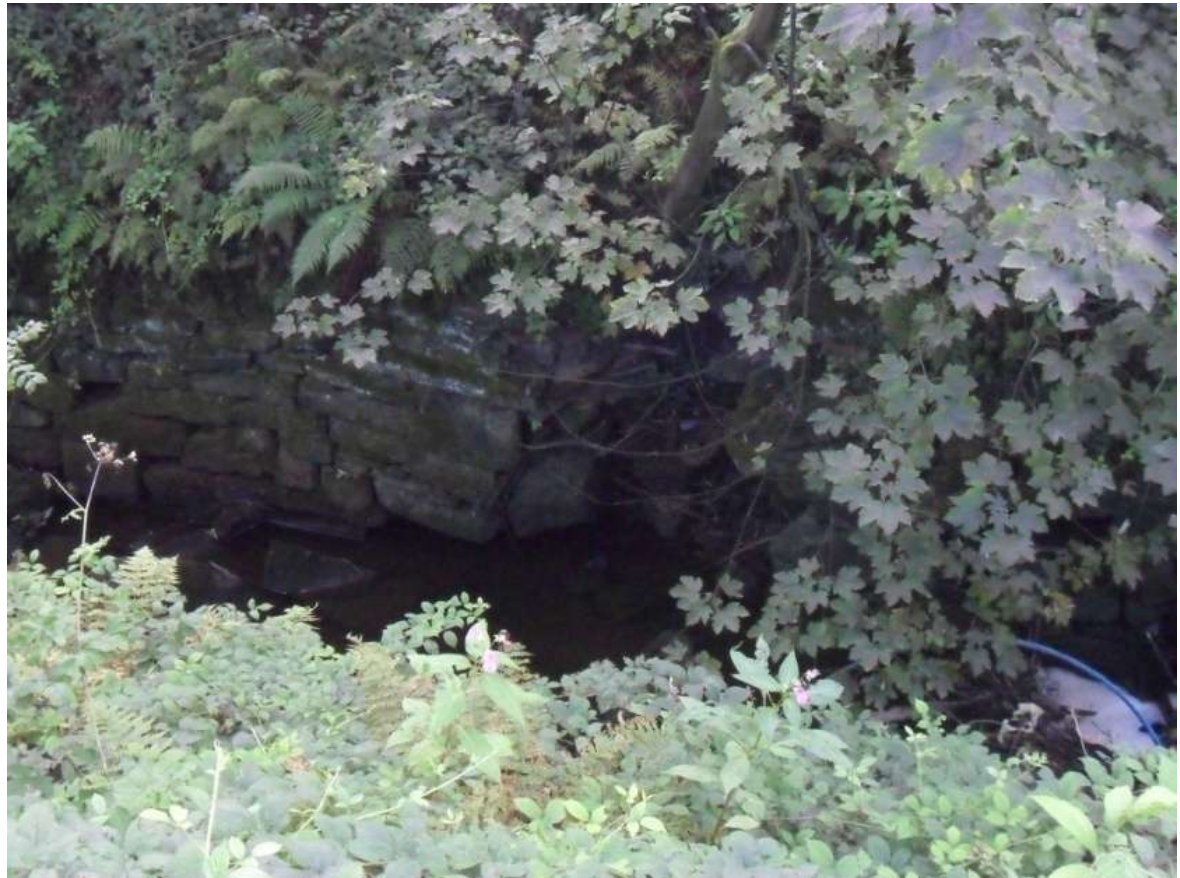
Need to maintain the structural integrity of the masonry retaining walls protecting old lodges associated with the historically important former Calico print works.

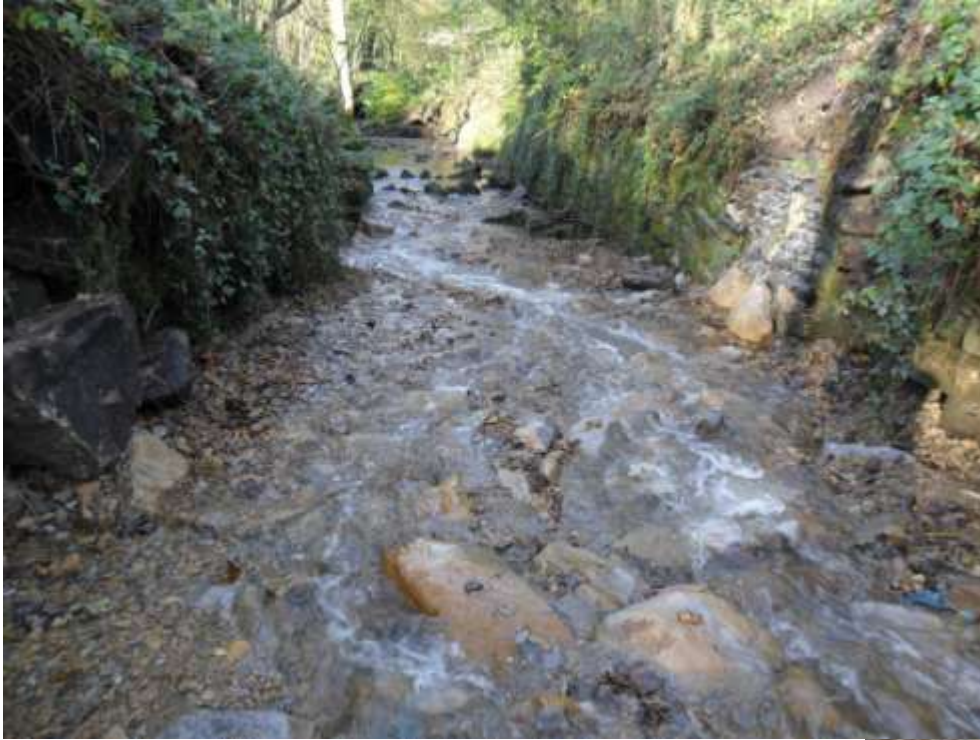
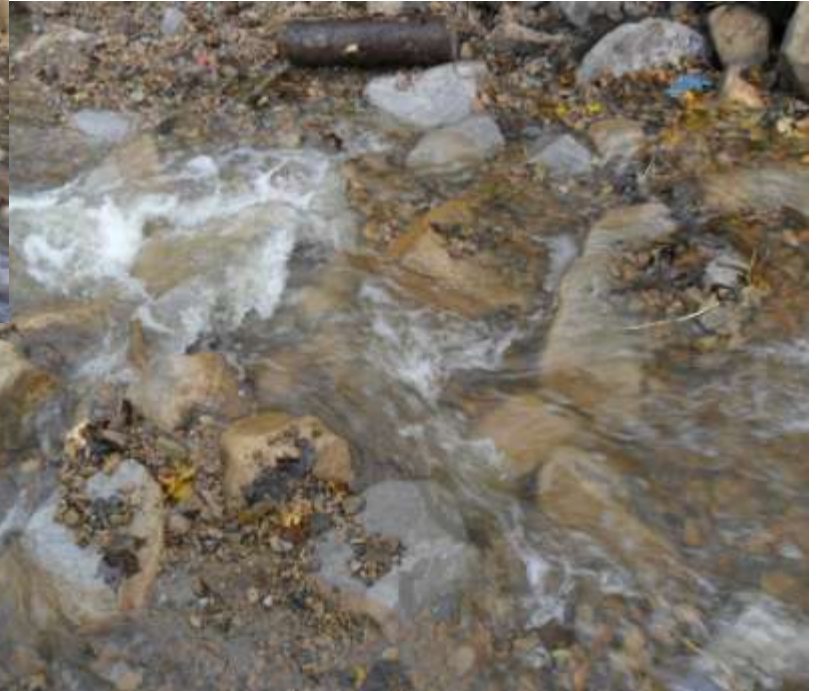
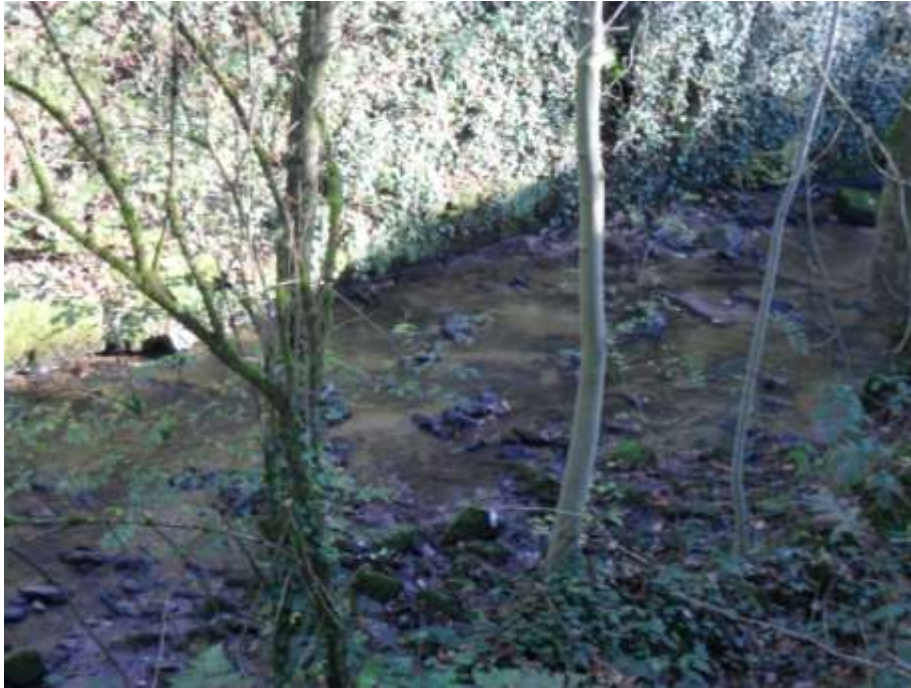
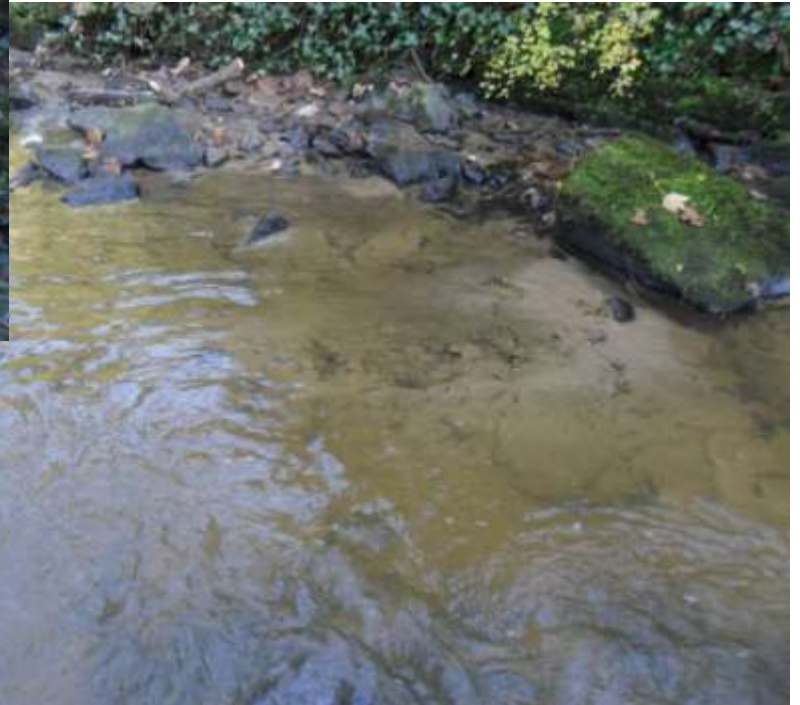
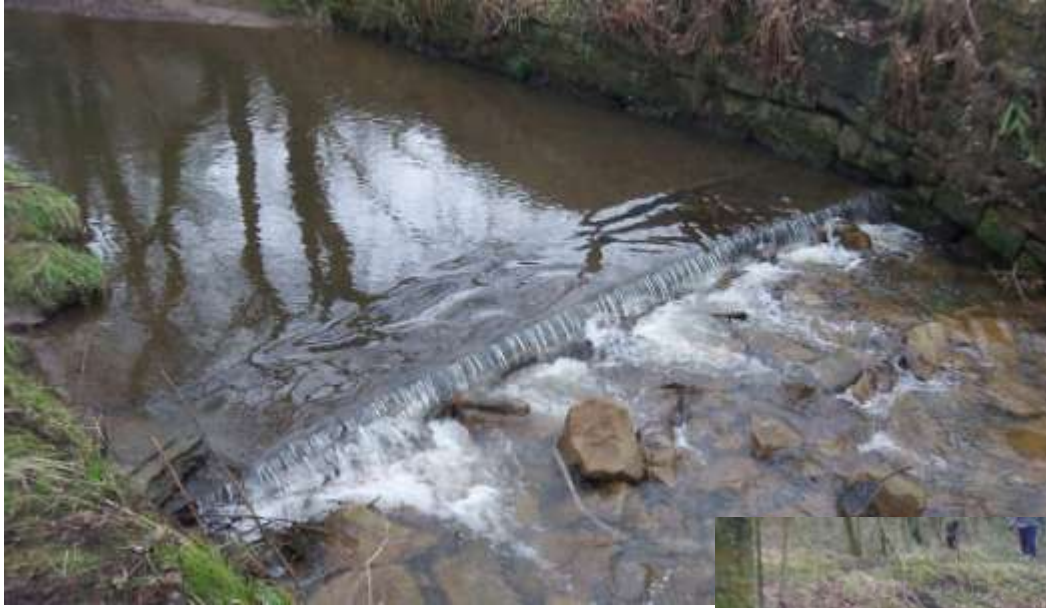
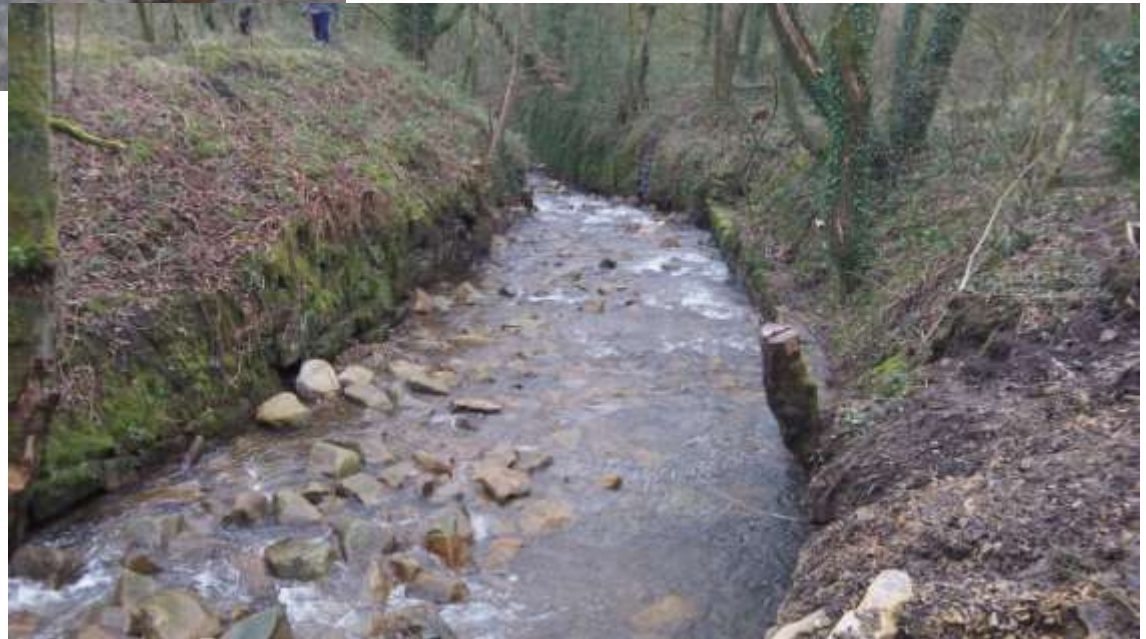
- Project 'constrained' by historic setting
- Options informed by geomorphologic audit
- Functional channel morphology restored
- Generally successful: Infill 'mix' is critical
- Enthusiastic and knowledgeable regulators helped
- Conservative approach led to missed opportunities
- Experienced, willing and able contractor is key
- Gravel accumulated in culvert downstream, not elsewhere
- £41k
