# Restoring Meanders to Straightened Rivers

## 1.1 New meandering channel through open fields

### RIVER COLE

LOCATION - COLESHILL, (OXON/WILTS BORDER) SU234935

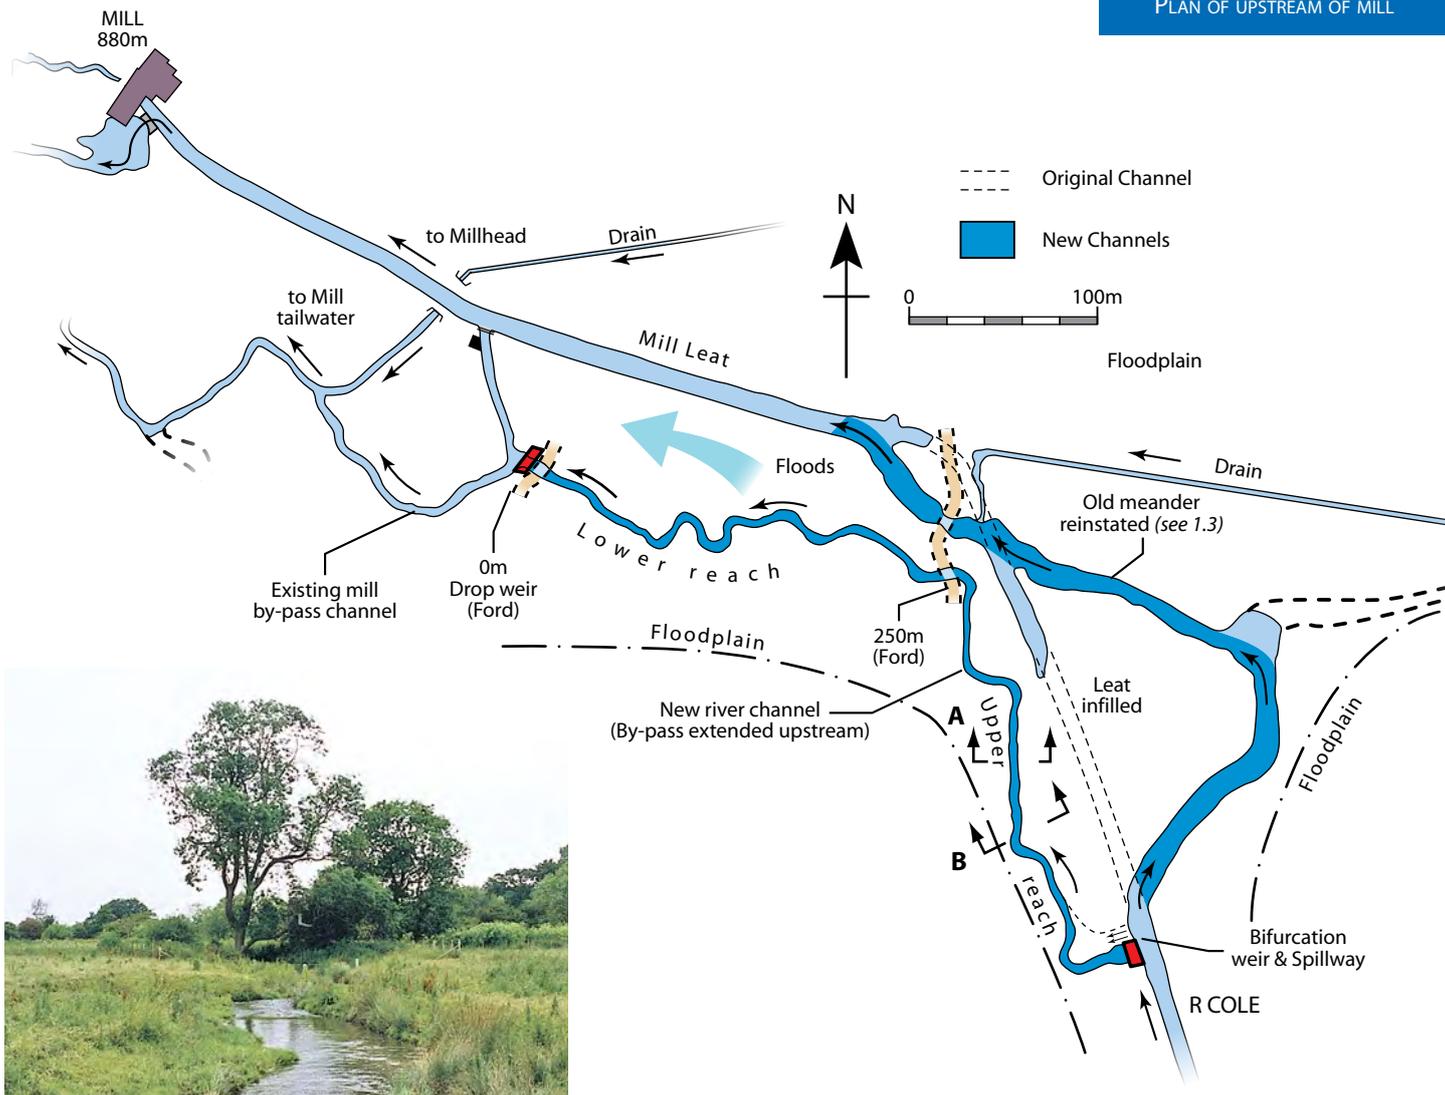
Figure 1.1.1

PLAN OF UPSTREAM OF MILL

The existing mill by-pass follows an ancient course of the River Cole. Remnants of its ancient course were also evident in the fields between chainage zero and 250m, (lower reach), so the new channel was set to follow these at a fairly uniform depth of c. 1m. Upstream of ch. 250m the new channel deviates from any natural course because it had to be aligned roughly parallel to the mill leat which is unnaturally close to the edge of the floodplain. Land levels along this upper reach rise significantly above the average for the floodplain, hence the new channel is deeper. Meanders were set out to 'mimic' the natural form evident in the lower reach.

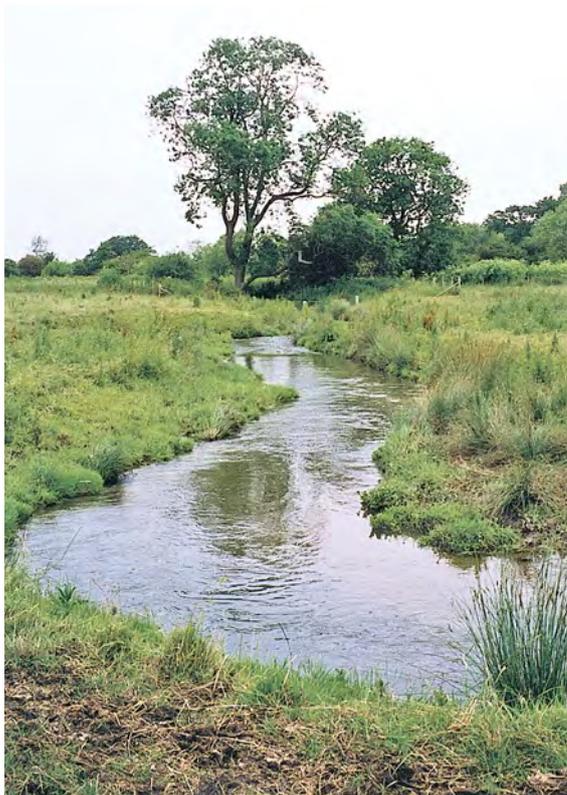
Lower reach in Summer – August 1997

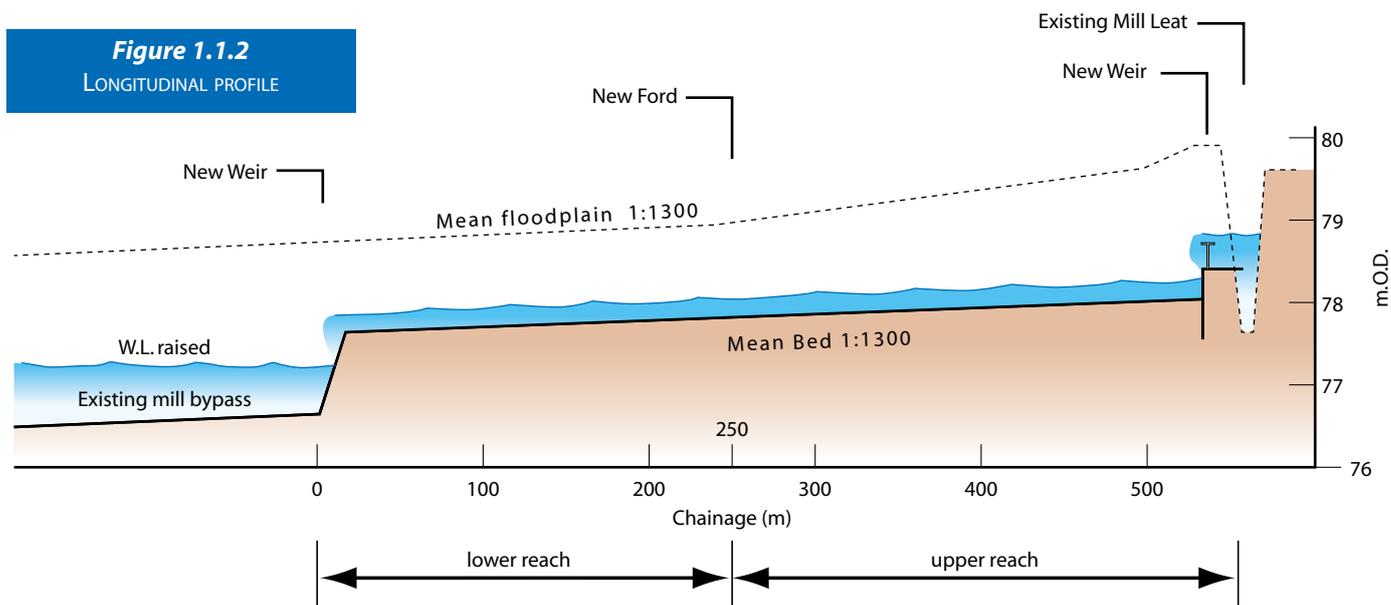
**Figure 1.1.2**  
LONGITUDINAL PROFILE

The new mean bed gradient was set at 1:1300 to match the mean floodplain gradient. The bed elevation was set to give the shallowest channel possible whilst having just sufficient depth to contain summer spates. The resultant channel bed is elevated higher than the old mill by-pass, but is lower than the retained water level in the mill leat which feeds it. Drop weirs were therefore required at each end (see Techniques 5.1 and 5.2).

Whilst weirs are generally undesirable, the alternative of deeper channels was more so at this site. The drop at the downstream end was reduced in height as a consequence of introducing new meanders downstream of the mill; these raised normal water level in the existing mill by-pass to historic levels (see Technique 1.2).

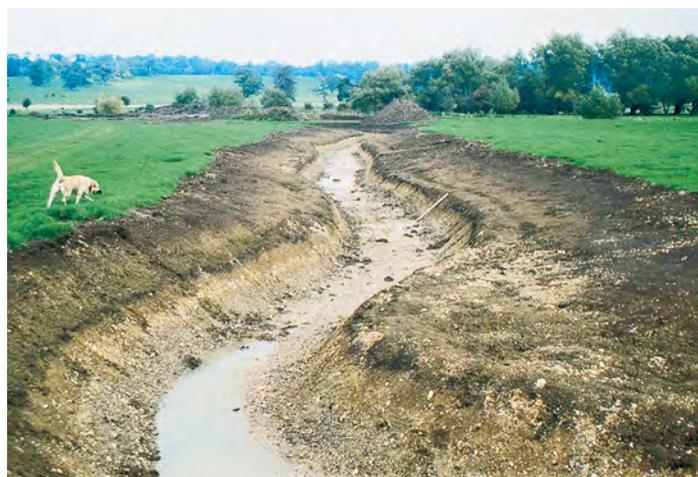
Upper reach at time of excavation – October 1995

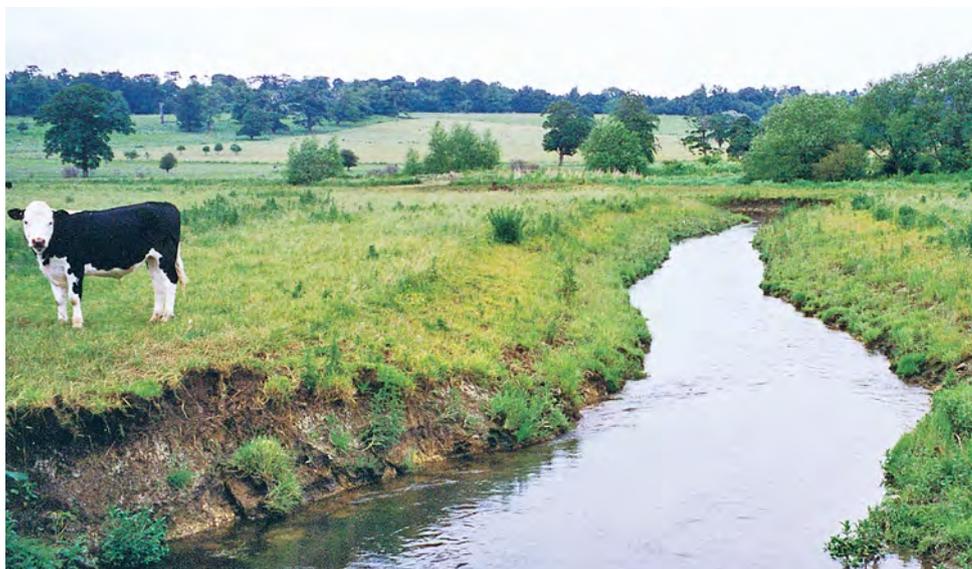
Upper reach – 1998

The upper reach of the channel developed an intermittent bed substrate of gravel as well as small riffles of gravel below each meander. Limited supplies of gravel are derived from the clays exposed towards the bottom of the channel; none are carried down from the upper catchment. Additional gravels were imported to this reach one year after construction and 'seeded' into each pool for distribution by flood currents.

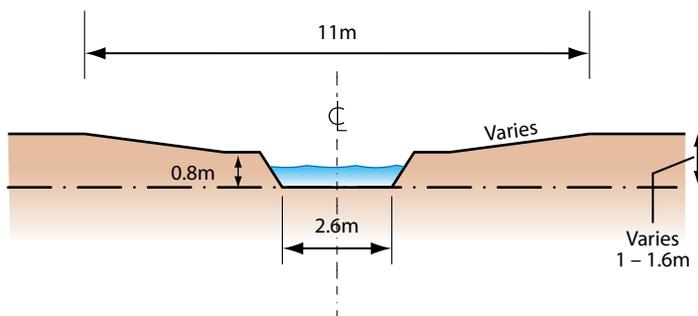
Figure 1.1.3

Section A shows a normal flow channel 2.6m wide by 0.8m deep - the geomorphology of the Cole indicates this to be the ideal size of channel. Because overall channel depth needed to exceed 0.8m (Figure 1.1.2). The upper banks were graded back as flat as practical.

SECTION A THROUGH SYMMETRICAL CHANNEL

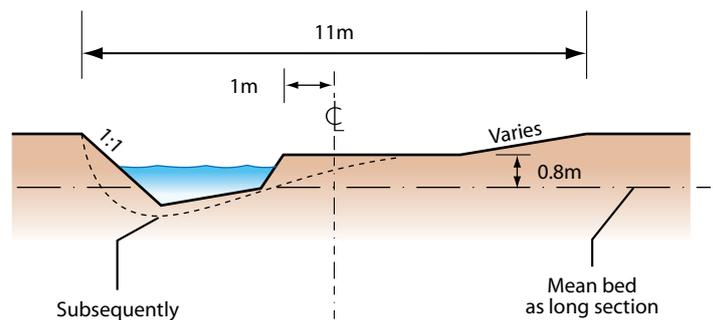
Figure 1.1.4

Section B shows a compatible asymmetrical profile introduced at each significant bend. The deepest bed level is cut below the mean bed gradient to introduce pools. The 1:1 batters on the outside of the bend were expected to steepen through natural channel adjustment.

Land levels were lowered to a depth of 0.8m above mean bed as shown on Section B. As all meanders are small in amplitude, no further shaping was undertaken; profiles were simply rounded off to give smooth transitions into Section A either side. The profile was later modified (see *Subsequent Performance*).

SECTION B THROUGH SYMMETRICAL CHANNEL

The stiff clays in the river banks resisted erosion preventing cliffs from forming on the outside of meander bends where 1:1 batters were cut. Conversely, floodwaters were racing across the flat areas formed on the inside of each meander causing scour of the surfaces. The asymmetrical profiles were subsequently re-excavated as indicated on Section B.

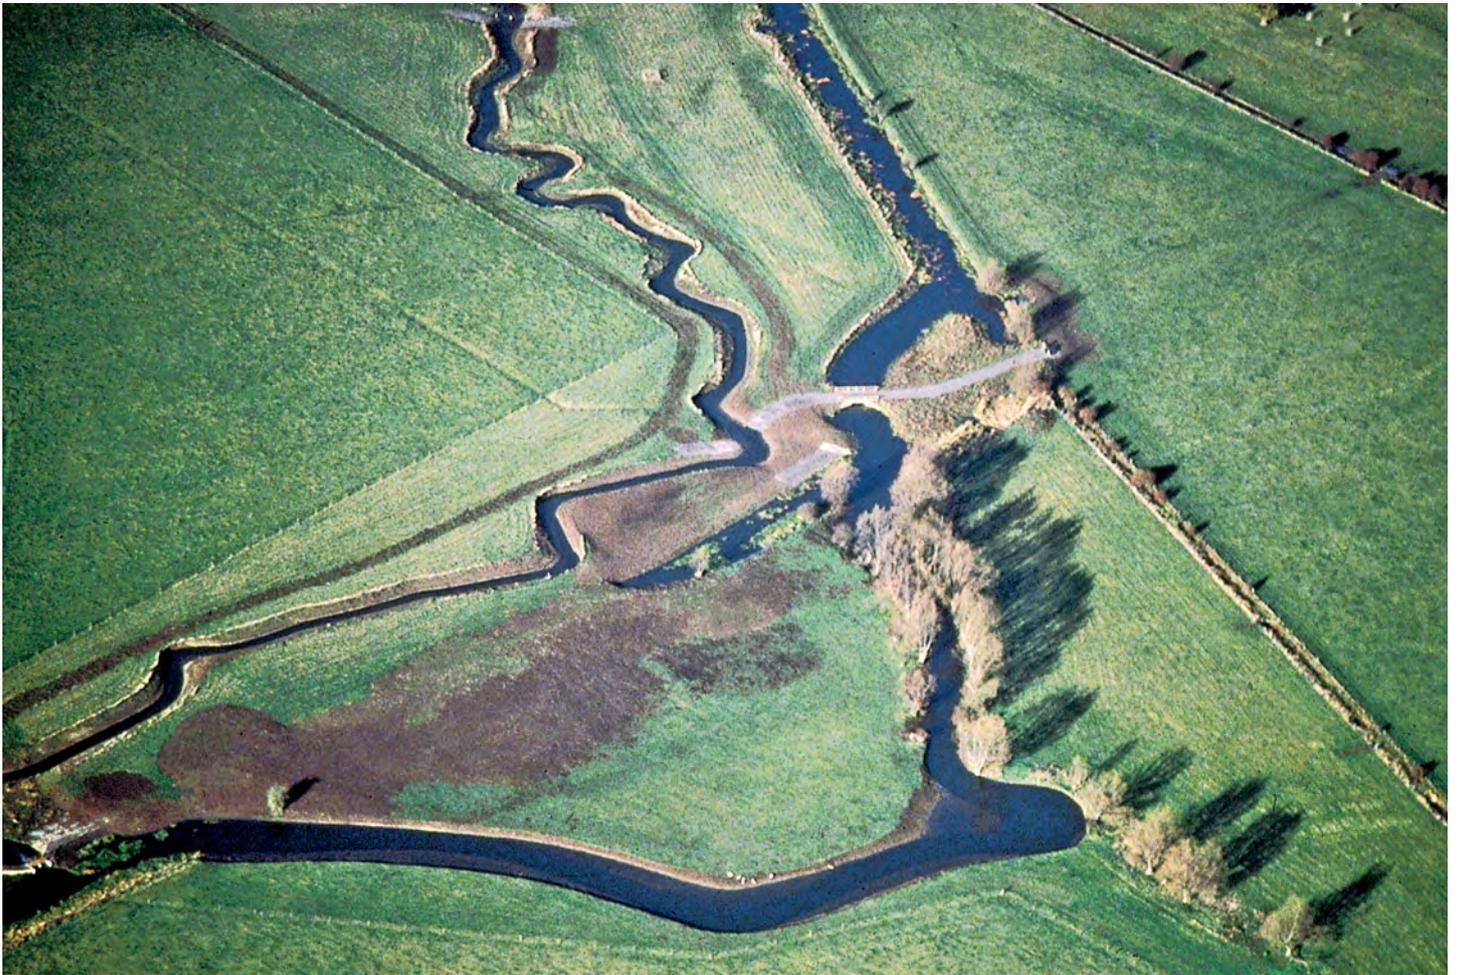
The new meandering river course and the restored meander in the mill leat (see 1.3) – July 1997  
Photo: Environment Agency
