Restoring Meanders to Straightened Rivers

1.2 New channel meandering either side of existing channel

RIVER COLE

LOCATION - COLESHILL, (OXON/WILTS BORDER) SU234935

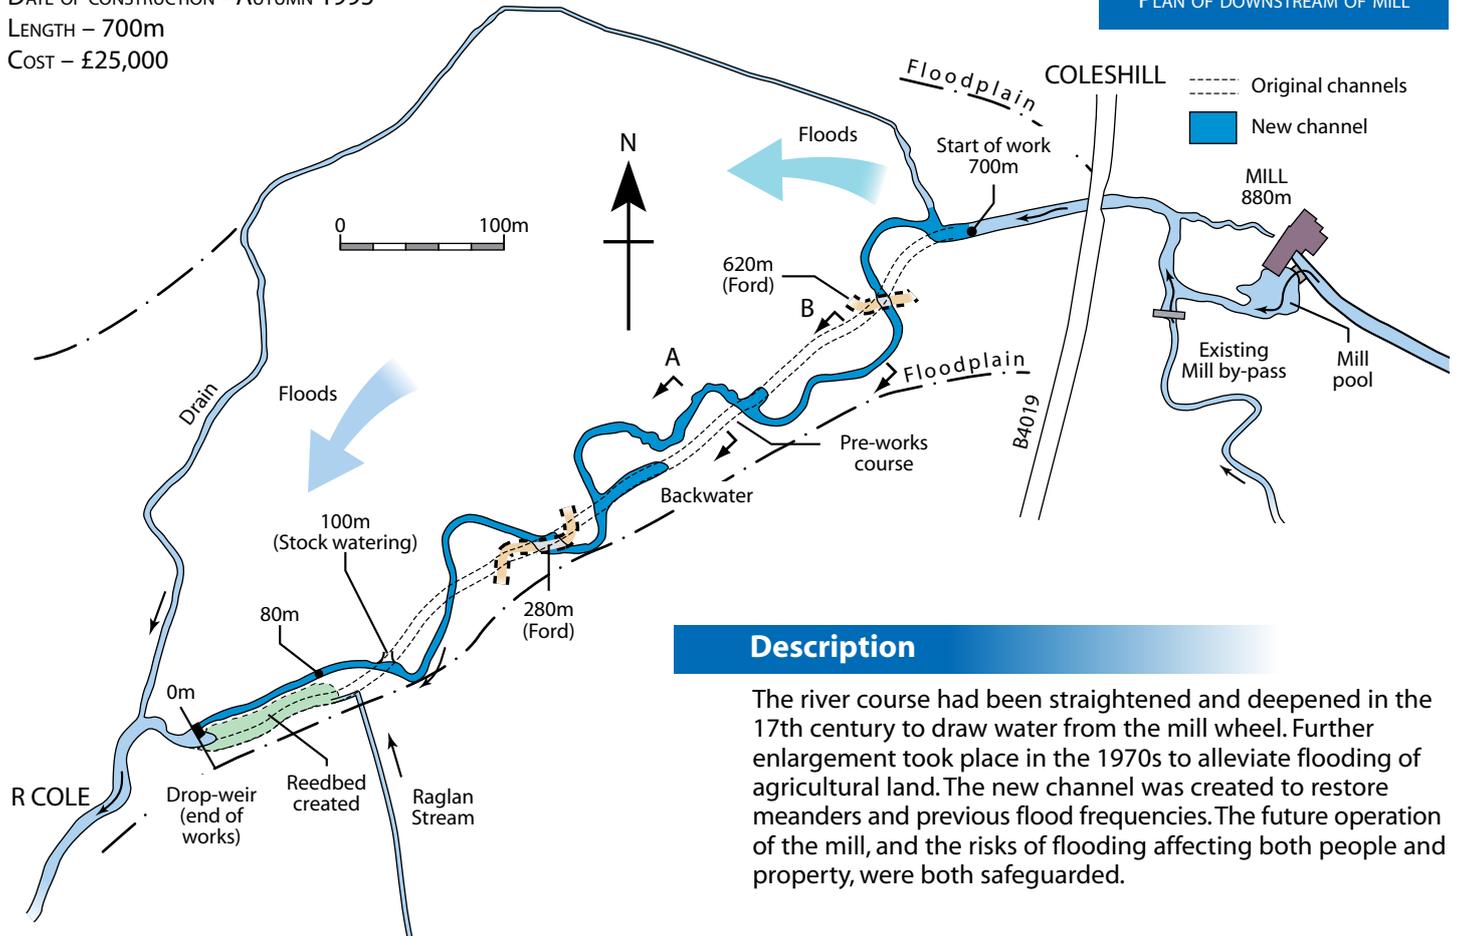
Figure 1.2.1

PLAN OF DOWNSTREAM OF MILL

Practical influences on the meander layout were the desire to retain several mature willows on the new river banks, and to maintain a sensible balance of land areas lost/gained either side of the old straight course. A geomorphological audit of the river, including a study of meander form evident in the downstream reach, finalised the layout. The relatively straight reach between ch. 0 and 80m avoided disturbing a fritillary meadow alongside and facilitated a riverside reedbed downstream of the Raglan Stream junction (see Part 9). At ch. 280m the meander deliberately cut into rising ground just off the floodplain to provide a local cliff face c. 2.5m high.

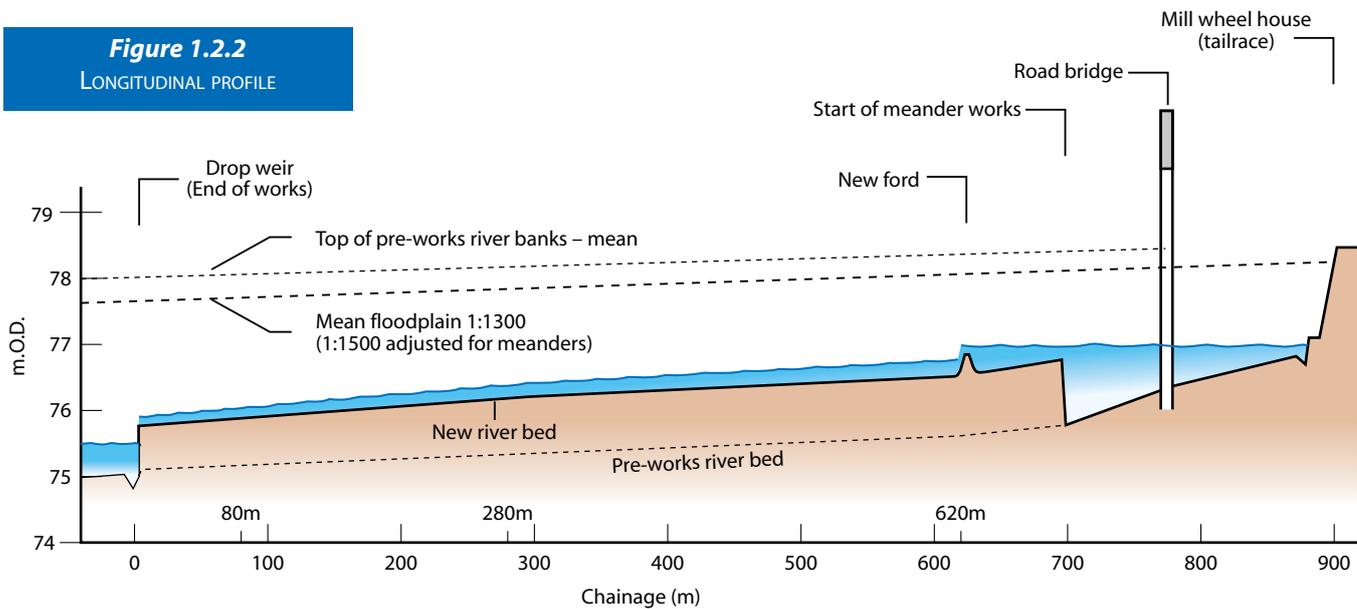
Figure 1.2.2
LONGITUDINAL PROFILE

The elevation of the new river bed was raised by up to 1.0m, the maximum possible that still enabled water to flow freely from the old mill wheel tailrace. The bed gradient would ideally have paralleled that of the mean floodplain gradient (1:1300 straight; 1:1500 meandered) but was steepened to reduce the height of the drop structure needed at the downstream end of the reach. The actual bed gradients constructed are: chainage 0-280m at 1:740; 280-620m at 1:1000; 620-700m at 1:460; these equate to a mean of 1:700.

The raised bed enabled impoundment of water upstream of the works, restoring historic levels in the mill pool and the mill by-pass. A stone ford was built at ch. 620m to safeguard water levels against any downward scour of the new bed.

These were all lowered by c. 0.4m to levels that approximated to the mean floodplain levels (Figure 1.2.2).

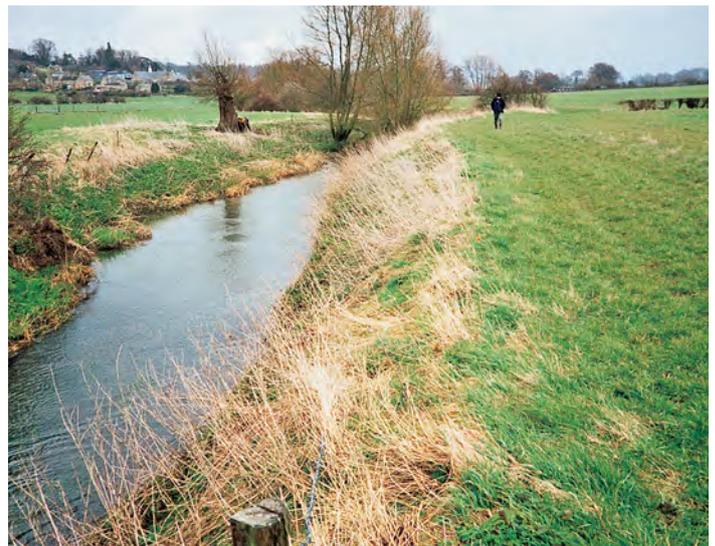
Channel before works – 1994

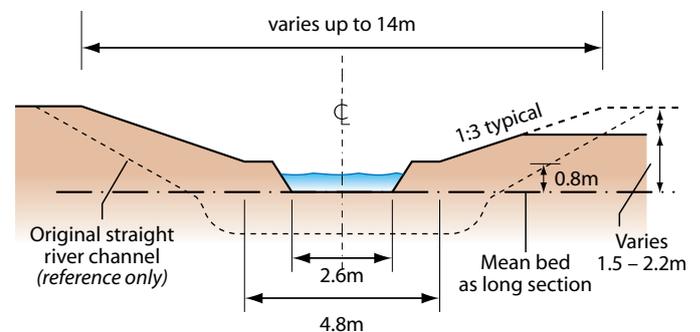
Figure 1.2.3
SECTION A THROUGH ASYMMETRICAL CHANNEL

Section A shows a normal flow channel 2.6m wide by 0.8m deep. The geomorphological audit of the Cole indicates this to be the ideal size of channel. Because actual channel depths were greater than 0.8m, the upper banks were graded back at shallow profiles.

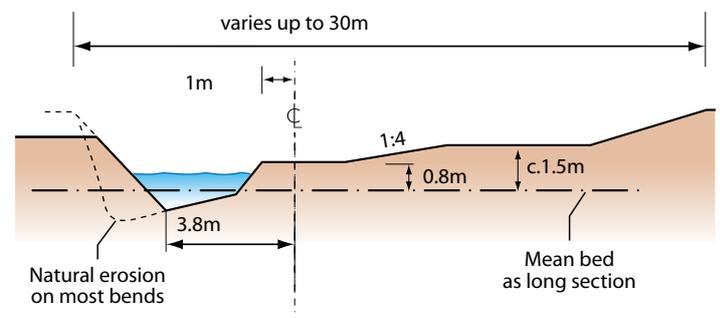
Figure 1.2.4
SECTION B THROUGH ASYMMETRICAL CHANNEL

Section B shows a compatible asymmetrical section introduced at each bend. The deepest bed level is below the mean bed gradient to ensure that pools are sustained.

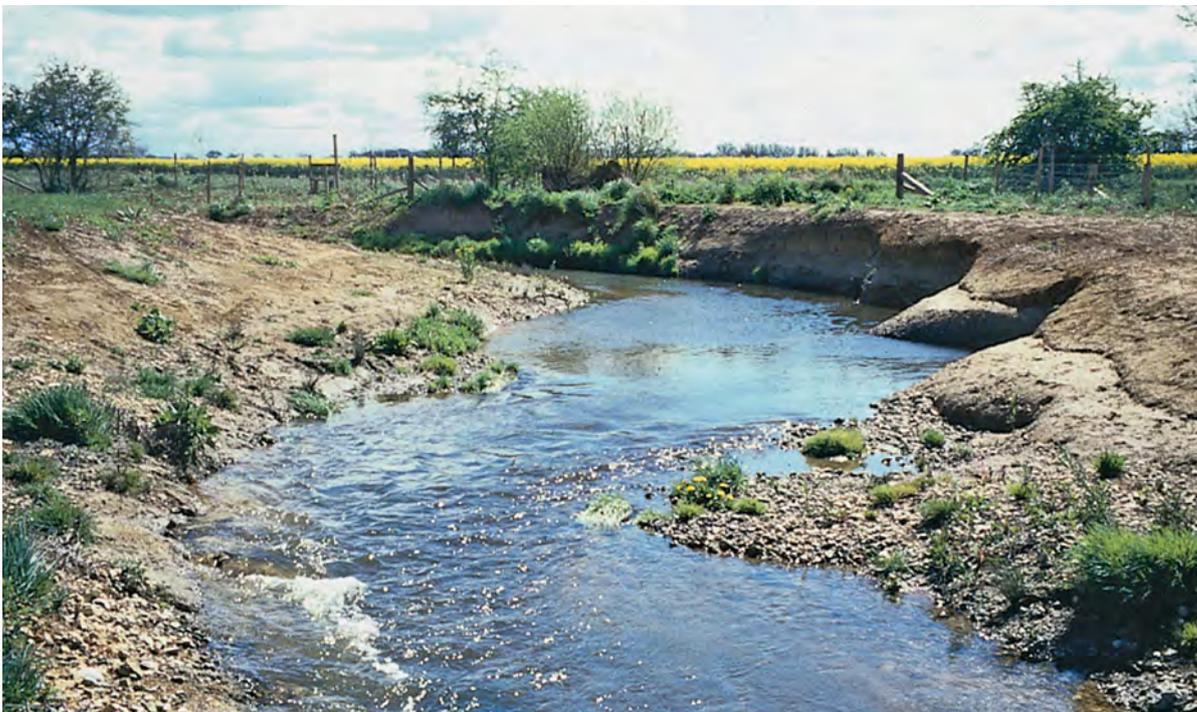
Spates of floodwater immediately following completion of the new channel led to rapid and extensive reshaping of the channel. Cliffs were eroded, pools were scoured and gravel riffles and sandy shoals deposited, all creating desirable natural features within the reach. Excess sediments built up immediately downstream of the works, helping to restore a further reach of the original over-deep channel. Since these initial adjustments, subsequent spates have satisfactorily sustained the regime

described but at a much lower rate of change. Intervention has been limited to further flattening of the profile of the inside of the south side bend at ch. 280m. The river is largely unvegetated after two summers, although marginal vegetation is becoming established. A wide range of soil types are exposed in the channel and these account for the diversity of features that are now evident.

Diverse new channel
– Two years after construction.
– March 1997

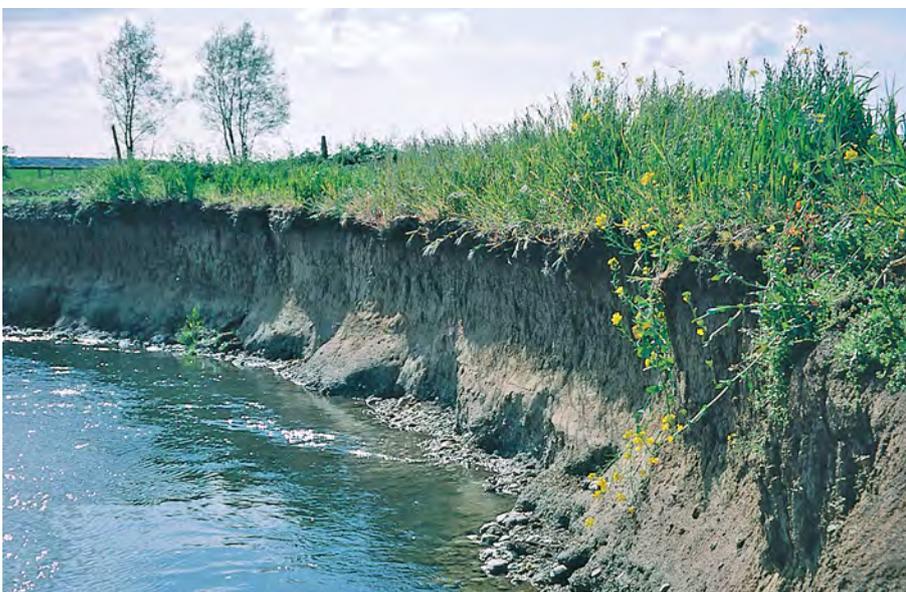
Natural cliff formation
post works – March 1997
