Restoring Meanders to Straightened Rivers

1.3 New meander in an impounded river channel

RIVER COLE

LOCATION - COLESHILL, OXON/WILTS BORDER, SU234935

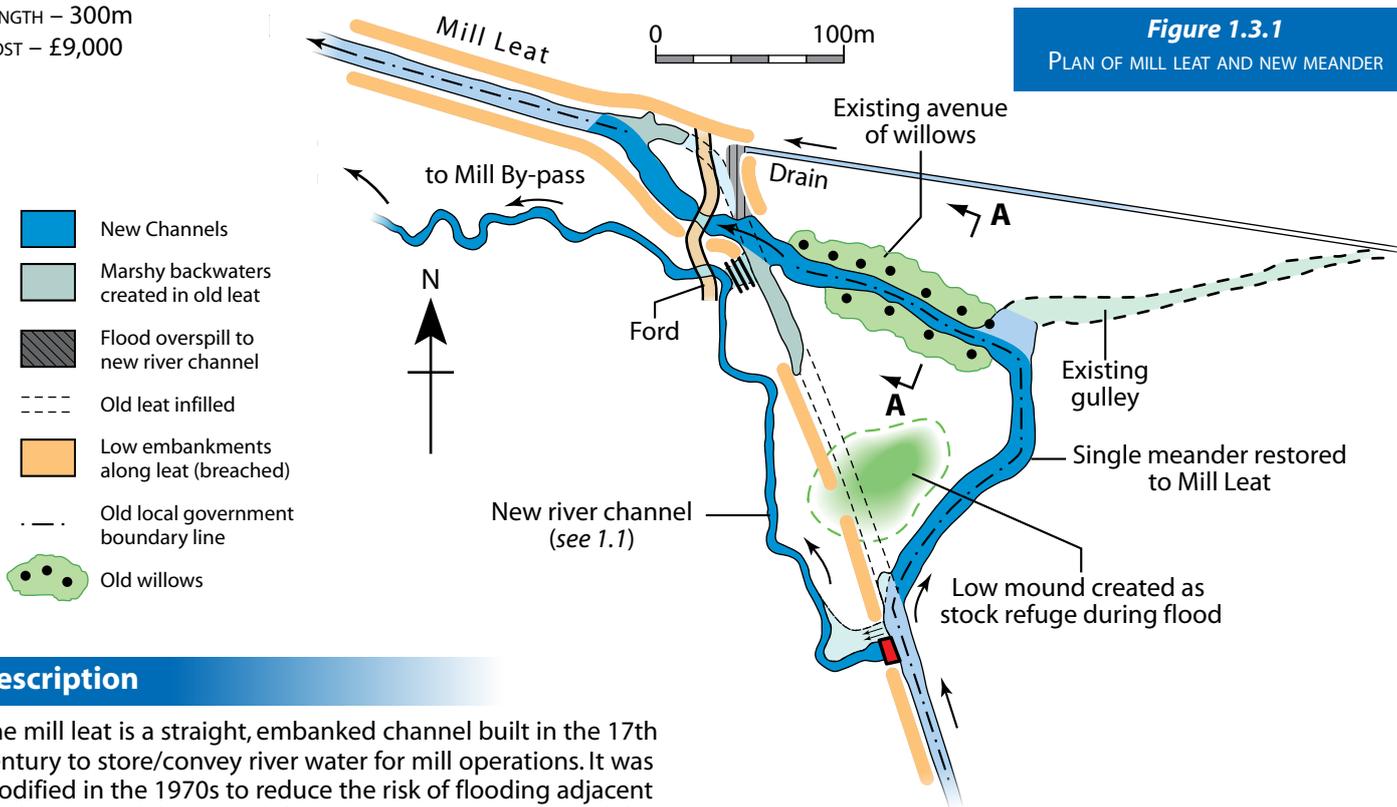
Figure 1.3.1
PLAN OF MILL LEAT AND NEW MEANDER

The pre-existence of the meander was evident in two ways. A shallow, muddy depression between a short avenue of old willow pollards, branching off the leat, delineated part of an old river channel. A study of old maps indicated that an historic local government boundary line passes between the willows, continuing in a clear meander line that rejoined the leat further upstream. This line was adopted as the centre line of the new meander because of the strong precedence.

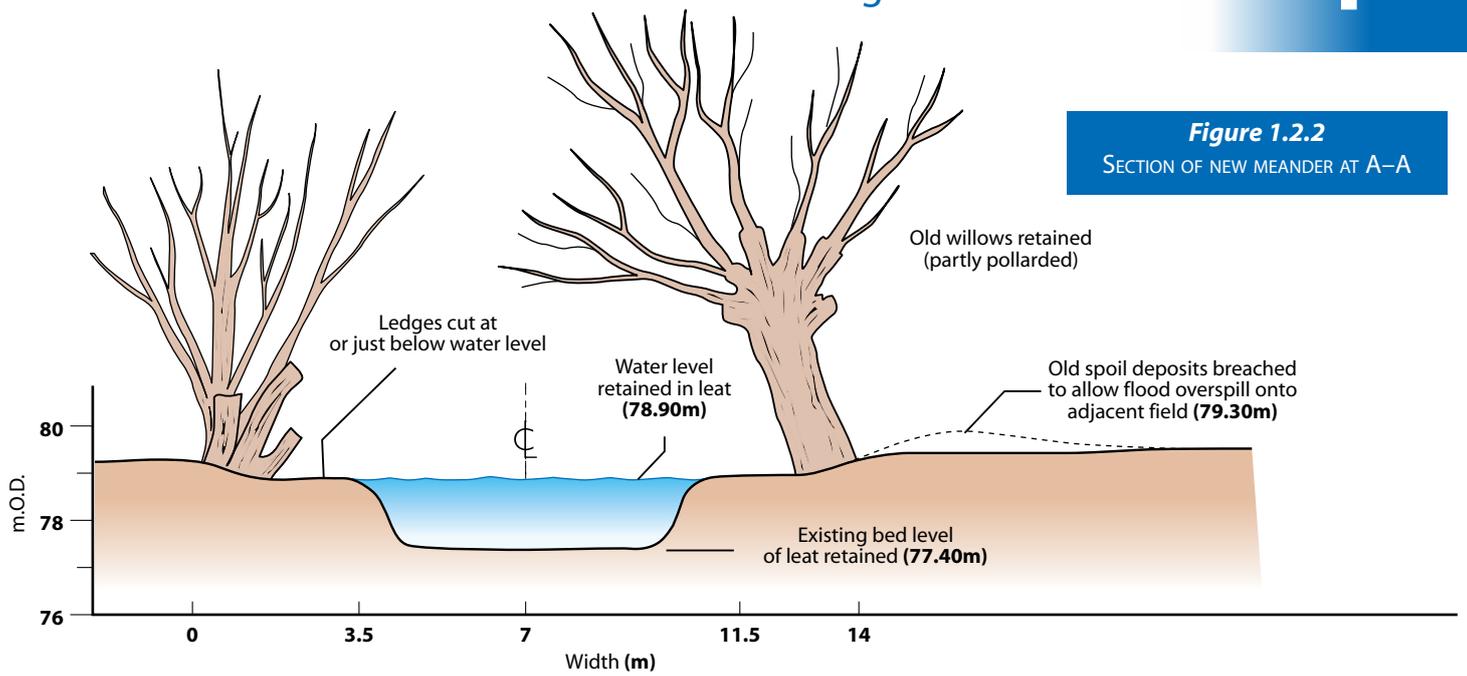
Figure 1.2.2
SECTION OF NEW MEANDER AT A-A

The width of channel between bank tops was selected to retain the willows. The resulting dimensions closely matched the top width of the remaining mill leat, so was confirmed as suitable. The existing leat cross-section displayed wide ledges at, or about, normal water level that were cattle trodden either side of a deep, relatively clear, central channel. The new cross-section mirrors this configuration.

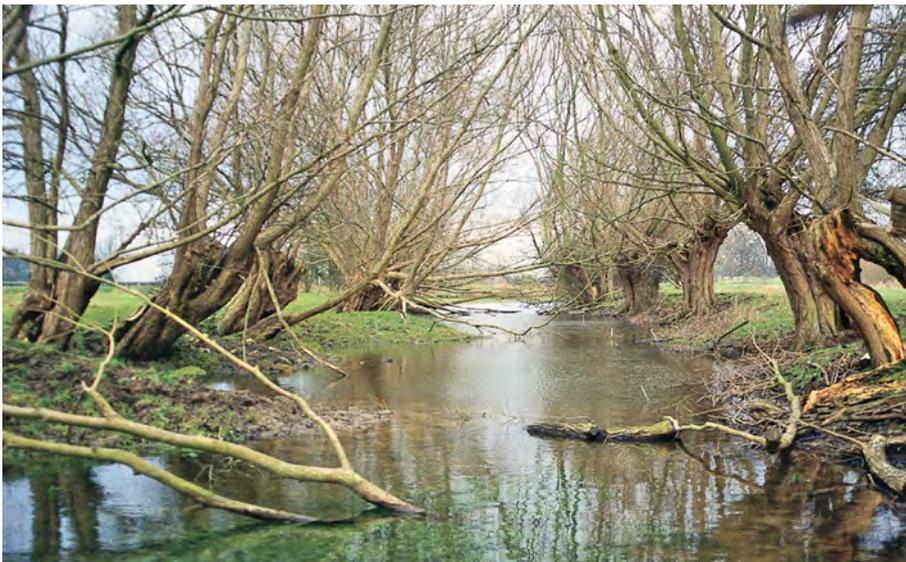
Remnant of meander
– pre-works – January 1996
(shallow water held temporarily after heavy rain/flooding).

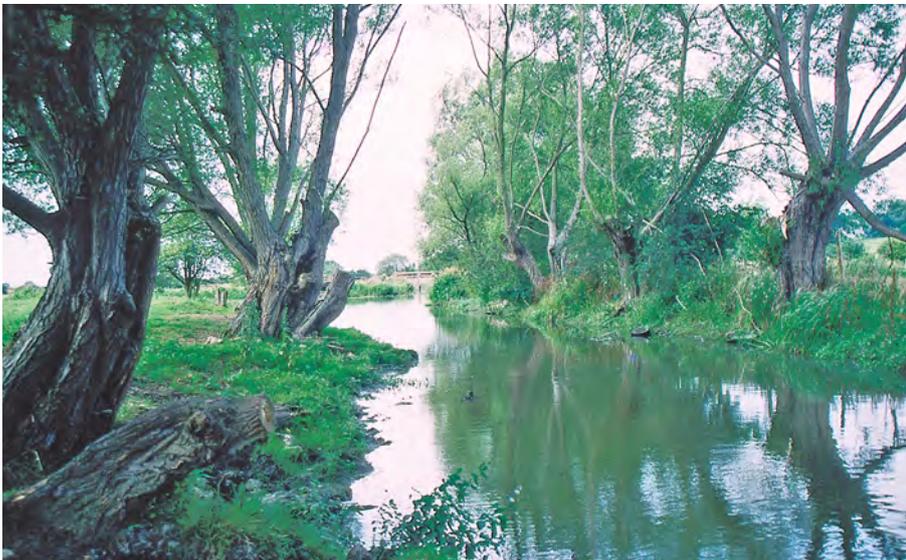
Re-excavated meander
– Autumn 1997
