# Restoring Meanders to Straightened Rivers

## 1.5 New meandering channel replacing concrete weirs

### RIVER MARDEN

LOCATION – Town centre at Calne, Wiltshire ST998710

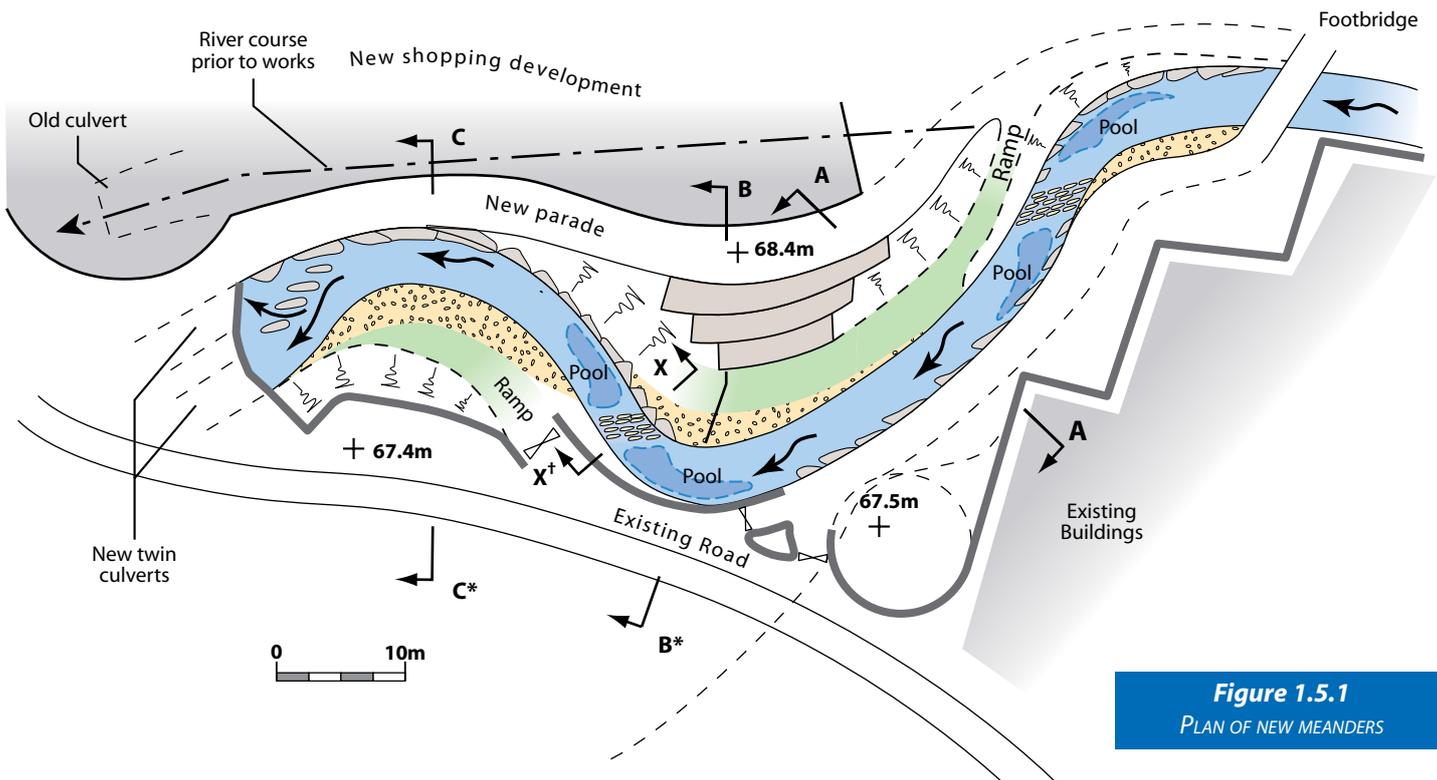
**Figure 1.5.1**  
PLAN OF NEW MEANDERS

The diversion necessitated the re-siting of the upstream part of twin box culverts that carry the river under the main road. *Figure 1.5.1* shows the location of old and new culverts. The double meander route between the existing channel and the new culverts was optimised within the constraints of the existing and new buildings shown.

The pools and shoals have remained fixed as designed and some redistribution of the bed gravels that were introduced has occurred. Whilst there has been some movement of bed material into the left hand culvert this has not been excessive (see Figure 1.5.1).

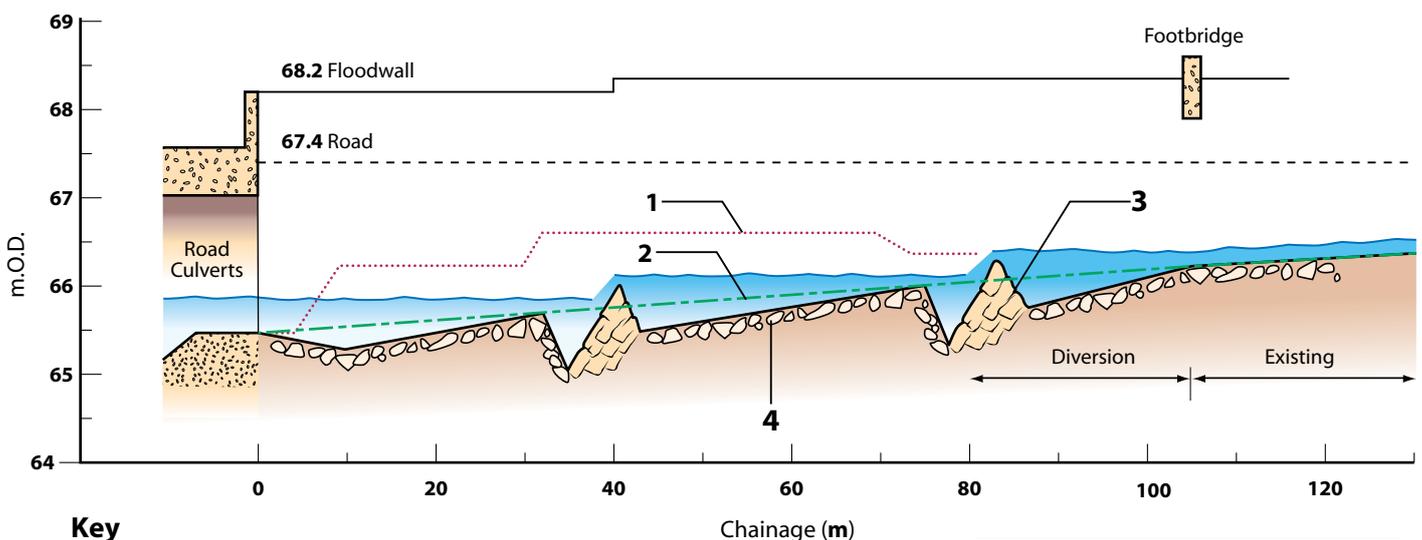
**Figure 1.5.2**  
LONGITUDINAL PROFILE

The gradient of the new river bed became 'fixed' between the culvert invert and the existing upstream level. *Figure 1.5.2* shows the resultant longitudinal profile with a mean bed gradient of 1 in 140. This gradient is much steeper than arises naturally on this part of the river with consequent high water velocities when the river is in flood.

shown as feature 3 on figure 1.5.2. They are located just downstream of each meander bend where underwater bars of river bed substrate e.g. gravels would naturally accumulate in the form of riffles. The stonework on adjacent walls and river bank was linked across the bed with stone laid at the same dip slope. Technique 5.4 shows details of these. They incorporate a gently sloping downstream face, much like a riffle. This enables the easy passage of migratory fish to be achieved and creates a ‘tumbling’ water feature rather than a sharp fall.

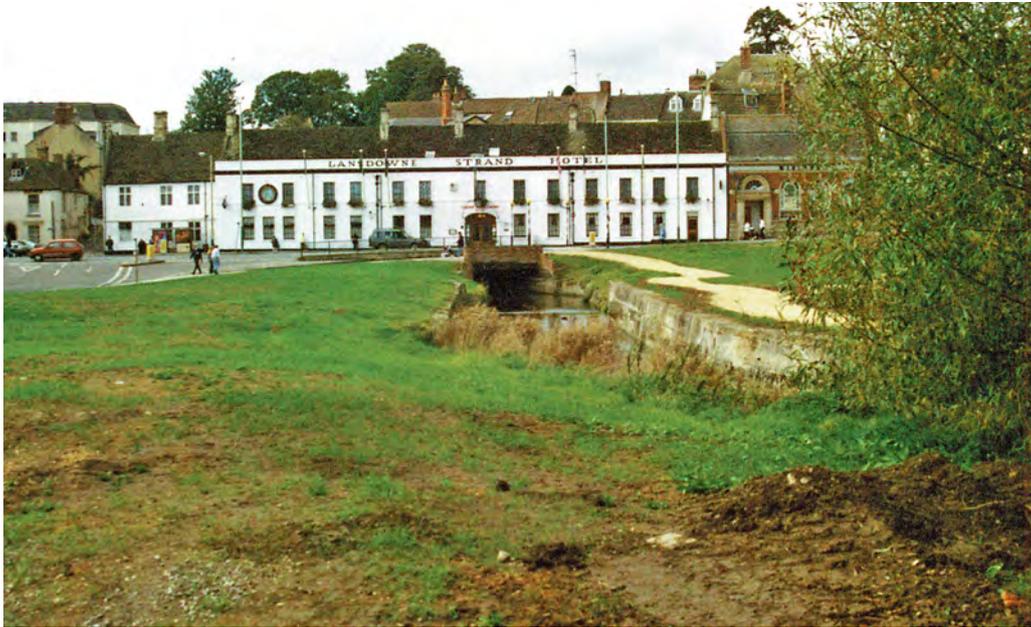
A town centre factory had been demolished leaving a reach of river flowing through the site in a straight, concrete channel. The channel bed dropped vertically in two places forming weirs that barred the passage of fish and were unsightly.

Before:  
View downstream towards culvert

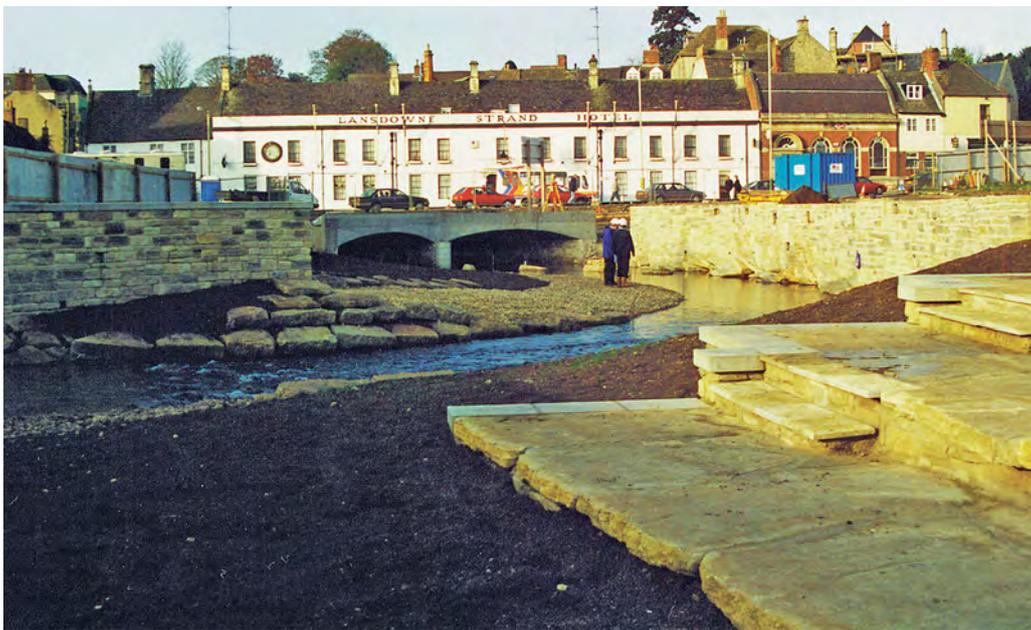
Completion:  
View of the new river course

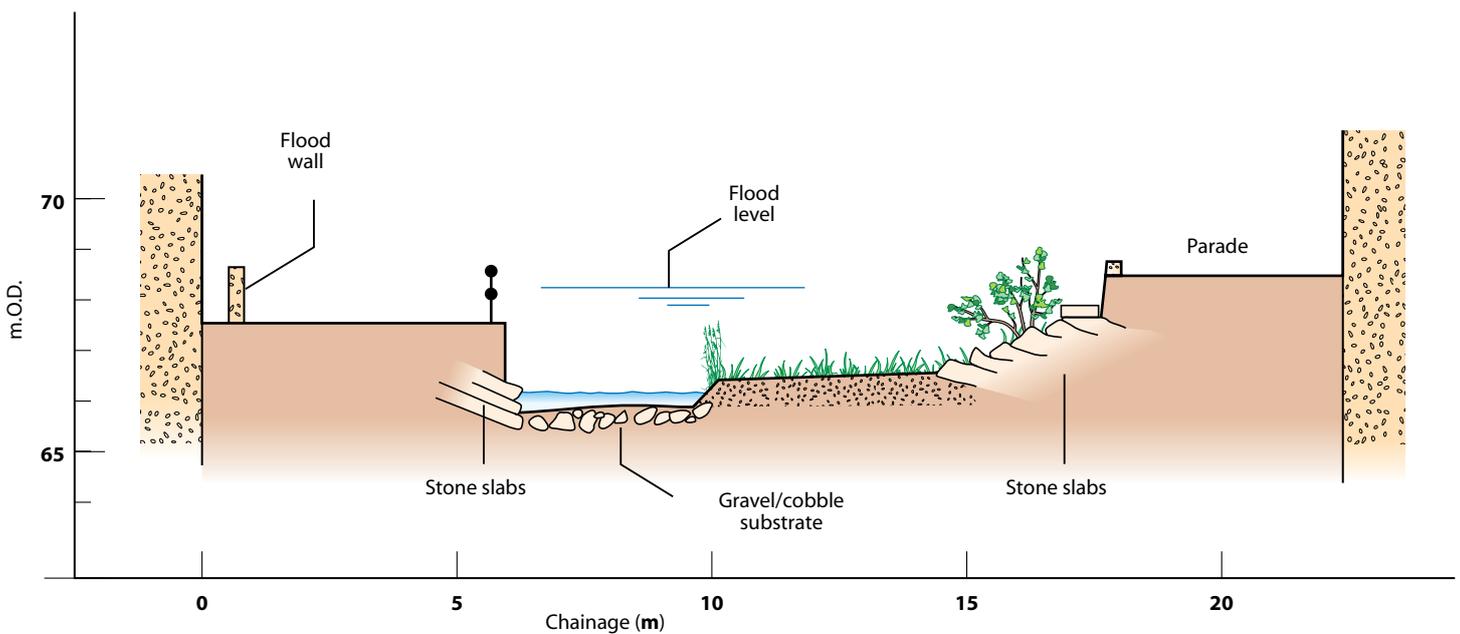
Figure 1.5.3

*At the bottom of earth slopes on outer bends liable to erosion*  
Slabs were laid exactly as above with consistent direction of dip and strike torevet these banks with varying faces depending upon the channel alignment of each location. See section A–A, figure 1.5.3 for aspects of both wall foundations and bank revetments.

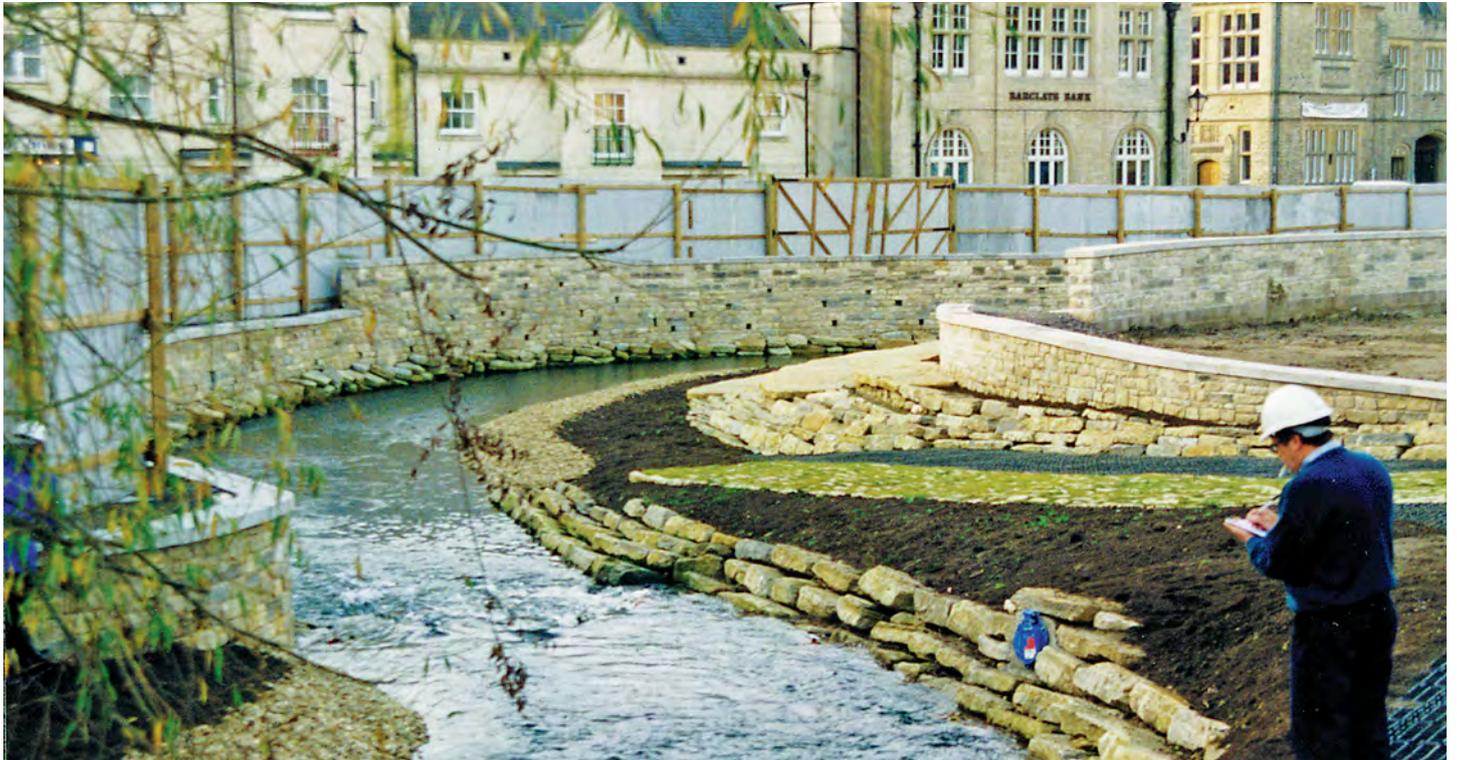
View of Section A (fig 1.5.3) on completion

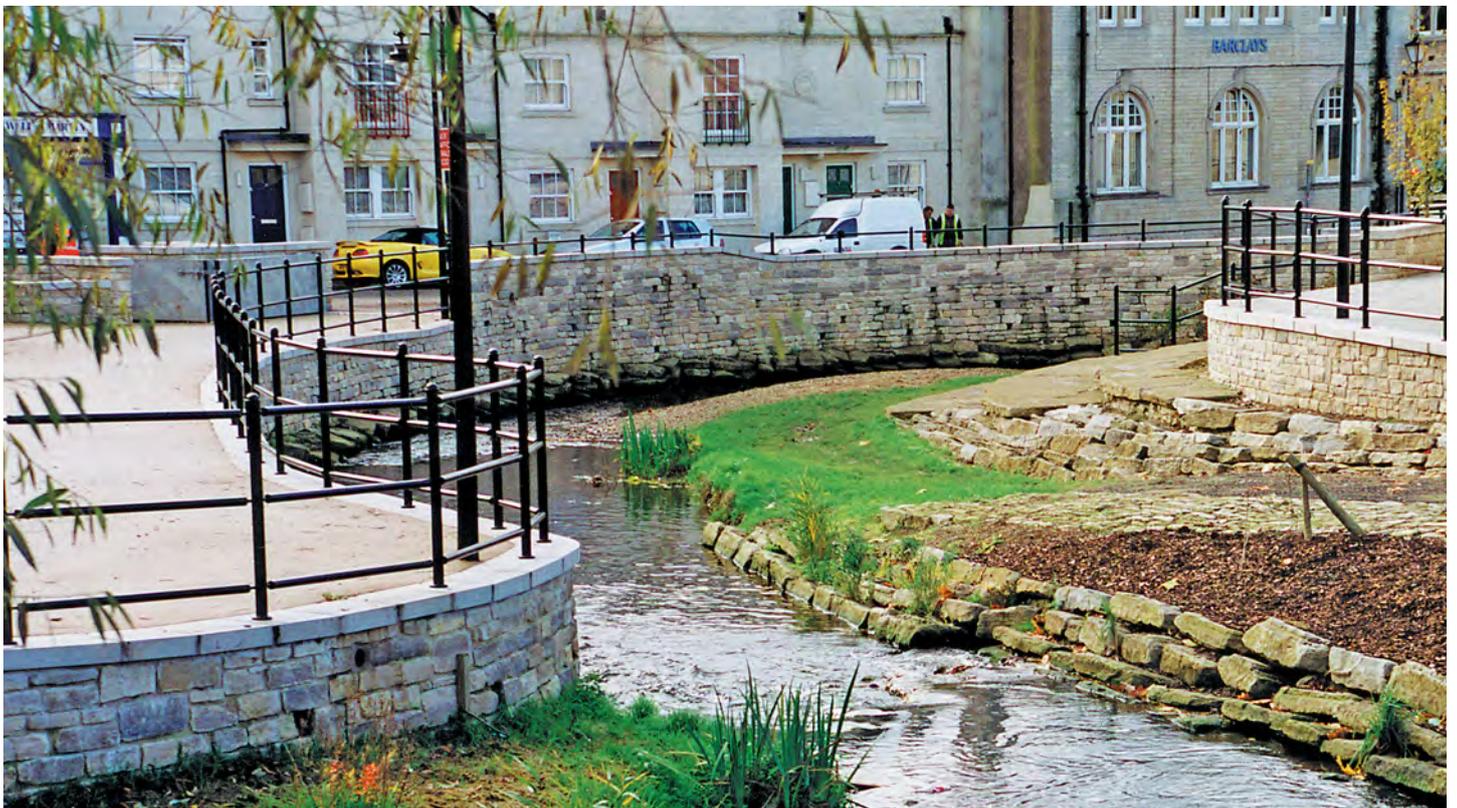
View of Section A in November 2001

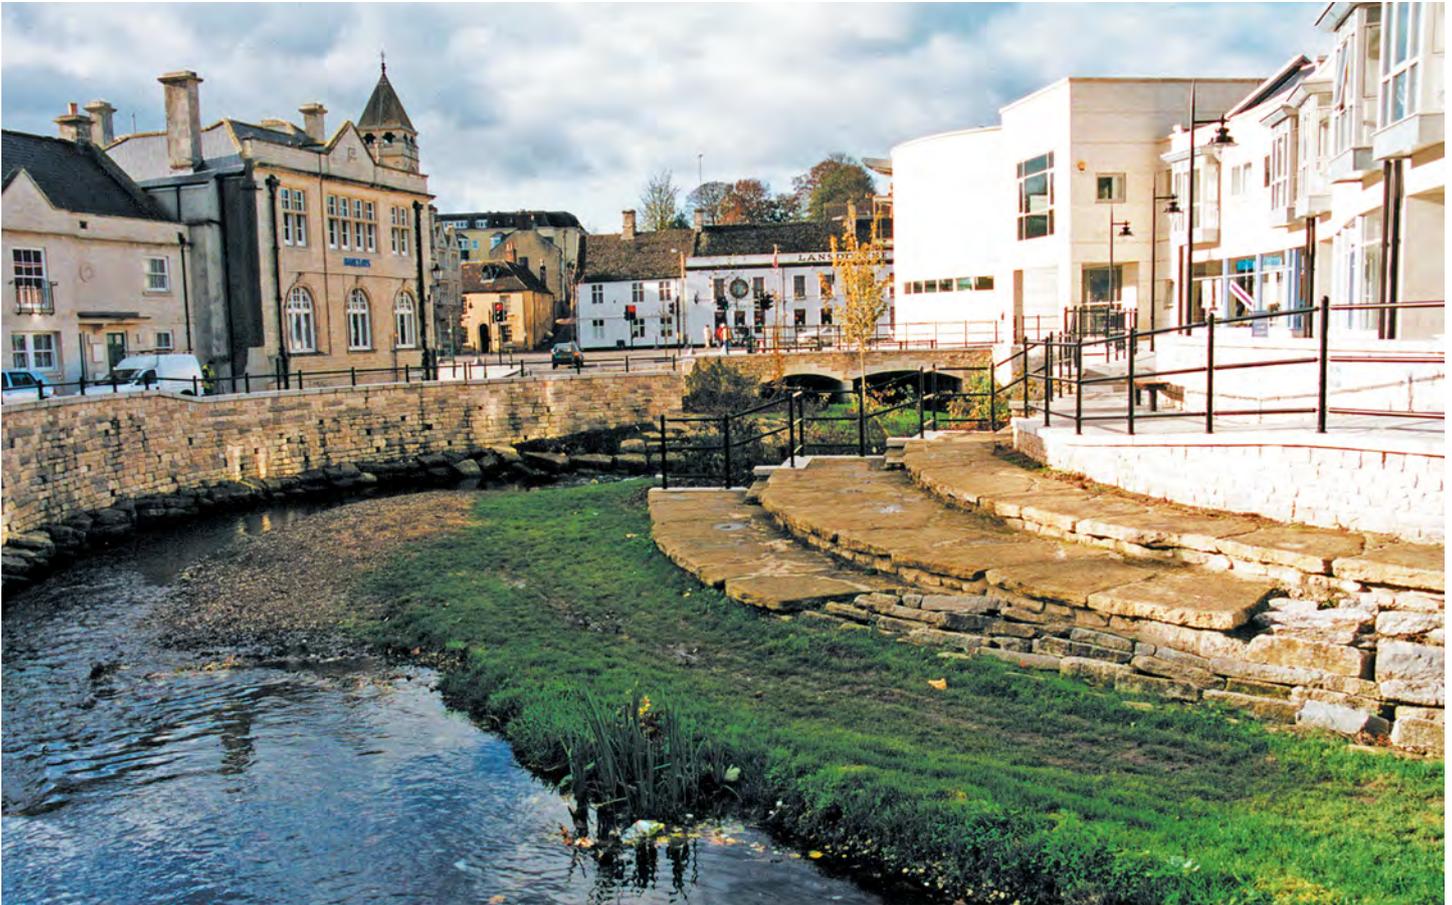
After: The new town centre in November 2001

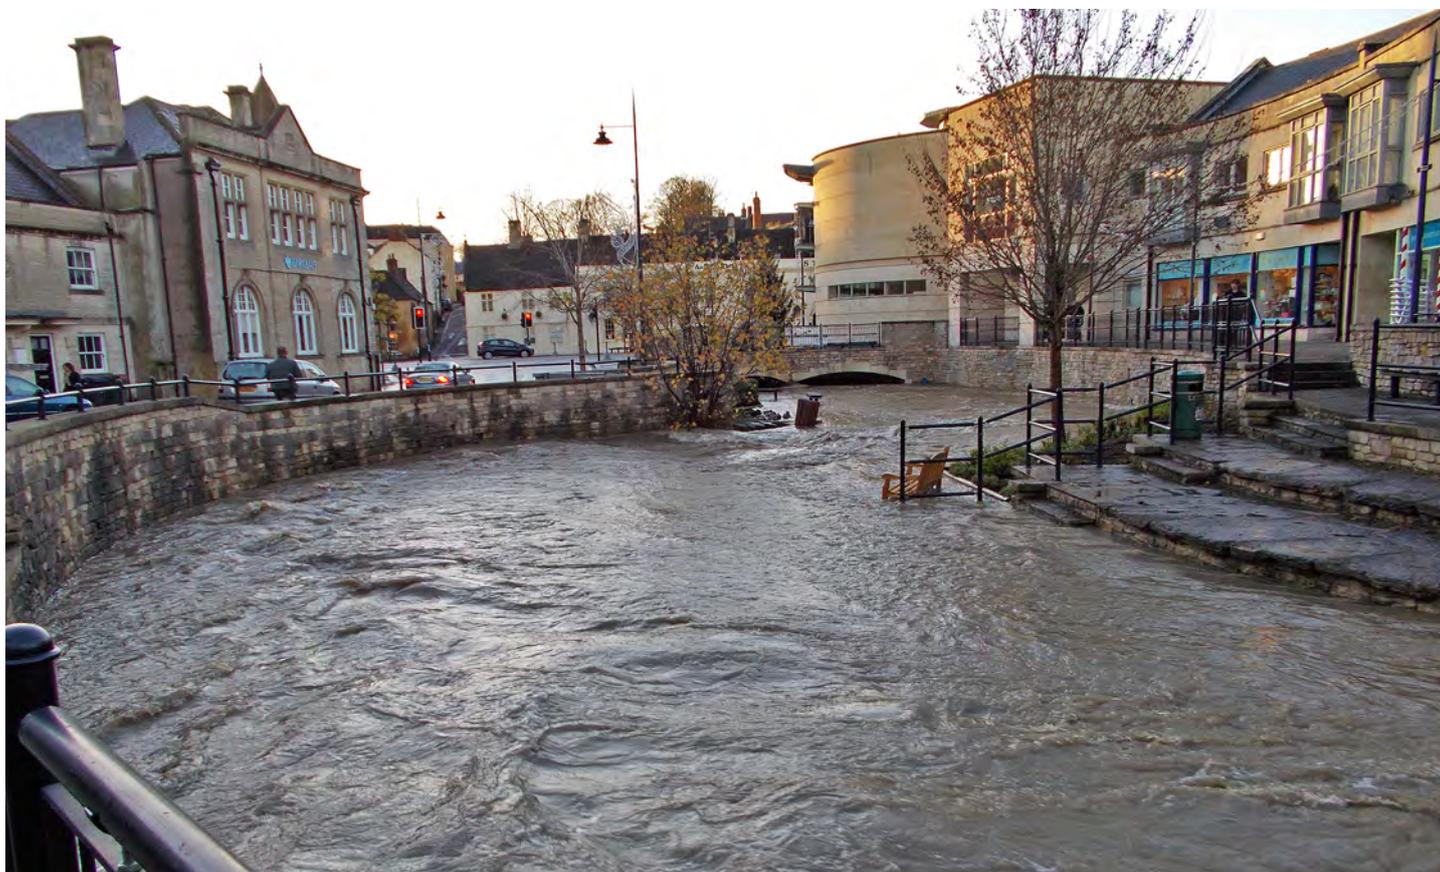
The flood walls have not breached since construction. The photograph below illustrates the additional flood capacity provided by the scheme.

The river in flood – the flood gates are closed and the much increased capacity protects the town centre – November 2012

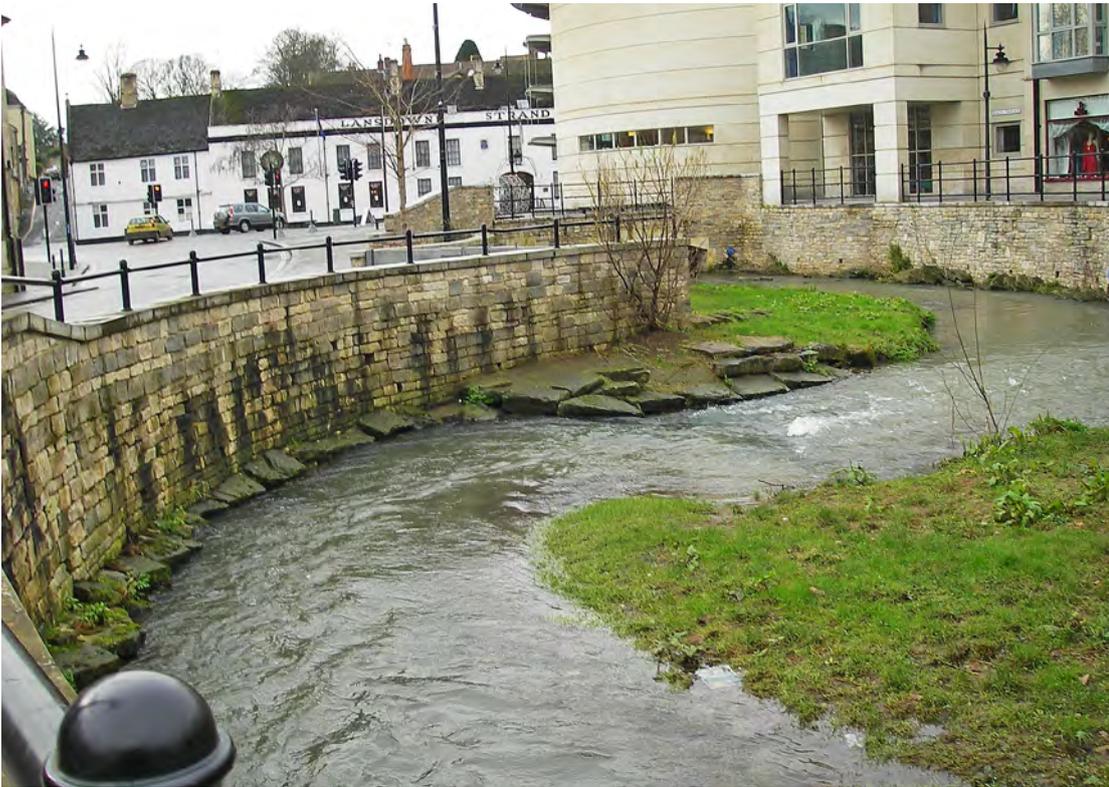
The designed channel and shallow grassed slopes hold up well over the winter period – early 2006

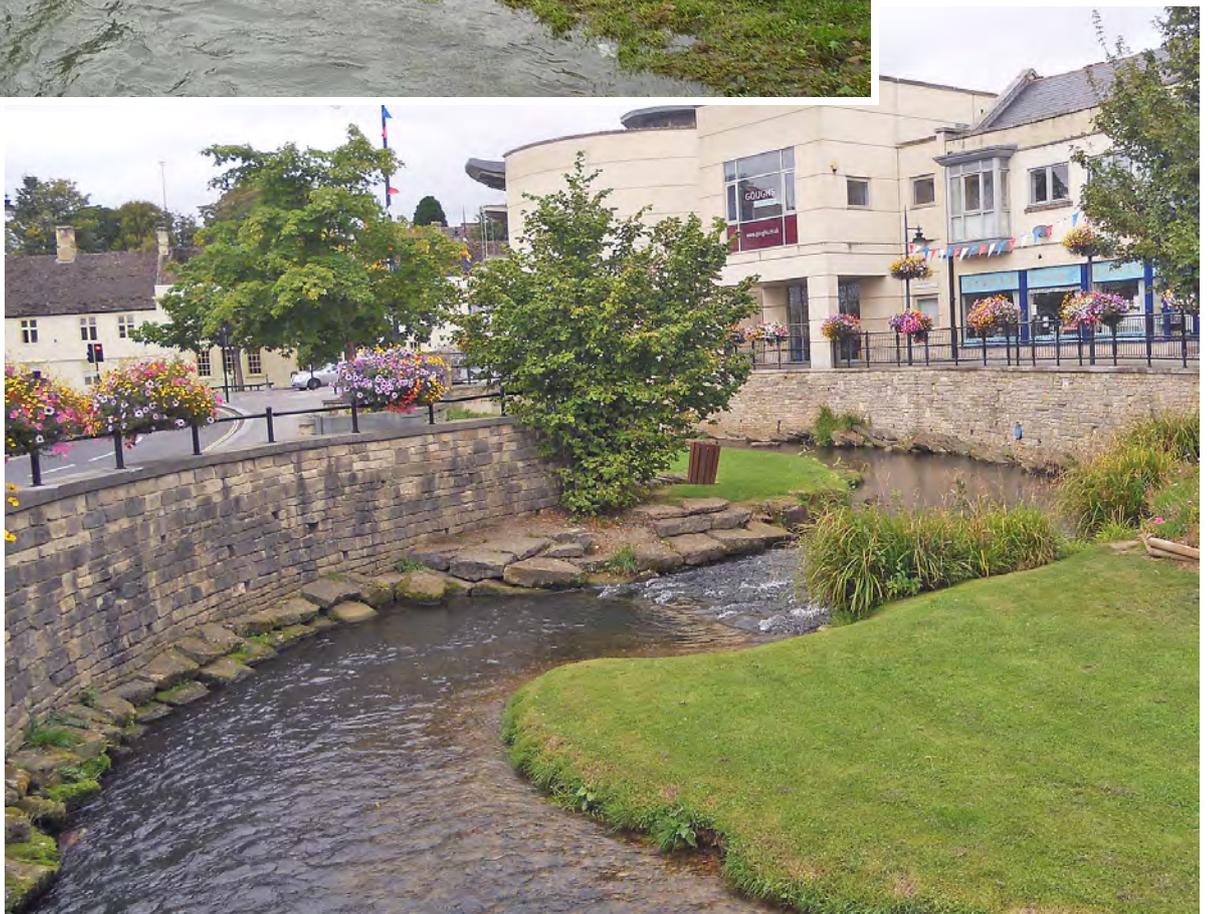
Mown green river edge to allow public access in summer.

Here the river's appearance is heavily managed as part of the aesthetics of the new town centre – 2010
