Restoring Meanders to Straightened Rivers

1.9 Reconnecting a remnant meander

RIVER ROTHER

LOCATION - PETWORTH, WEST SUSSEX FROM SU98051906

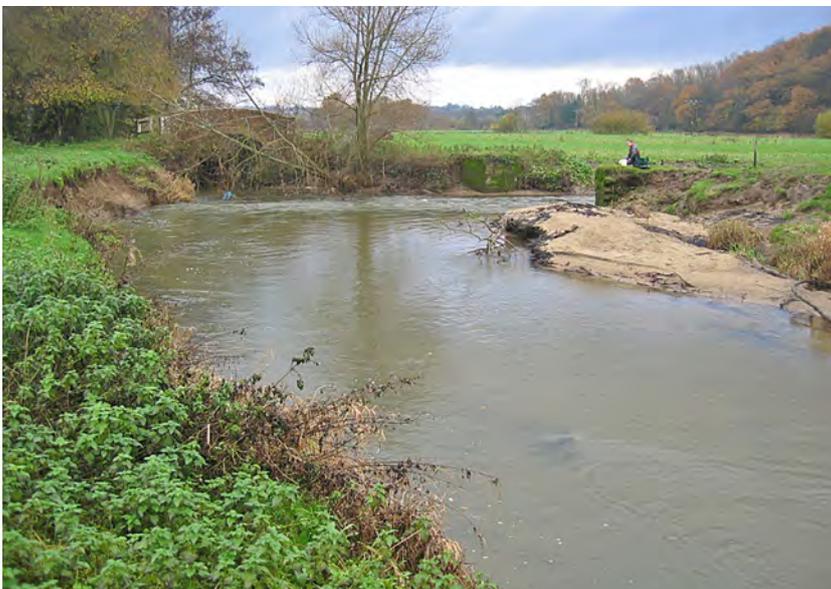
Two ancient stone abutment walls at the exit of the loop indicating the historic channel width – 2004

In order to prevent undermining of the stone abutment walls (which were of archaeological significance) at the downstream confluence, sheet piling was driven down to bed level across the river and a 'bed check' created from a base layer of coarse locally-sourced sandstone. At the entrance to the loop a ford was created for farm traffic and to serve as another bed check. It too was dressed with gravel to mimic a natural riffle.

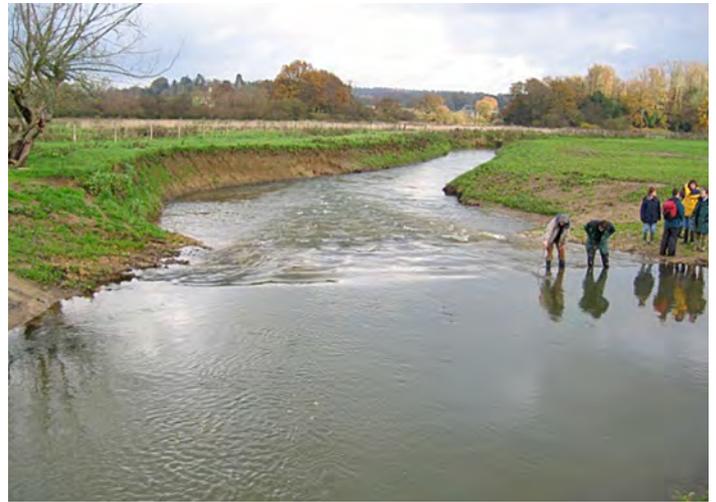
Bed check riffle and ford at entrance to the loop post-construction – 2004

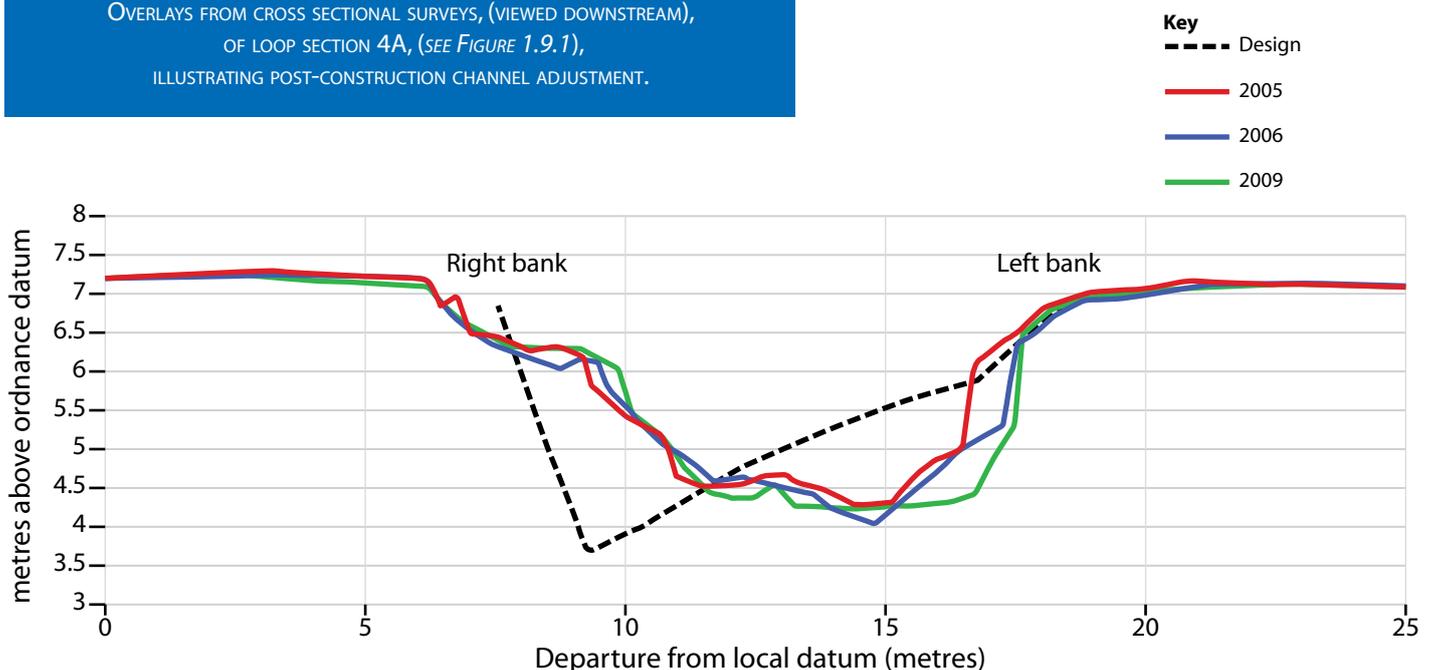
Figure 1.9.3

OVERLAYS FROM CROSS SECTIONAL SURVEYS, (VIEWED DOWNSTREAM), OF LOOP SECTION 4A, (SEE FIGURE 1.9.1), ILLUSTRATING POST-CONSTRUCTION CHANNEL ADJUSTMENT.

Monitoring of the site between 2002 and 2009 indicated a positive performance of the technique. Changes were observed in cross-sectional area (see Figure 1.9.3) suggesting a dominance of erosion over deposition in the loop. There was no significant (more than one metre) lateral channel change between autumn 2004 and a survey in 2006, but small-scale channel adjustment has been widespread. Therefore it can be concluded that the pre-restoration issue of sedimentation in the loop has been resolved and that the newly-excavated channel is slowly adjusting to a more natural, and desirable, form.

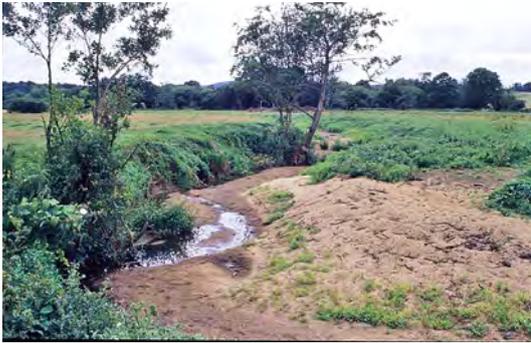
The loop rapidly became blocked with deposits of sand, as the flow velocity fell due to the reduced flow passing into the loop.

© RRC Sand in the meander loop pre-restoration – June 2004

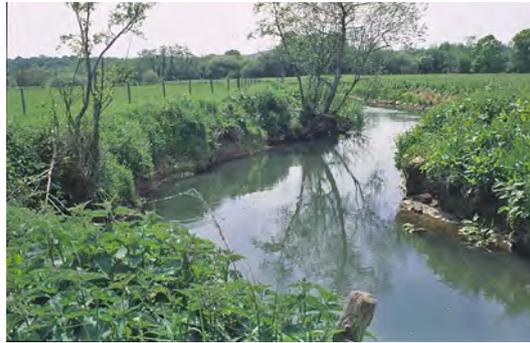
© RRC Flow in the excavated meander loop post-restoration – 2005

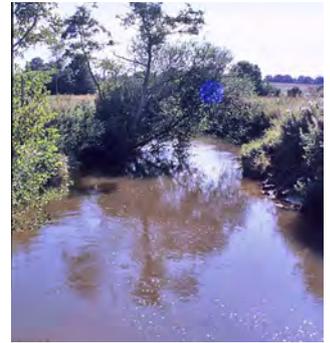
© RRC The same meander loop (three years post works) – 2007

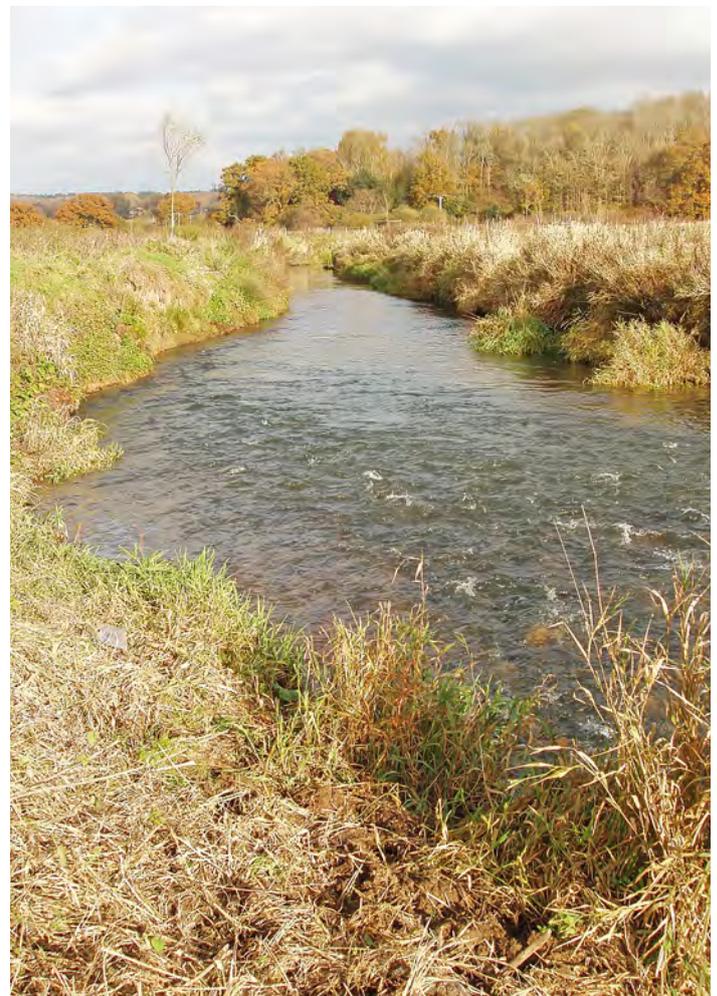
© RRC Shopham Loop post-restoration – 2009
