# Enhancing Straightened River Channels

## 3.7 Replacing a concrete drain with a 'natural' channel

### YARDLEY BROOK

LOCATION - SHARD END, SOUTH-EAST BIRMINGHAM SP118198

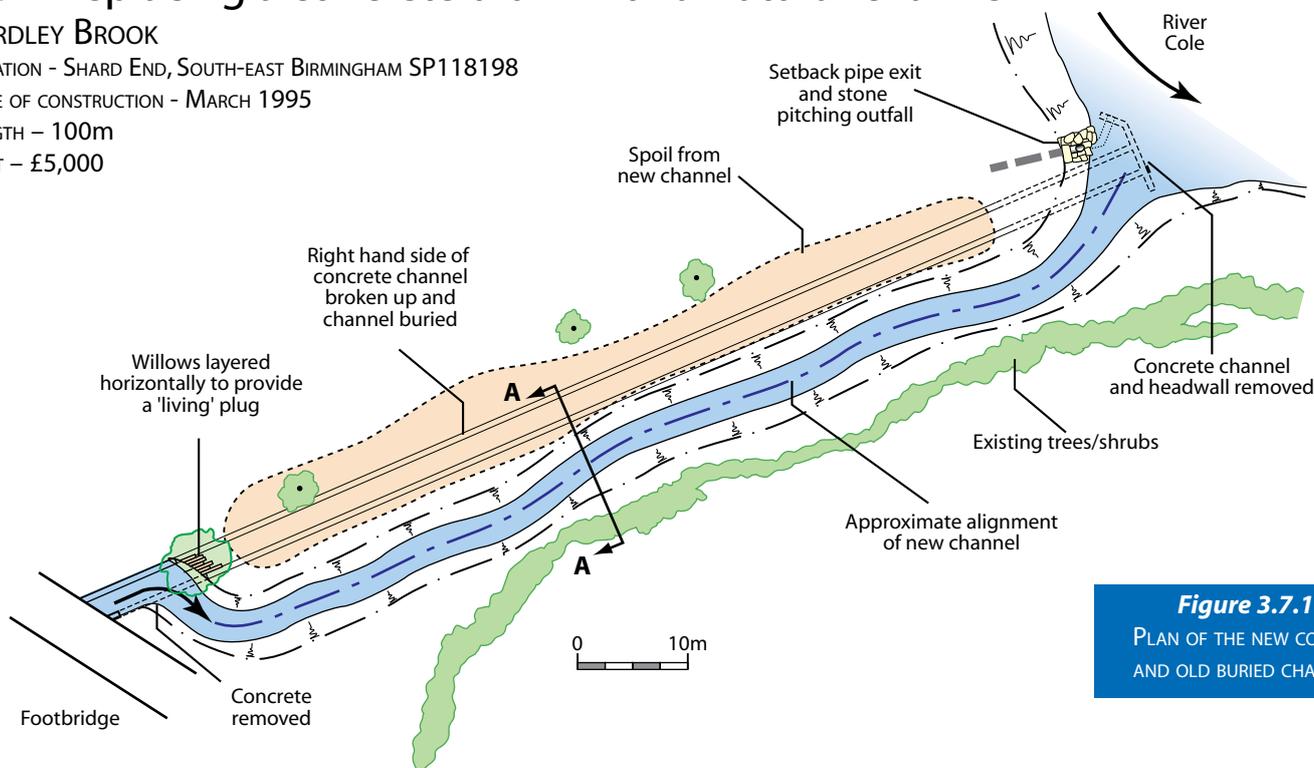
**Figure 3.7.1**  
PLAN OF THE NEW COURSE  
AND OLD BURIED CHANNEL

Figure 3.7.1 shows the 100m sinuous channel that was excavated alongside the brook. The new course was excavated at a greater depth than the concrete channel bed. Previously the bed of the River Cole had been approximately 0.7m below the concrete outfall, as a result of deepening of the Cole over the lifetime of the concrete brook. A simple 'V' shaped channel was dug with sloping earth banks as it was decided that the brook could sufficiently shape itself. Over-specifying the design would not be cost-effective.

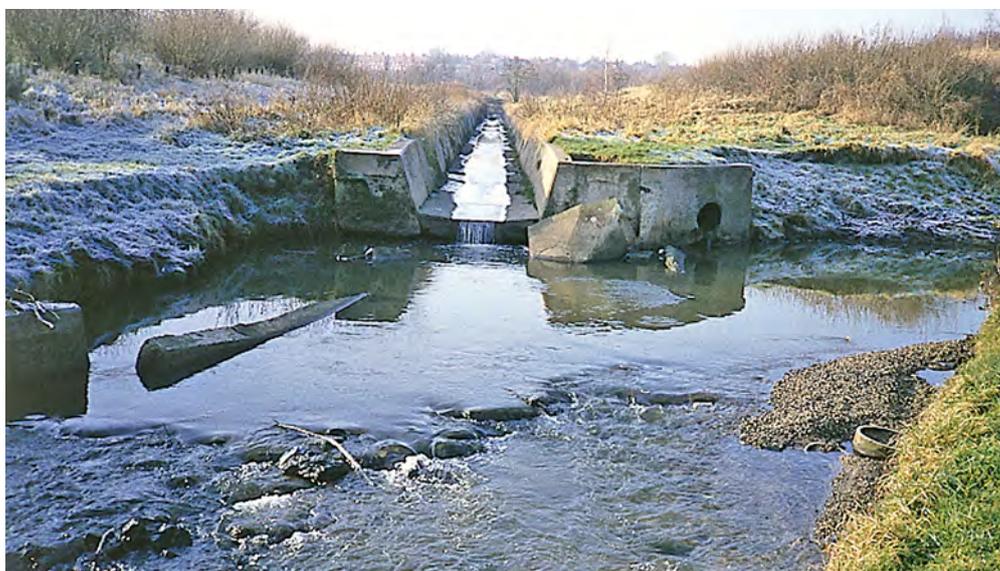
Yardley Brook entering the River Cole before works

The brook was constrained in a concrete sleeve, offering no possibility for small-scale in-channel enhancement. Rehabilitation required removal of the brook from its 100m long concrete surround. Complete relocation, rather than removing the concrete, was the cheaper option.

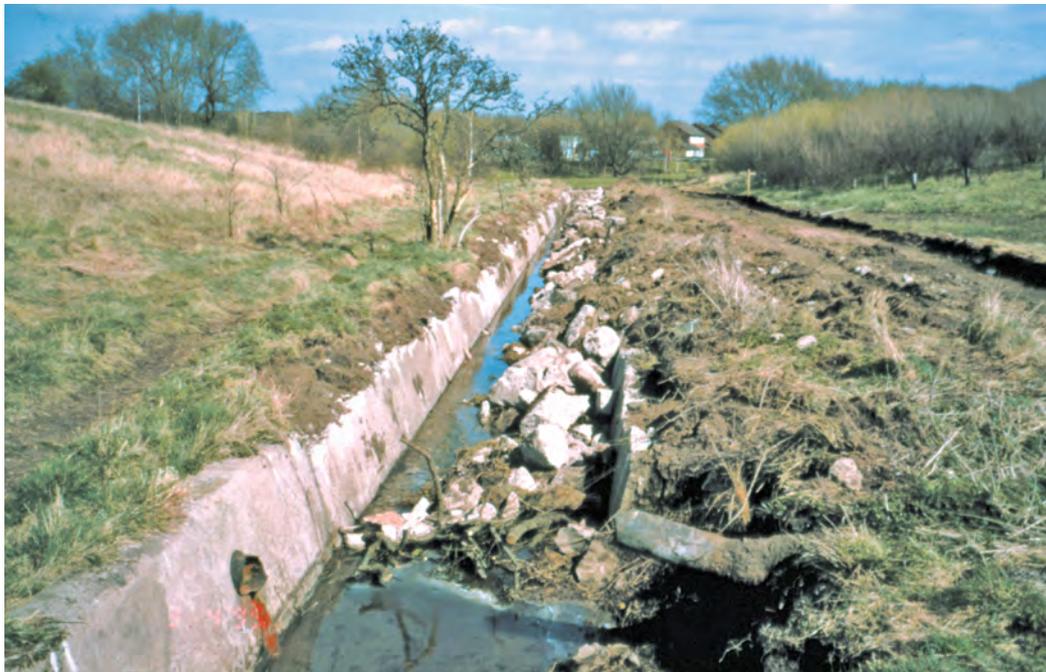
Concrete channel being broken up

The lip of the concrete channel was broken up using an excavator, to ensure that once buried the remnant channel would not protrude above ground level. The broken concrete was pushed into the barely flowing channel.

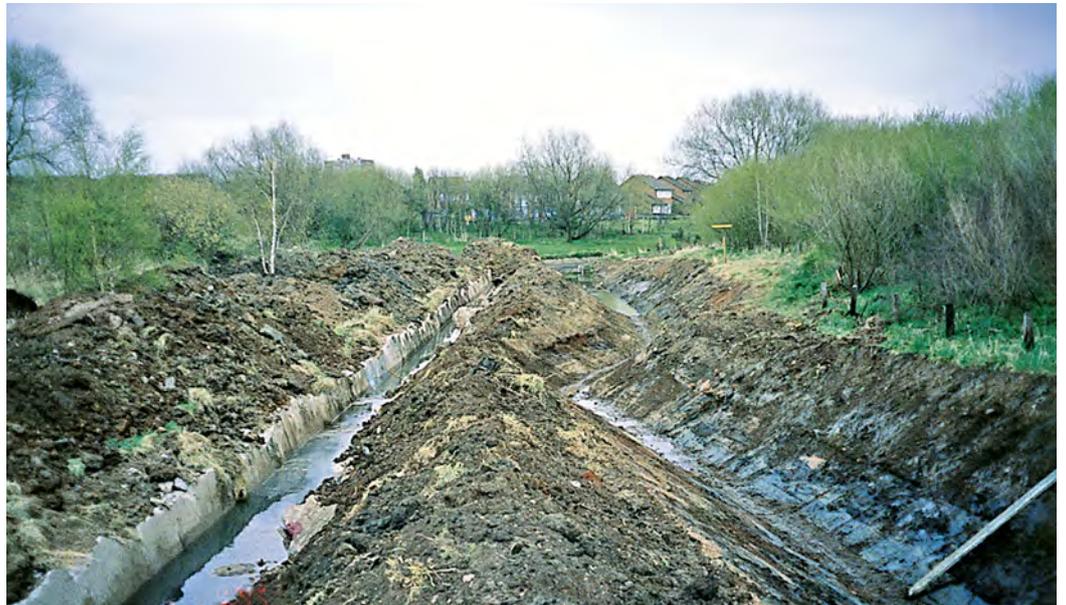
The 'new' brook being excavated adjacent to the old channel. Spoil stockpiled

All spoil was stock-piled between the new and the old channel, and where this became too narrow, on the opposite bank of the old channel. This maintained the flow through the old drain and allowed all work to be carried out in the dry. Once completed, flow was diverted through the new course, and the old channel was filled using the spoil from the new.

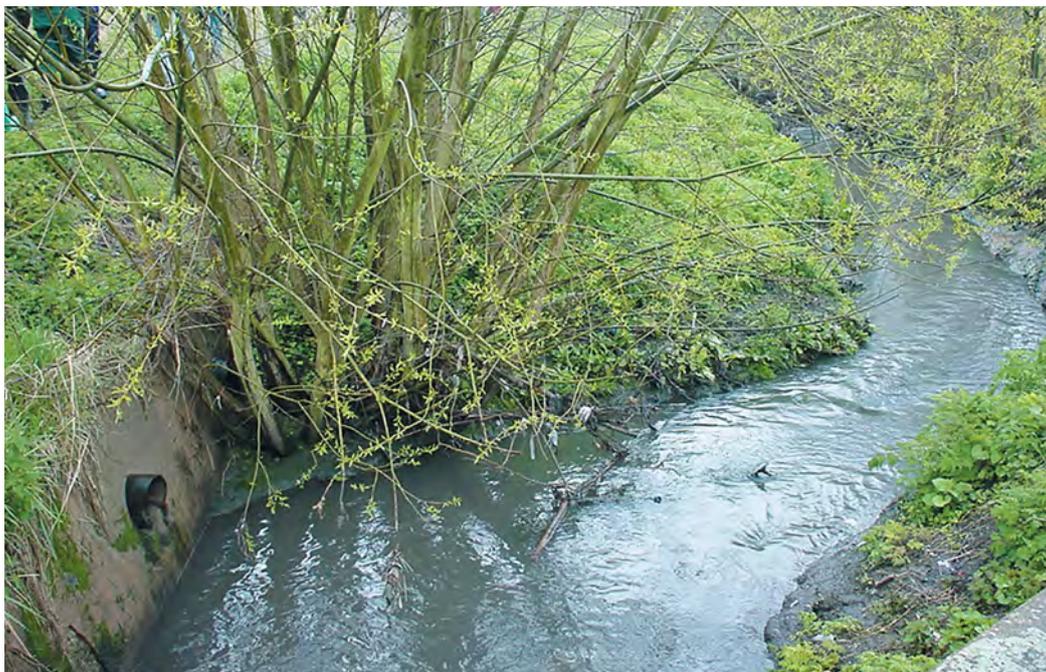
Live willow plug

The live willow plug has grown to secure the breakout point of the new brook. This area now blends in well with the general appearance of the brook and its self-set bankside trees and shrubs.

The live willow plug at the upstream end of the brook has continued to be very successful as a bioengineered bank stabilisation method.

At the upstream end of the 'new' brook the old course was blocked with rubble then plugged with live willows (*Salix spp.*) laid in during the in-filling process to form a growing plug.

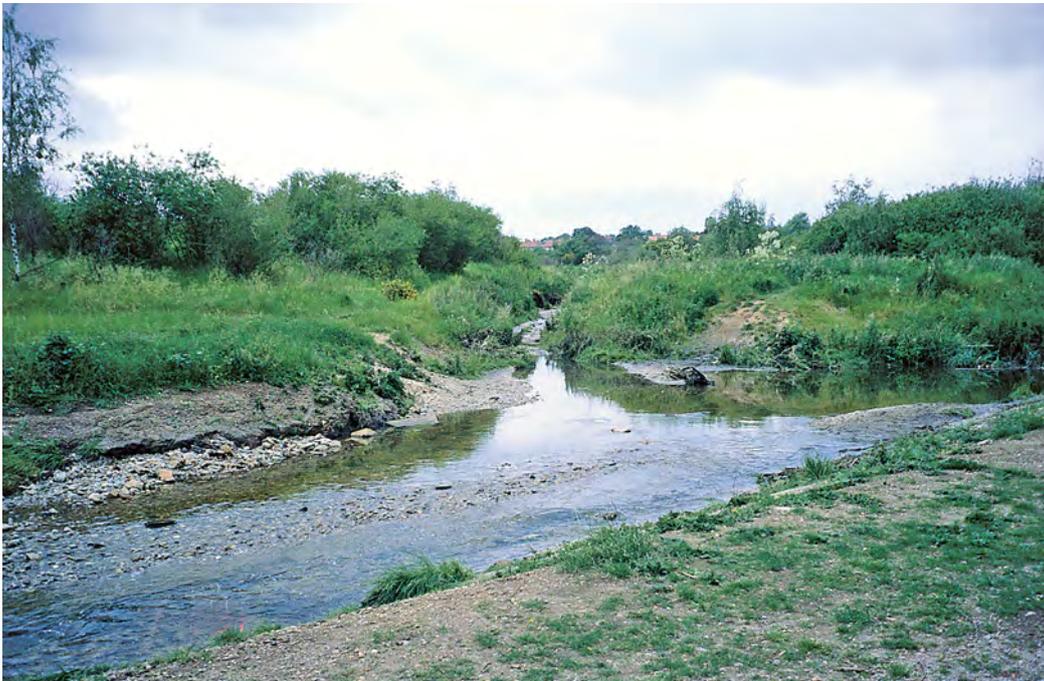
After – the new 'natural' Brook

After completion winter flows quickly began to 'develop' the kinds of natural channel features one would associate with a small brook. The 'V' shape quickly transformed through erosion of the loose fill material into a much more 'natural' channel 2-3m wide. This process has continued as the site matures.

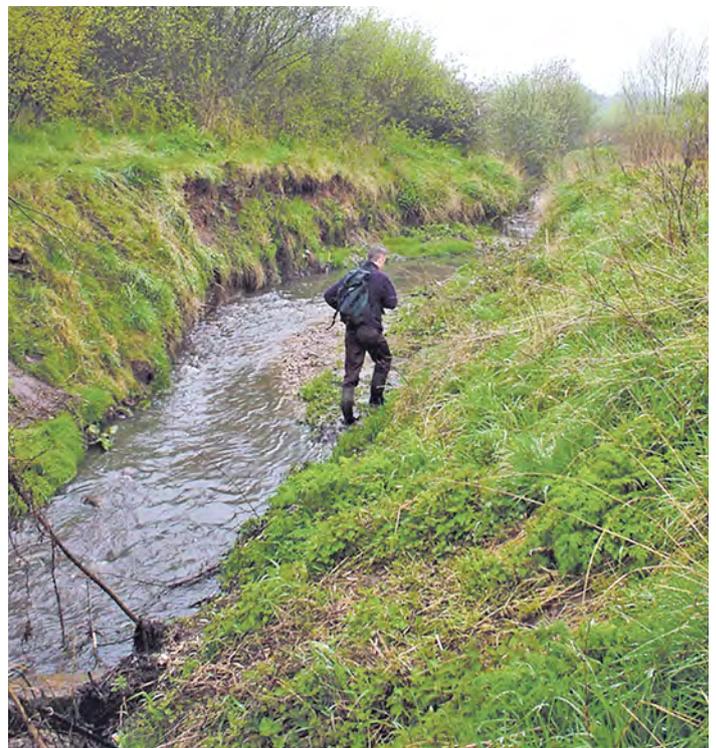
Six years on, Yardley Brook has developed 'natural' channel features in contrast to the concrete channel previously in place. The brook still suffers from periodic poor water quality due to the dense urban population that surrounds it.

Six years on. Earth cliffs, gravel shoals and a diverse flow regime – April 2001

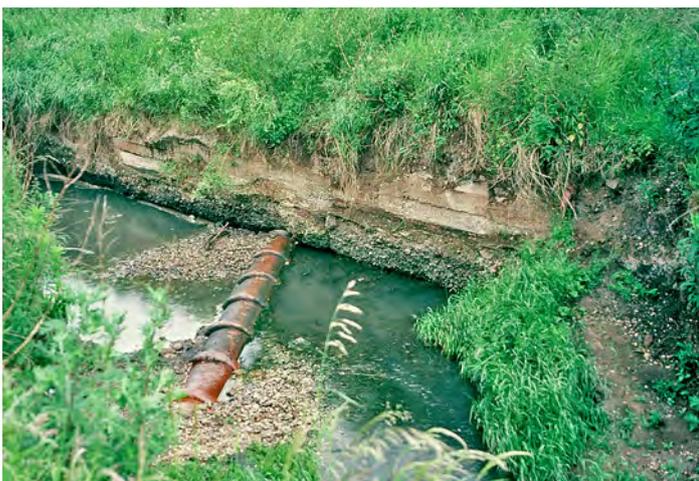
The project would have benefited from following the original plan, i.e. make a shallow V shaped cross section with the excavated material placed away from the bank. Instead the soil was piled up next to the channel making a much steeper V shaped channel. Erosion has removed much of the material which has contributed to raising the bed of the River Cole, at the mouth of the brook, by some 0.4m. In addition, as a result of the new channel having too steep a gradient in some places, a nick point started to move upstream exposing a sewer pipe. To remediate this, a layer of large gravel stones was laid on top to act as a check weir to prevent further erosion.

Erosion exposing sewer pipe as nickpoint moves upstream

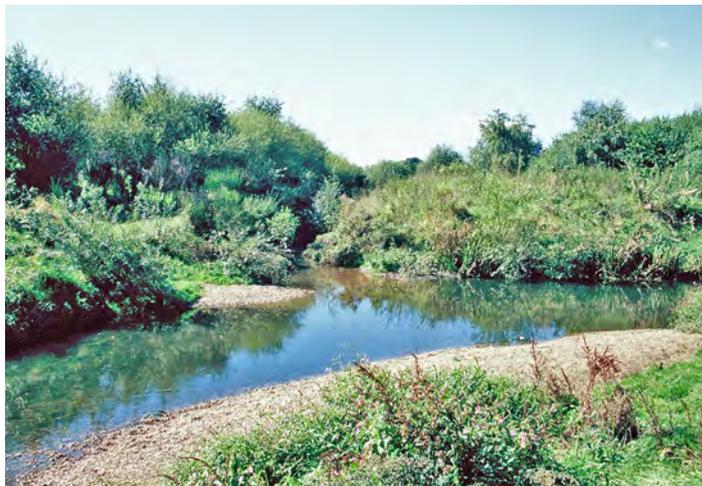
Yardley Brook flowing into Cole

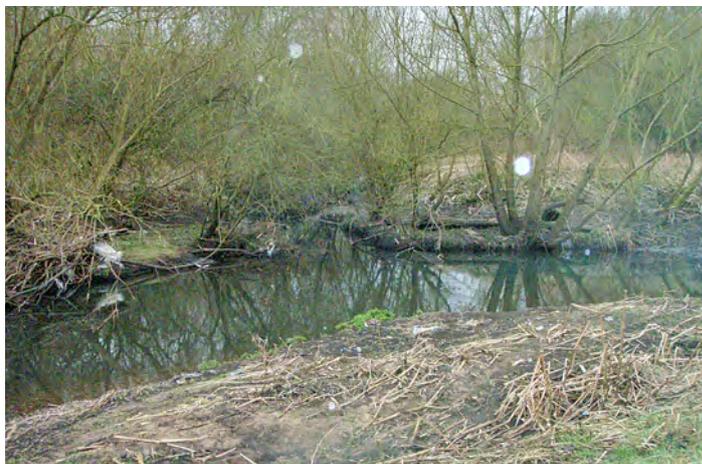
Yardley Brook flowing into the Cole. Riparian trees and vegetation have now grown up to stabilise the banks – February 2013
