River Cole, Yardley Brook

Technique: Replacing a concrete drain with a 'natural' river channel

the River Restoration Centre Case Study Series

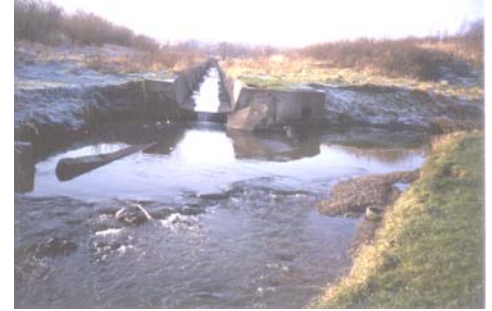
Yardley Brook prior to restoration works

- The lip of the concrete channel was broken up using an excavator, and the broken concrete was pushed into the barely flowing channel.
- A 100m sinuous channel was excavated alongside the brook. A simple 'V' shaped channel was dug with sloping earth banks as it was decided that the brook could sufficiently shape itself. All spoil was stock-piled between the new and the old channel and, where this became too narrow, on the opposite bank of the old channel. This maintained the flow through the old drain and allowed all work to be carried out in the dry.

- Once completed, flow was diverted through the new course, and the old channel was filled using the spoil from the new. At the upstream end of the 'new' brook the old course was again blocked with rubble then capped with earth. Live willows were laid in during the in-filling process to form a growing plug.

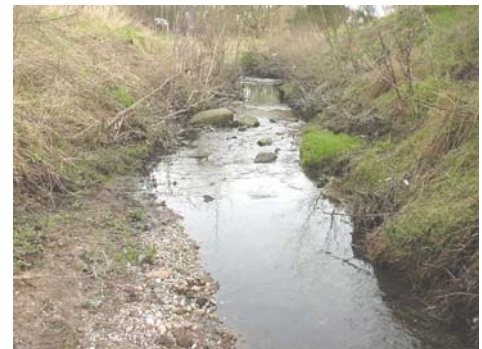
Immediately following the diversion to the new channel a dramatic change in the brook was achieved in terms of landscape, visual amenity and ecology. After completion, winter flows quickly began to shape the kinds of natural channel features one would associate with a small brook. Six years on, Yardley Brook has developed 'natural' channel features in contrast to the concrete channel previously in place. The brook still suffers from periodic poor water quality due to the dense urban population that surrounds the brook. The work was deemed so successful that a further length of the main River Cole was removed from a concrete straight-jacket in 1996-1997.

Natural channel features in the restored section of Yardley Brook
