RESTORING MEANDERS TO STRAIGHTENED RIVERS

1.3 New meander in an impounded river channel

RIVER COLE

LOCATION – Coleshill, Oxon/Wilts border, SU 234935

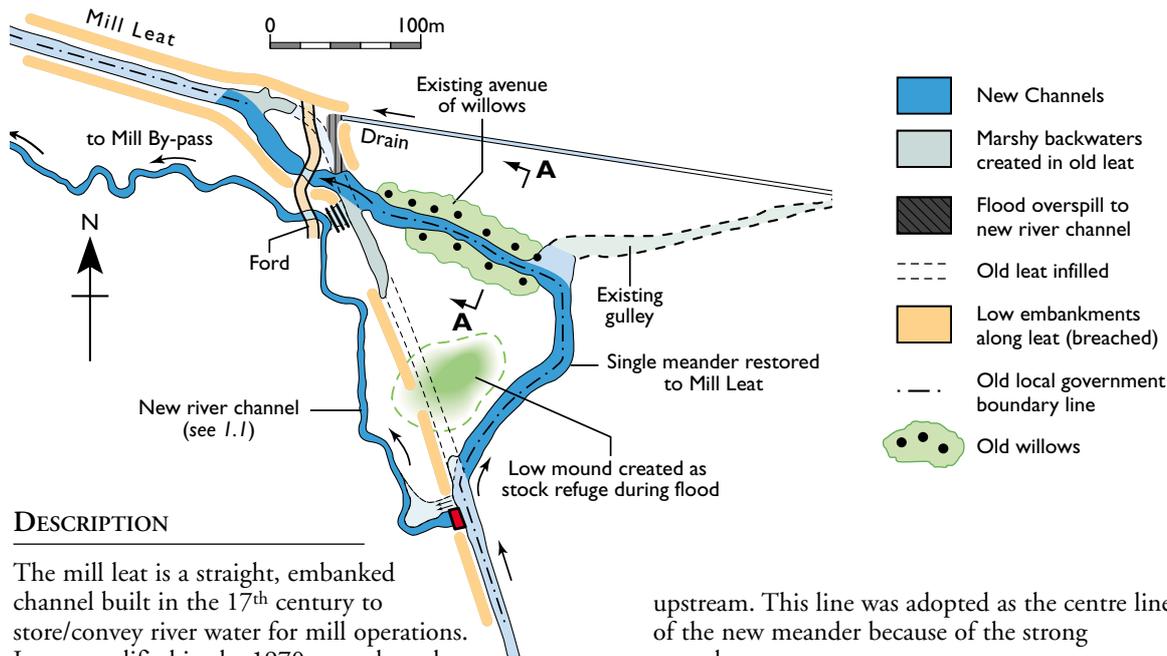
Figure 1.3.1
PLAN OF MILL LEAT AND NEW MEANDER

The pre-existence of the meander was evident in two ways. A shallow, muddy depression between a short avenue of old willow pollards, branching off the leat, delineated part of an old river channel. A study of old maps indicated that an historic local government boundary line passes between the willows, continuing in a clear meander line that rejoined the leat further

upstream. This line was adopted as the centre line of the new meander because of the strong precedence.

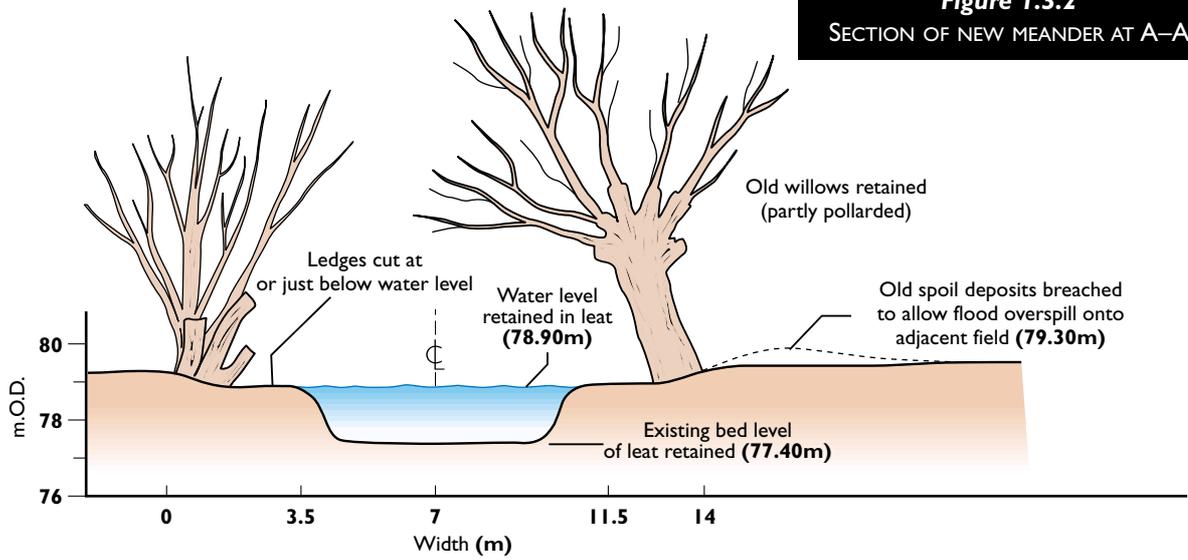
Figure 1.3.2
SECTION OF NEW MEANDER AT A-A

The width of channel between bank tops was selected to retain the willows. The resulting dimensions closely matched the top width of the remaining mill leat, so was confirmed as suitable. The existing leat cross-section displayed wide ledges at, or about, normal water level that were cattle trodden either side of a deep, relatively clear, central channel. The new cross-section mirrors this configuration.

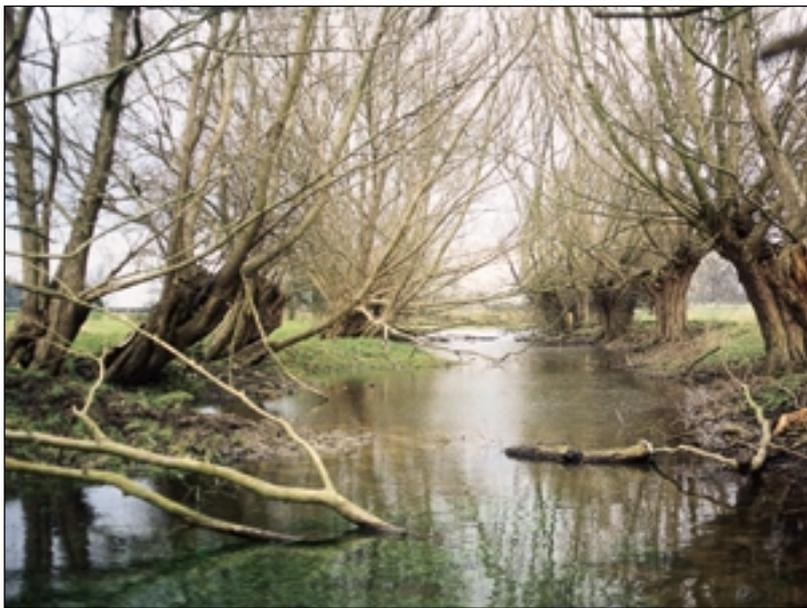
Remnant of meander – pre-works
– January 1996
(shallow water held temporarily
after heavy rain/flooding).

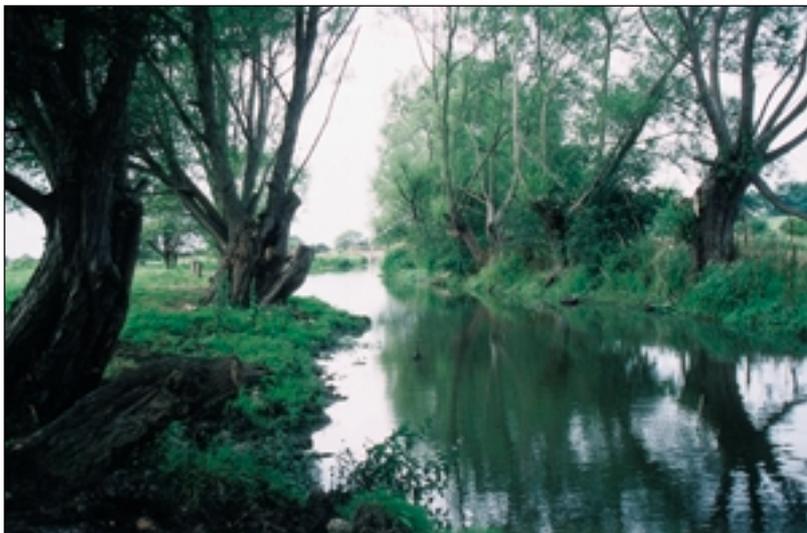
Re-excavated meander
– Autumn 1997
