Restoring Meanders to Straightened Rivers

1.7 Reconnecting remnant meanders

RIVER LITTLE OUSE

LOCATION - THETFORD, NORFOLK TL870812

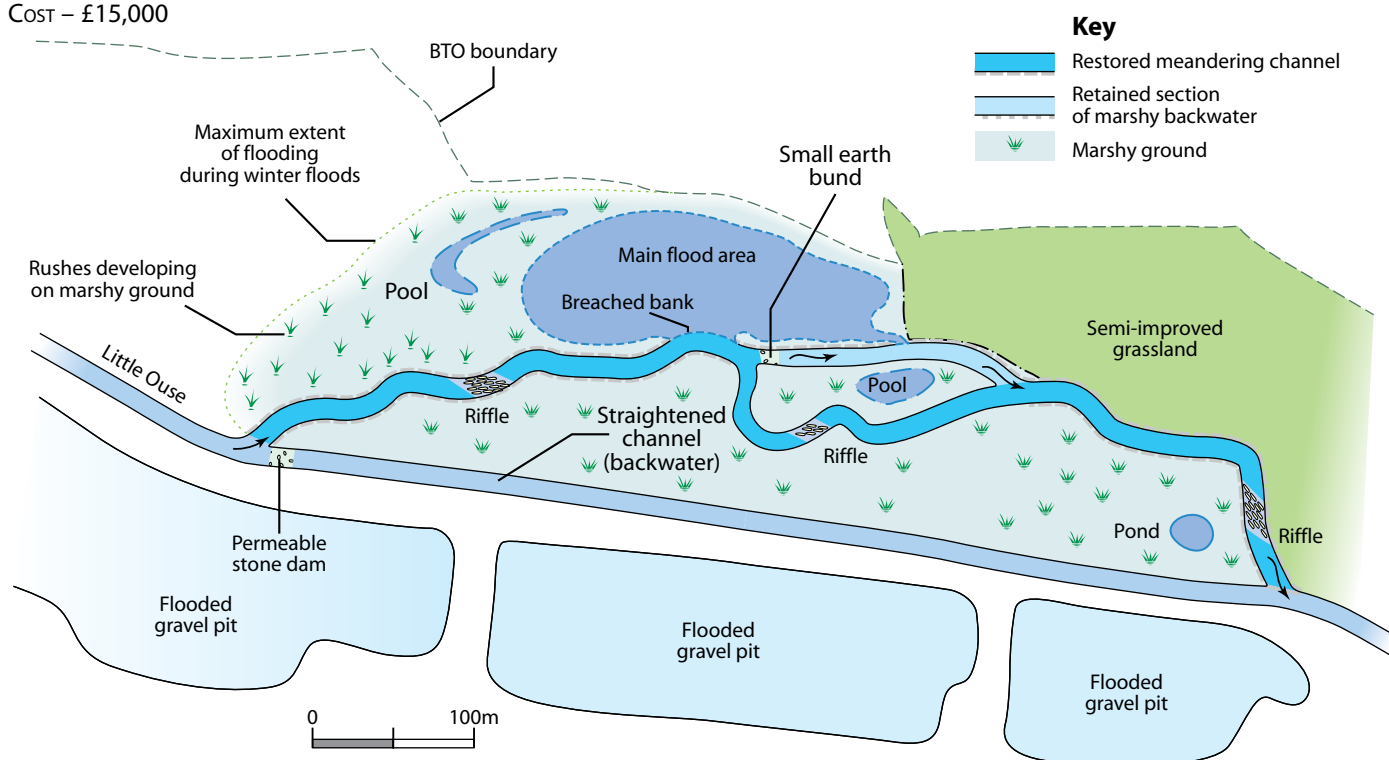
Figure 1.7.1
PLAN OF MEANDERS

Using a 50 foot (15m) reach dragline, a boulder and stone structure was placed into the river at the upstream end of the canalised reach (permeable stone dam on Figure 1.7.1), to raise the river level by 0.6m. This would ensure that approximately 90% of flow would be routed through the re-opened course.

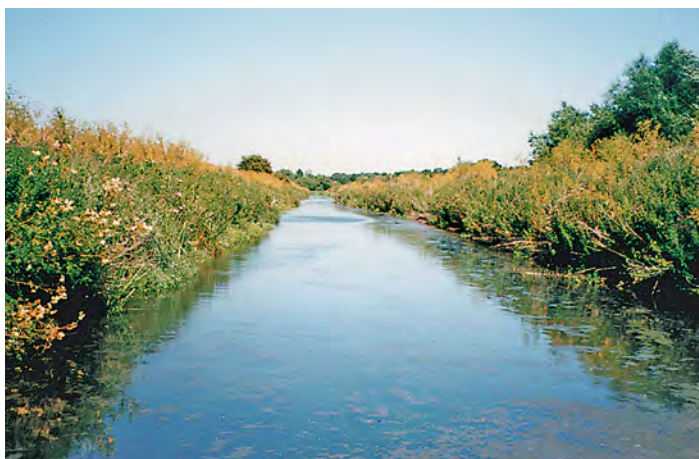
Canalised course of the Little Ouse

The new canalised course was straight, trapezoidal, circa 6m wide and 1-2m deep, with 3m dry, steep banks dominated by tall ruderals and grass. In-stream habitat was poor, macrophytes were confined mainly to the shallow margins, and the substrate was dominated by sand with some silt and gravel.

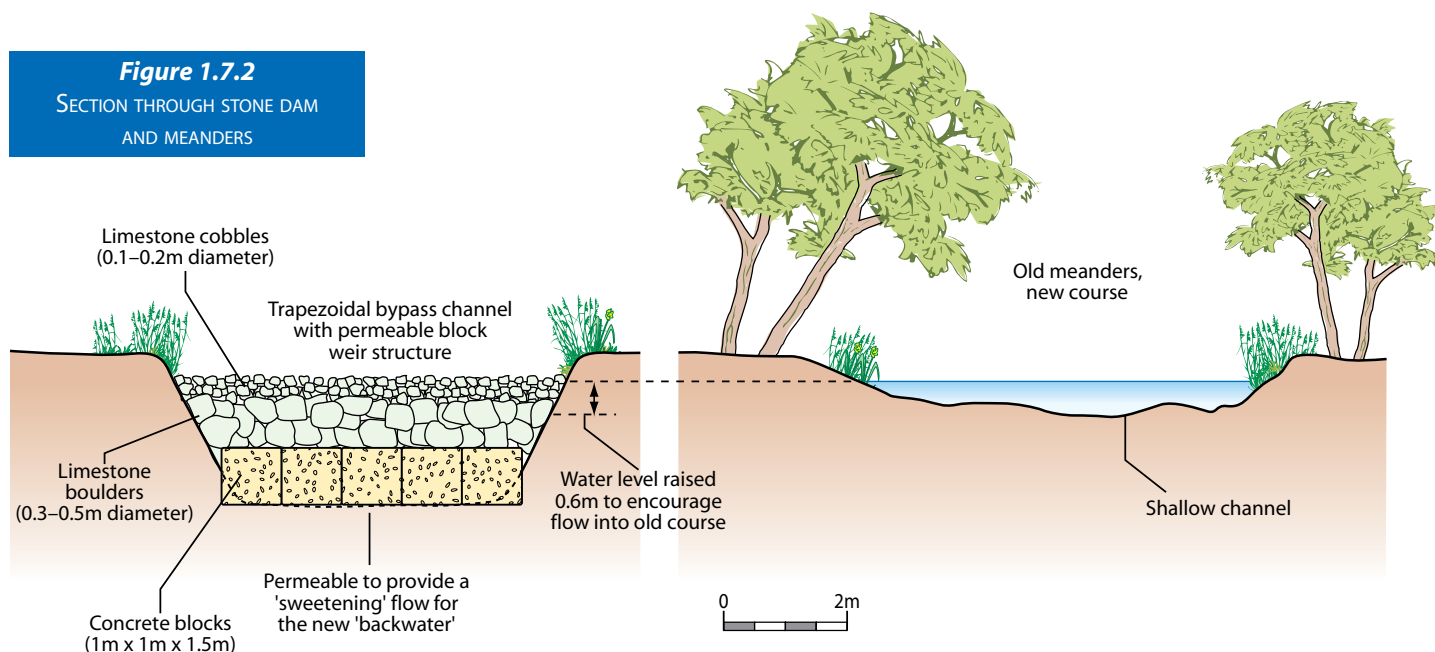
Figure 1.7.2

The structure, 6m wide by 10m long by 2m high, was constructed using 1.5m by 1m prefabricated concrete blocks below a 0.75m depth of boulder sized limestone, surfaced with 0.25m of cobble sized limestone. The 'weir' was designed to be permeable to provide a sweetening flow to the canalised channel. Flows, where levels exceed the 2m crest, will overtop and discharge through the retained canalised 'flood relief' backwater channel.

SECTION THROUGH STONE DAM
AND MEANDERS

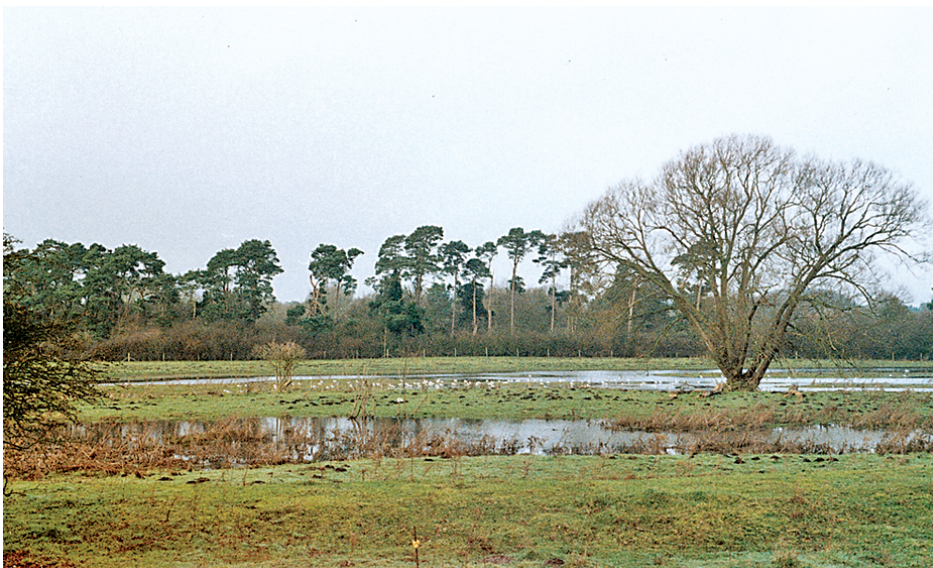
Flooding along meanders – Spring 1999

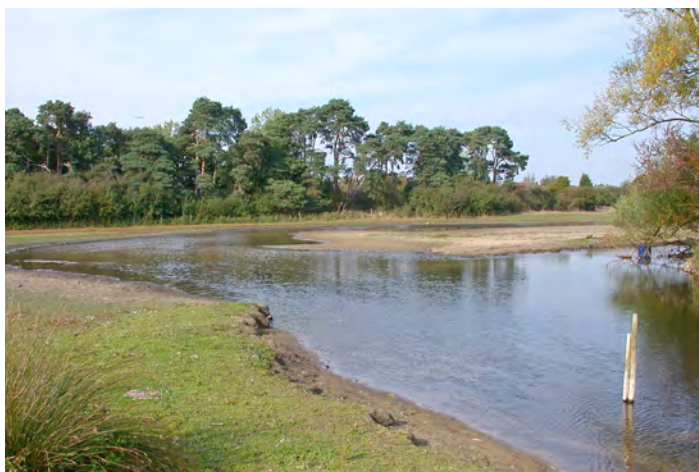
Main breach along the meanders – 2002

High river levels resulted in scour of the more vulnerable sections of meanders causing breaches in the banks. These were repaired using clay in 2002, but subsequently failed and further breaches occurred. These were exacerbated by a fallen willow (*Salix spp.*) branch that deflected the flow.

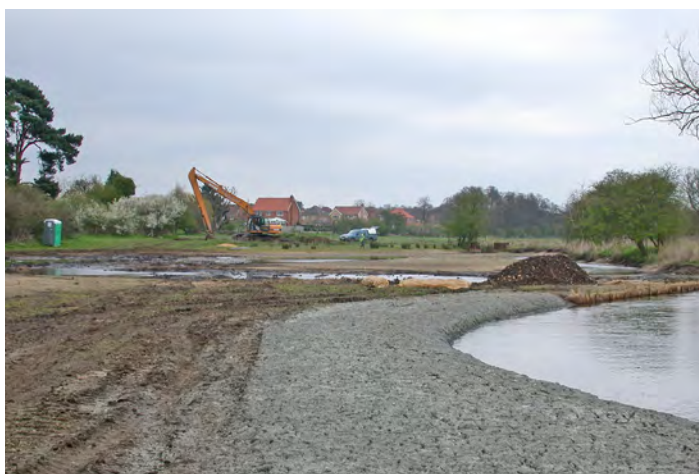
Same bank reinforced using blue clay – October 2003

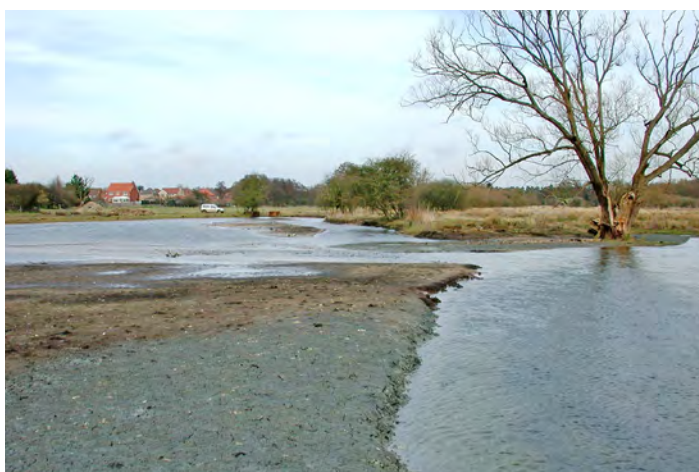
Breach of the reinforced clay bank – March 2004

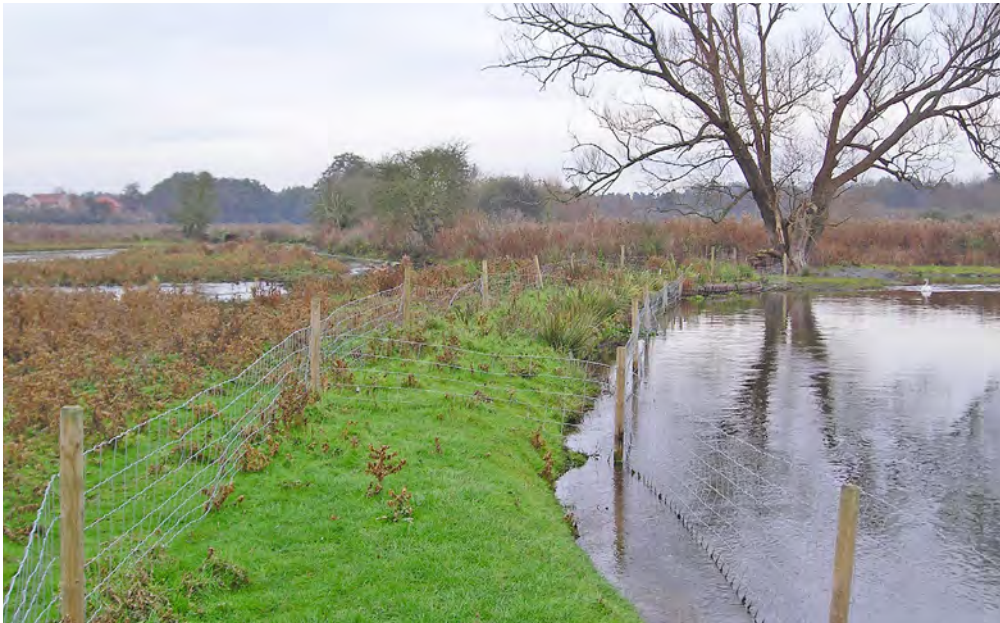
Initial vegetation growth
on pre-seeded coir matting
– December 2005

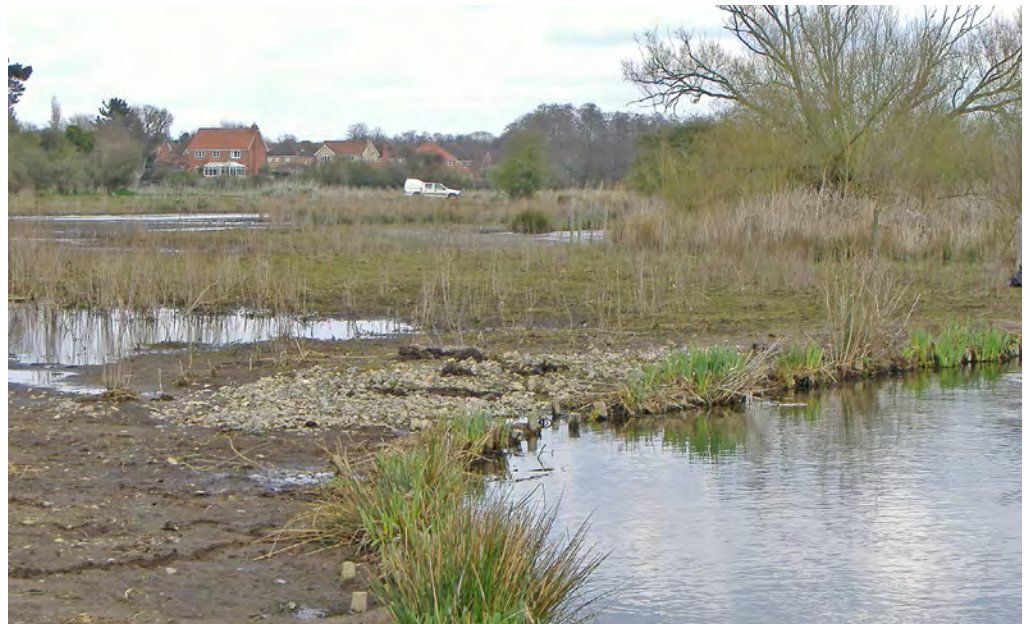
Clay bunds and the subsequent implementation of staked-in pre-planted matting and pallets installed to prevent erosion of these highly vulnerable banks have not been successful. In the case of the latter measure, it is possible that cattle poaching exacerbated the destruction of the matting and pallets.

Erosion of the coir matting
– April 2008

Monitoring of the vegetation has indicated that the banks greater than 0.35m in height have become well vegetated, indicating greater potential stability where overtopping is less frequent (i.e. time between floodplain flood events is designed to allow vegetation to establish). As a result a decision has been made to raise banks slightly from the original design. This is to ensure future over-topping only occurs when banks are stable and not vulnerable to erosion during the flood season. Young willow shrubs will be used to build up the banks to create 'living revetments'. Work will commence in September 2013 at an approximate cost of £6,000.
