Restoring Meanders to Straightened Rivers

1.8 Restoring a meandering course to a high energy river

ROTTAL BURN

LOCATION – GLEN CLOVA, ANGUS, SCOTLAND NO36936919

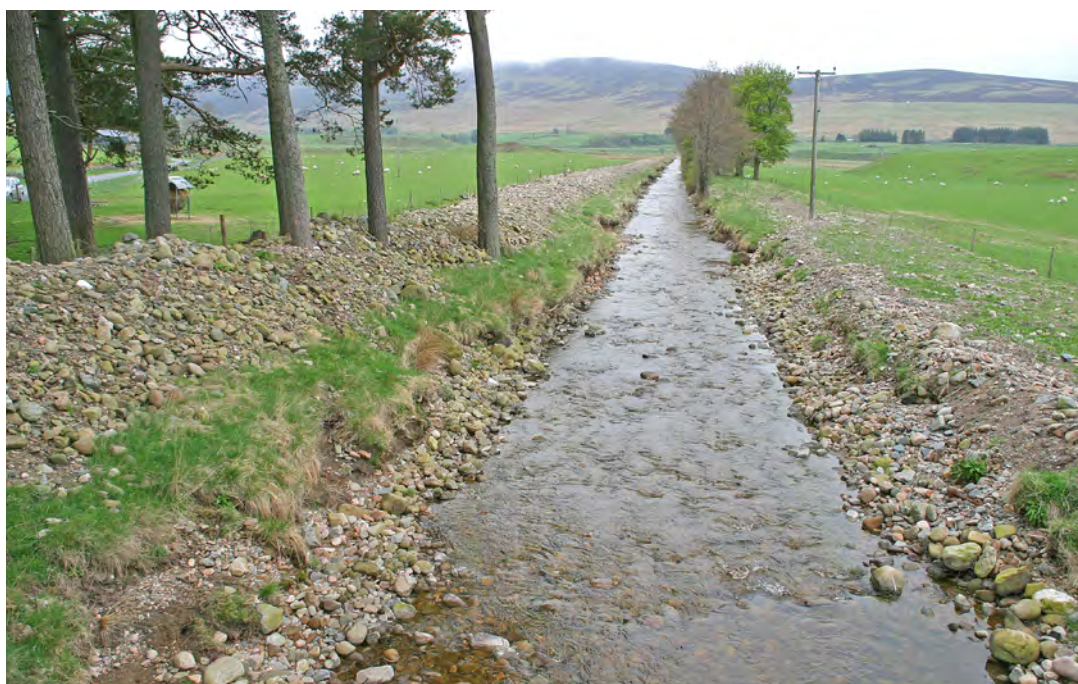
Dredged gravel forms an embankment on both banks. The channel runs in a straight line to the confluence with the River South Esk – May 2006

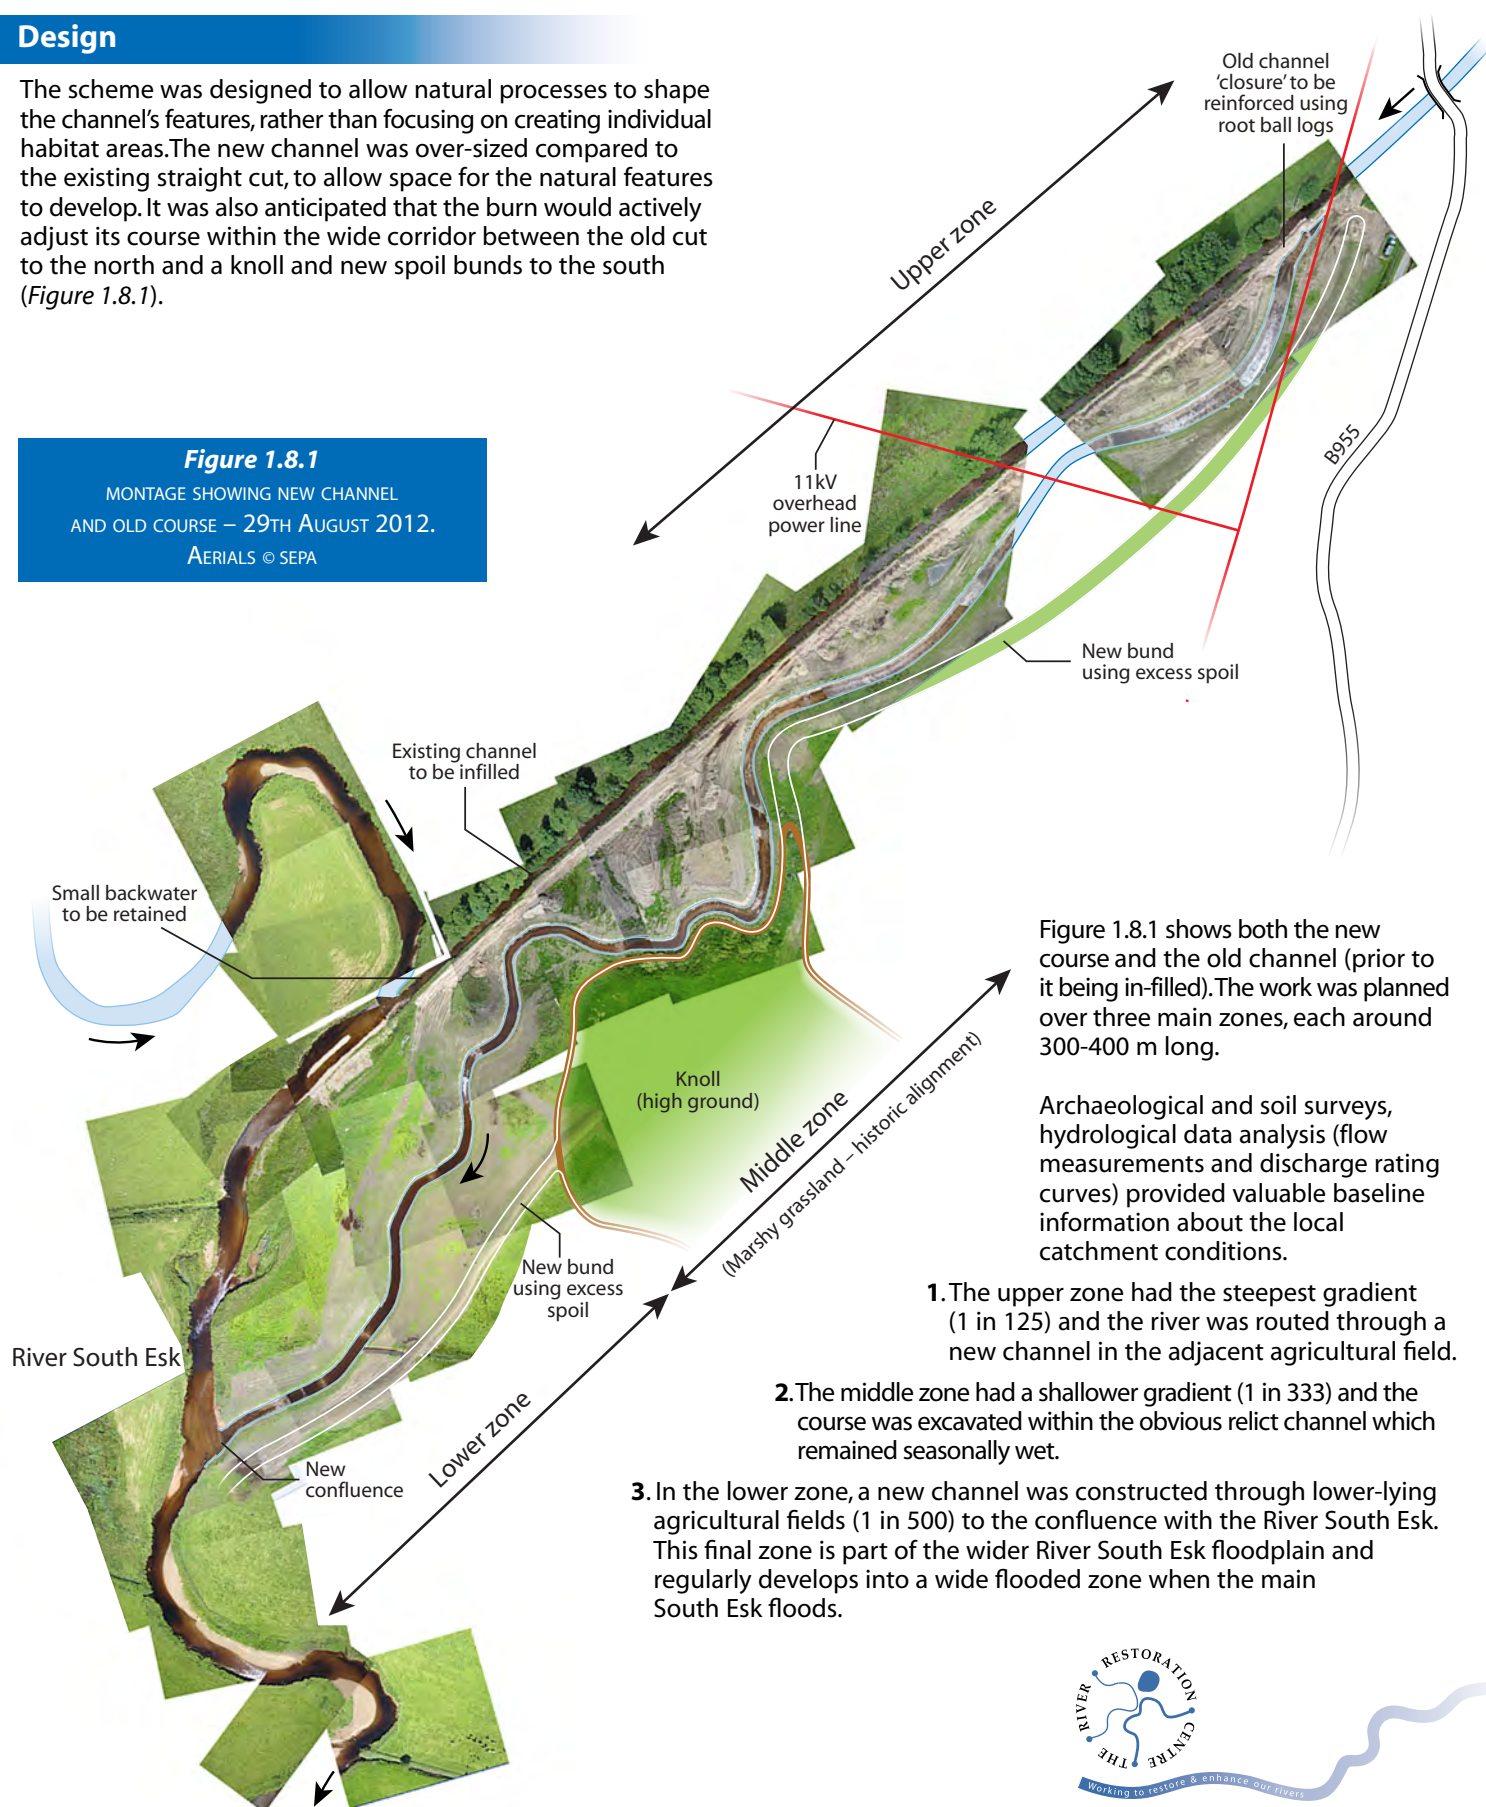
Figure 1.8.1

MONTAGE SHOWING NEW CHANNEL
AND OLD COURSE – 29TH AUGUST 2012.
AERIALS © SEPA

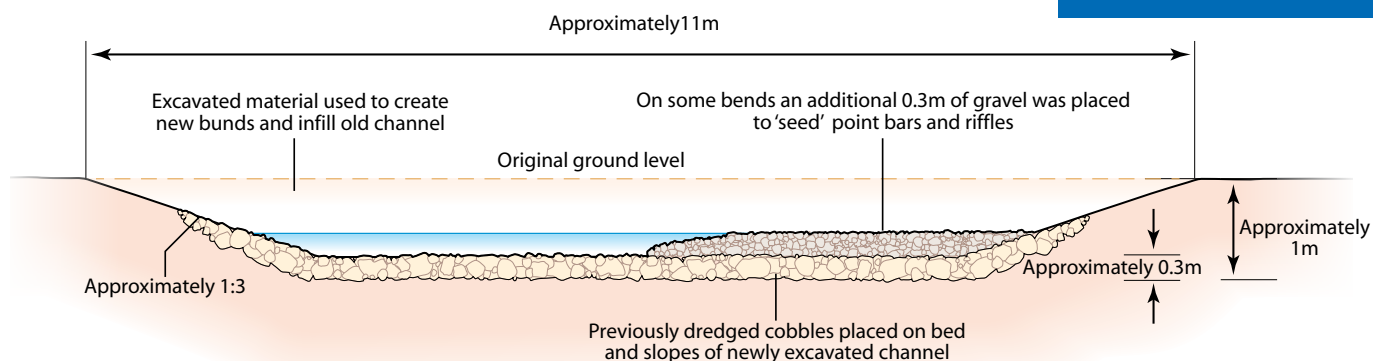
Figure 1.8.2

TYPICAL CROSS SECTION SHOWING A SIMPLE APPROACH TO THE CHANNEL DESIGN

In a further change, and working on the principle that the channel would quickly rework its material, the cross section at each meander was formed as a flat profile (similar to the straight runs – *Figure 1.8.2*). This allowed the bed of the channel to be used as a haul road for placing the gravel substrate. As a result, the channel profile remained relatively similar throughout but with distinct bed gradient changes over the three zones.

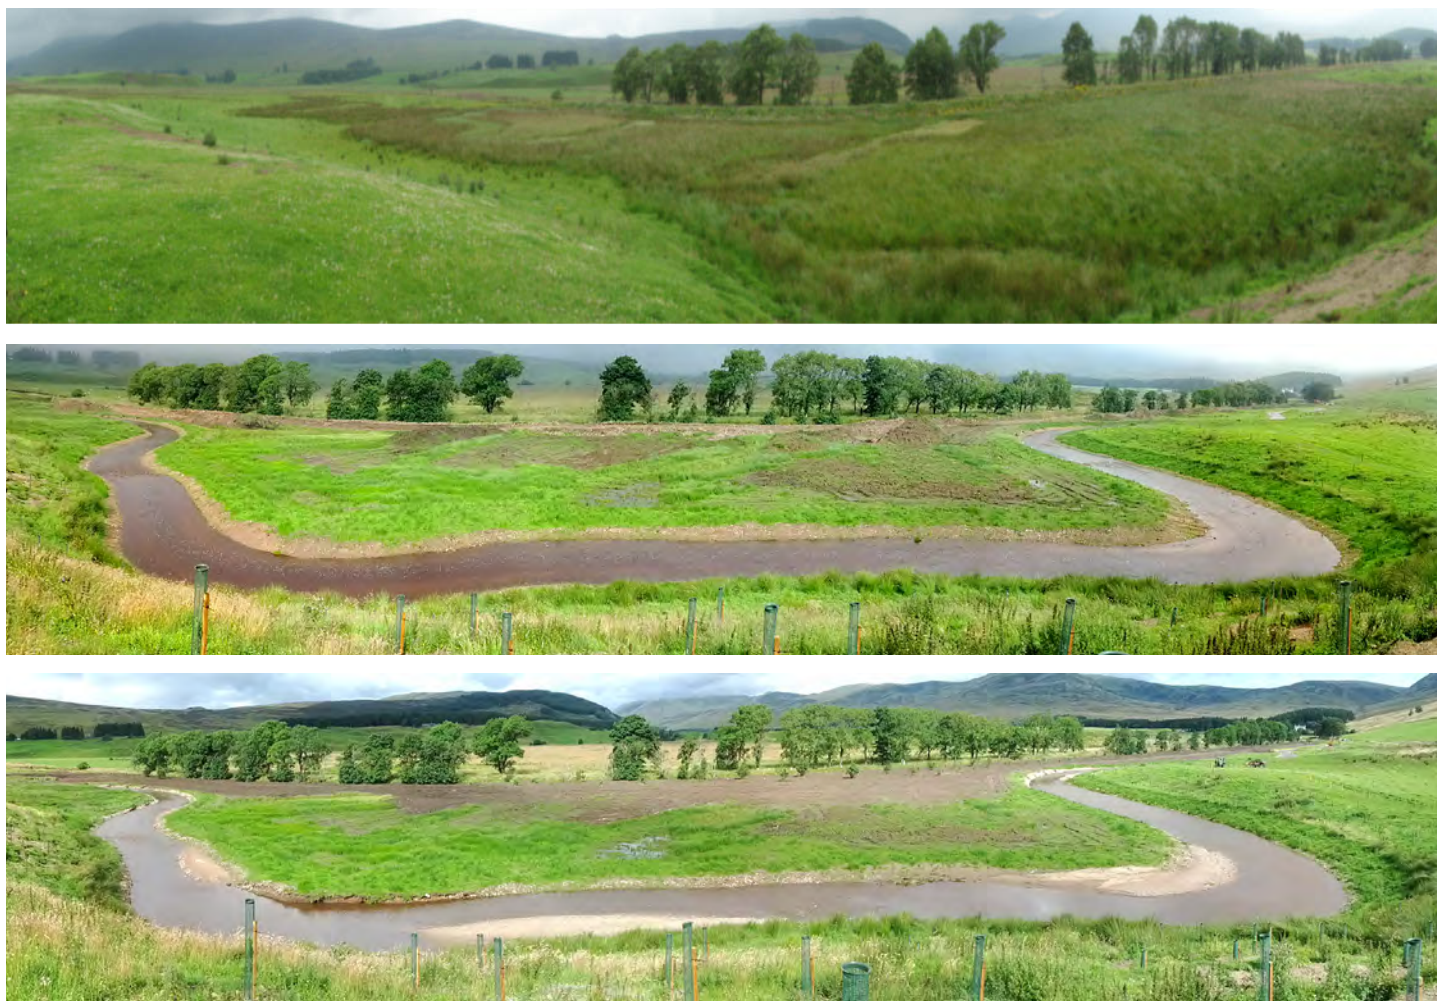
Three panoramas showing the development of the middle reach – 2011 to 2012

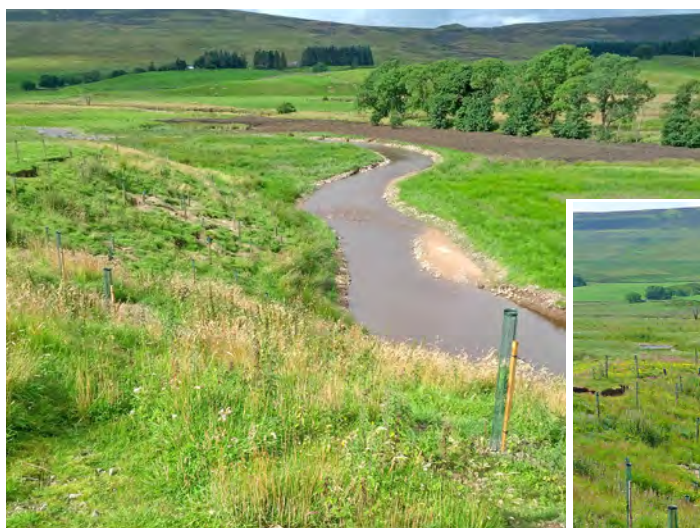
The newly excavated channel, viewed from the knoll, following the old course – Sept 2012

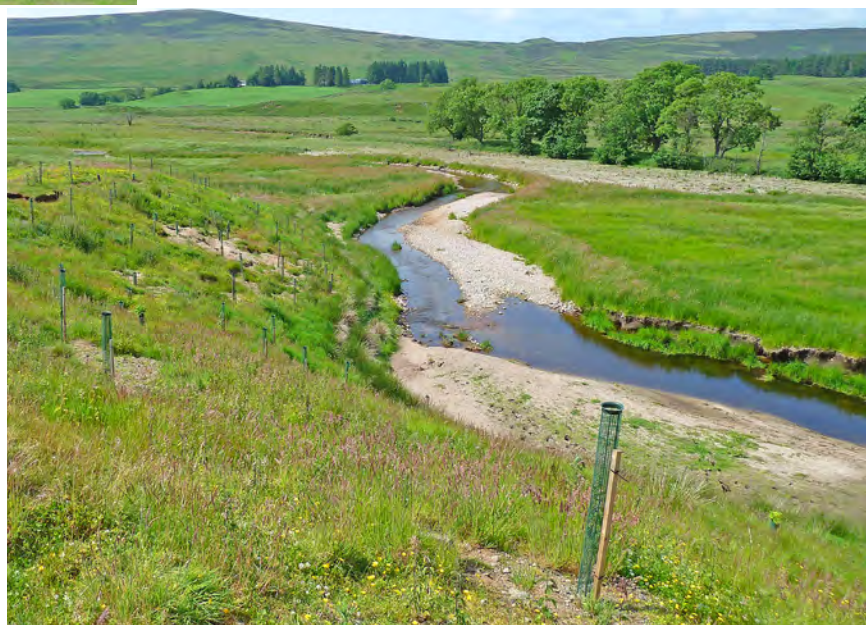
The channel is depositing and moving sediment, creating features – July 2013

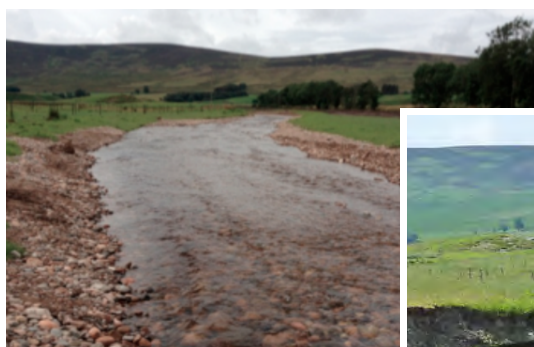
The as-dug channel with cobbles from the old dredgings embankment – 2012

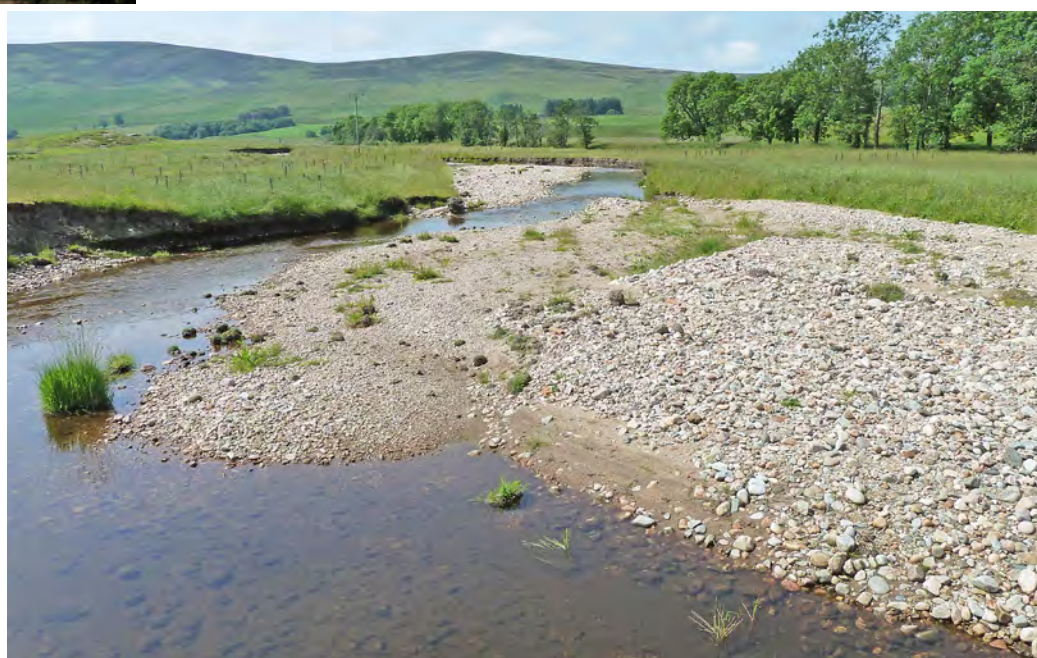
Subsequent deposition and erosion from, now unconstrained, natural processes – July 2013
