Removing or Passing Barriers

12.4 Weir lowering and rock ramp construction

RIVER CALDER

LOCATION - PADIHAM, EAST LANCASHIRE, SD78843308

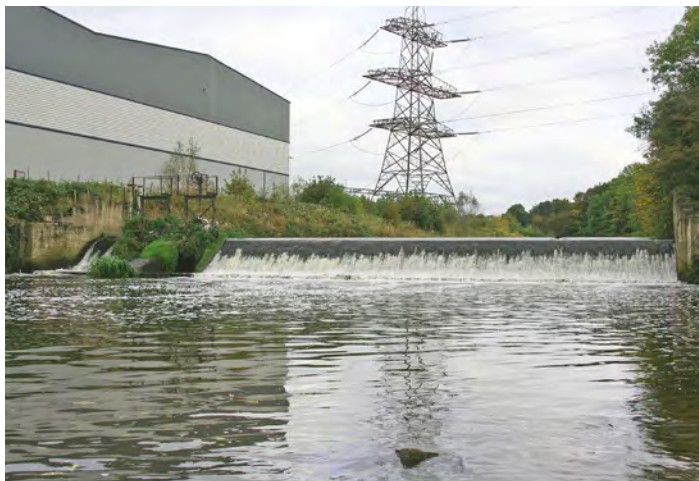
© Environment Agency Padiham Weir prior to works creating a total barrier to upstream fish migration – October 2005

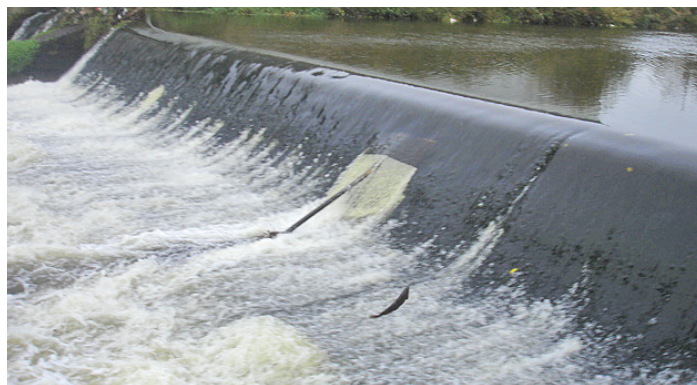
A 7lb Atlantic salmon attempting to jump the weir – November 2006

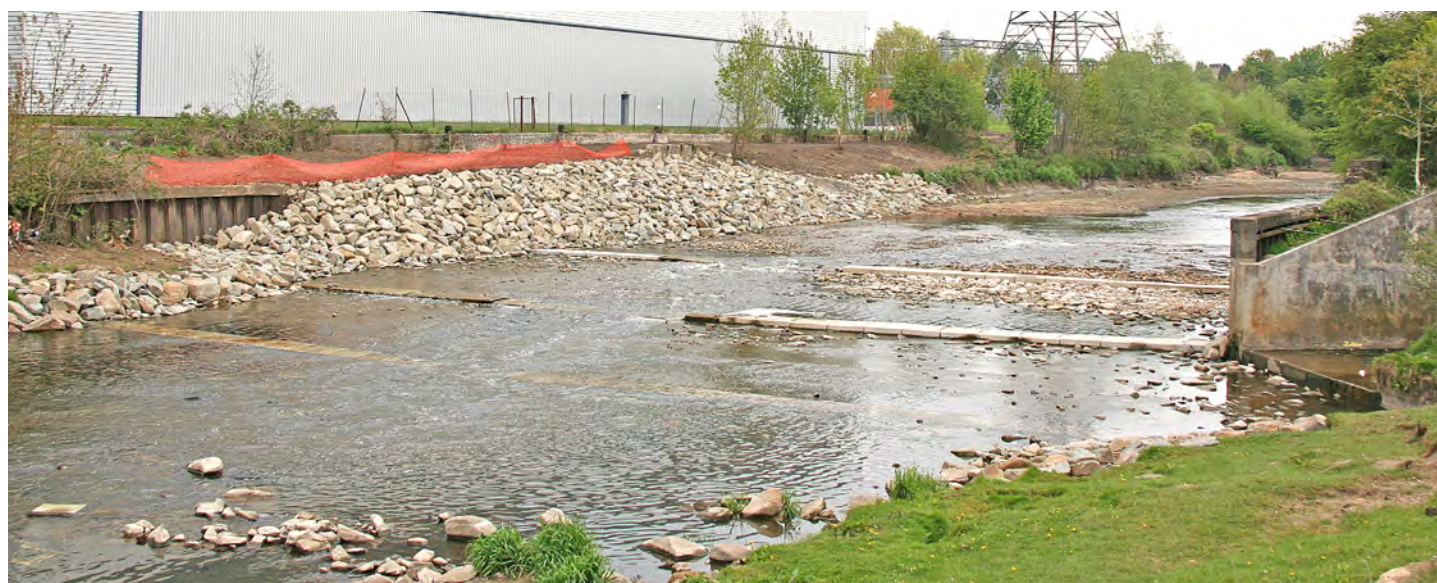
The site on completion. The low flow channel is visible through the centre of the bed check weirs – October 2010

The weir crest was lowered through a combination of diamond wire cutting (wire saw impregnated with diamond dust that can be used for concrete cutting underwater) and hydraulic breaking. A central shallow (0.3m) v-shaped, low flow channel was created. The crest of the original weir was lowered by 1.45m and it now acts effectively as a fourth check weir.

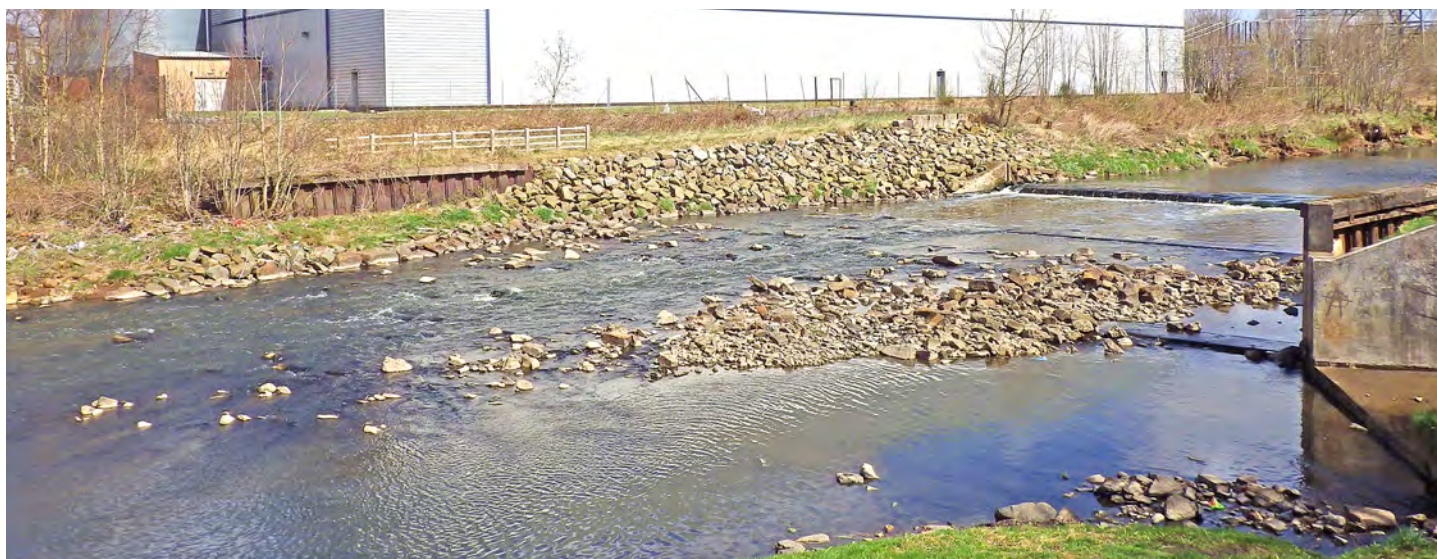
The material used in the rock ramp was selected to withstand the expected stream power at the site, however exceptionally high flows over a sustained period during 2012 appears to have caused significant scour and erosion both above and below the weir. Flow volumes experienced during 2012 resulted in velocities capable of entraining the material used for the rock ramp (the 1 in 50 year return period flood event in June had a peak flow of 220m³/s compared to median annual flood flow of 173m³/s).

Once a portion of the material had been scoured out, the uneven bed surface was vulnerable to further scour and turbulence and allowed more material to be scoured out during subsequent high flow events. The issues experienced at this site as a result of high flood flows highlight the importance of setting the size of stone used for the stone armouring according to bankfull flows.

The site after three years. Some of the material entrained during high flood flows has been carried downstream but the majority has remained in the vicinity of the rock ramp and is visible near to the left hand bank – April 2013
