Enhancing Straightened River Channels

3.8 Creation of on-line bays

RIVER TALL

LOCATION - ARDRESS, NR. MOY, CO. ARMAGH, N. IRELAND. OS MAP 19, H916555

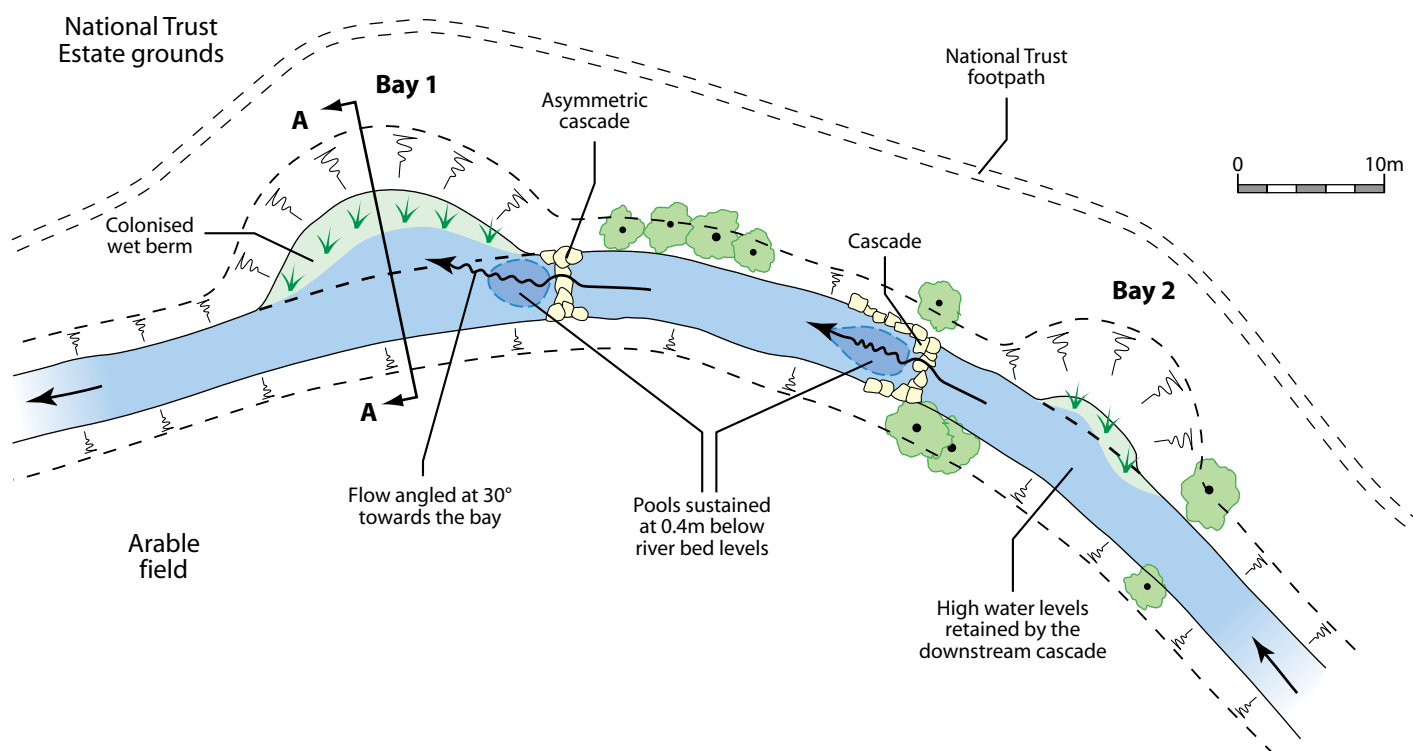
Figure 3.8.1
PLAN OF SITE

Four bays of differing sizes were excavated within the reach. Three of these were accompanied by upstream stone cascades, to generate turbulence and ensure that the bays remained 'open' rather than quickly silting up. The bays also incorporated a low ledge, just below summer water level to accommodate a variety of macrophyte species. *Figure 3.8.1* shows the two bays located at the downstream end of the enhancement reach.

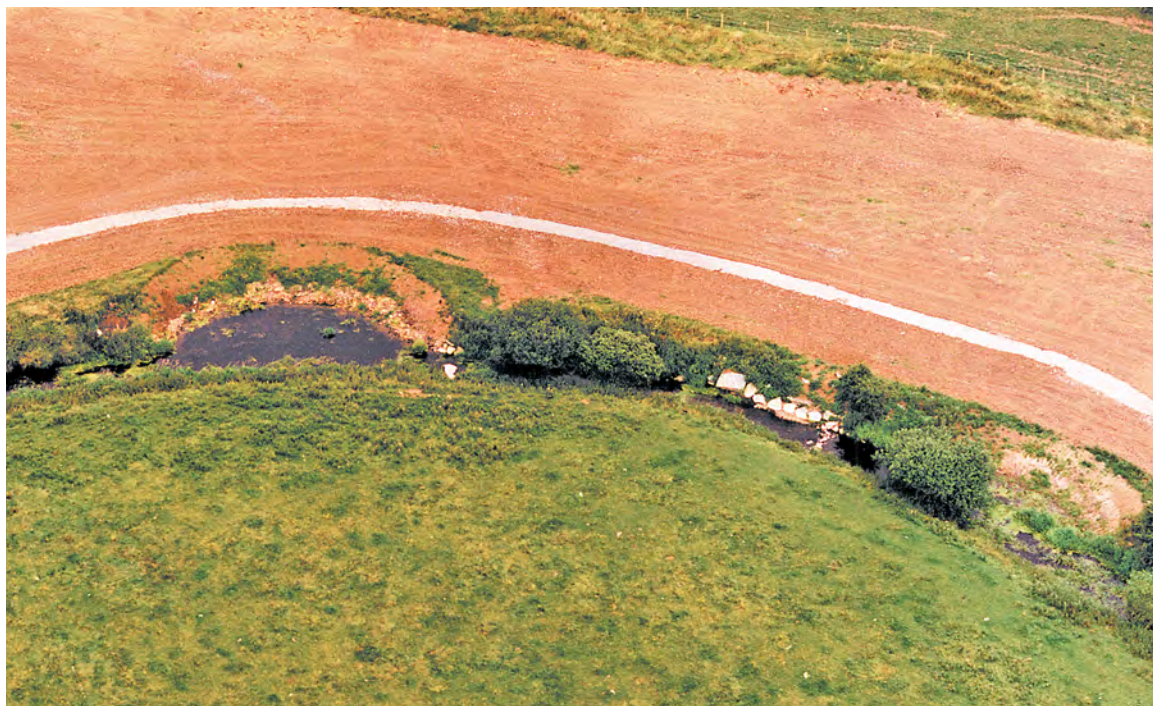
Downstream bays after less than a year.
Note: Bay 2 is already becoming choked with vegetation

Bay 2 rapidly silted up and colonised with emergent vegetation, spreading well into the main channel. The cascade for this bay was placed downstream, resulting in increased water levels from the backwater effect created. This has reduced flow velocity and now acts as a silt trap, promoting silt deposition and vegetation growth.

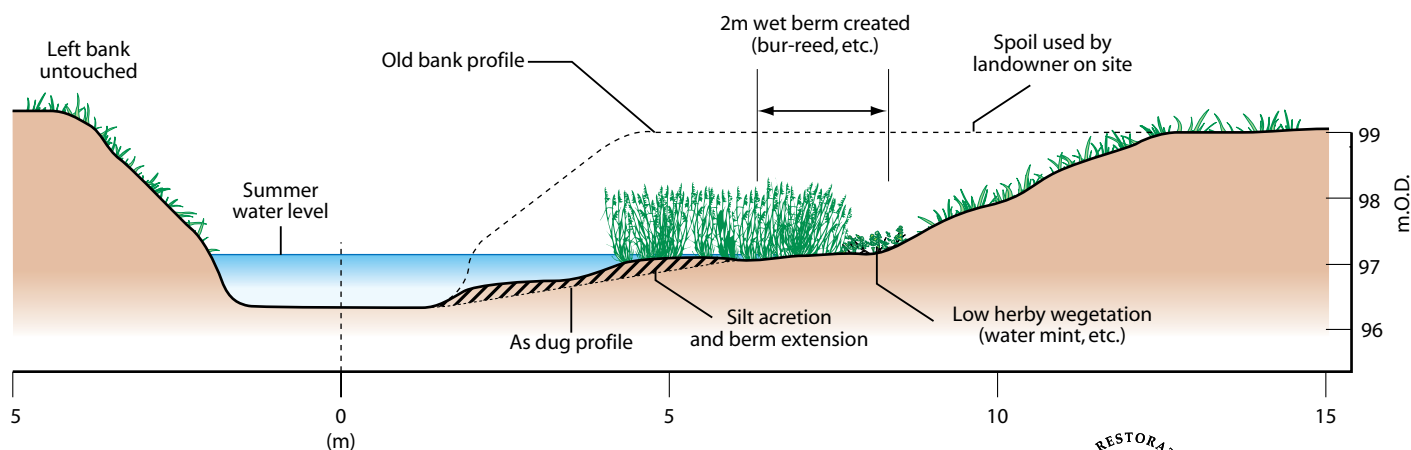
Figure 3.8.2
SECTION A THROUGH BAY 1

From the ledge the bank rises at a batter shallower than the existing 1:1 bank (approx. 1:2 to 1:3). The batter angle varies with the difference between bed and bank top from 2 – 4m (Figure 3.8.2).

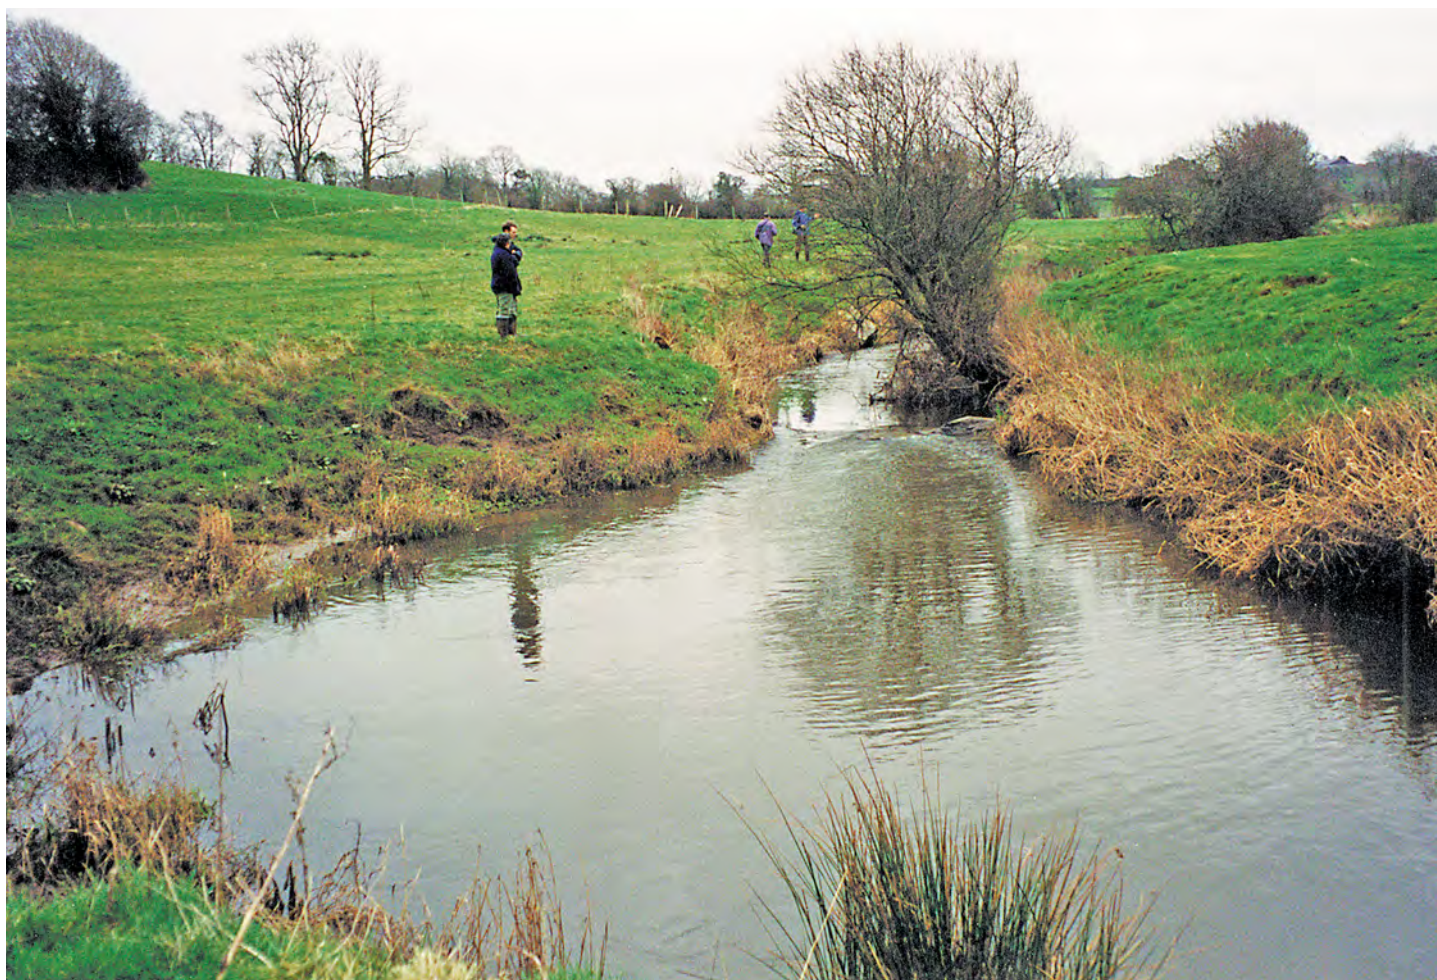
Bay 1 showing the angle of flow keeping the bay 'open'

Bay 1 is similar in size to bay 4 but is able to retain its open nature due to the positioning of its cascade. The flow of water over the boulders is angled into the bay, approximately 30 degrees offset from the main channel. This directional flow is helping to maintain the bay at low and high flows.

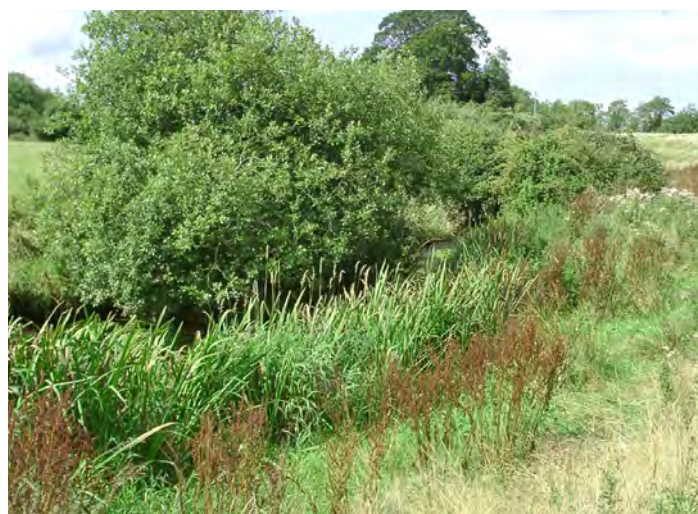
Bay 2, looking downstream.
Heavily vegetated – May 2012

The success of the bays varied depending on the presence, or otherwise, of a structure deflecting water into them. If the project was to be carried out again, more consideration would need to be given to either the location of the bays within the overall flow regime of the river, or be designed to include a deflection structure that would maintain flows into the bay. Additionally, the site would have benefited from a long term management plan, particularly for tree planting.
