### 8.4 Restoring a ford as a stock and vehicular crossing point

#### RIVER OGWEN

LOCATION - 5KM SOUTH OF BETHESDA, GWYNEDD SH641615

## 8.4 River Ogwen 2013 Update

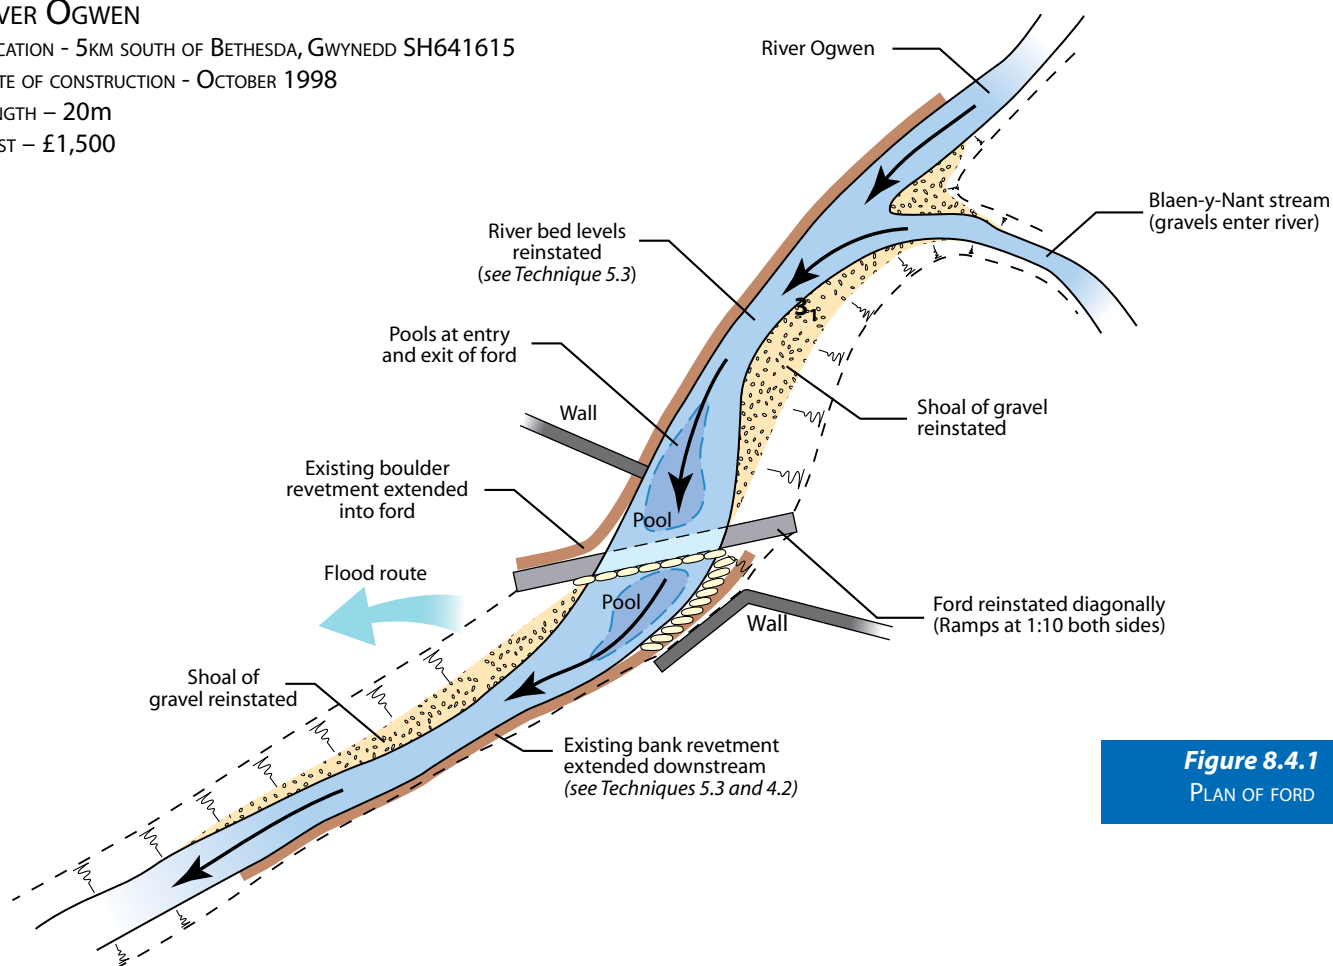
**Figure 8.4.1**  
PLAN OF FORD

The location of two solid stone walls on opposite banks of the river were a further consideration. The routing of overland floodwaters down the valley would clearly be interrupted by these opposing walls with all flow being concentrated between them coincident with the location of the ford (*see Figure 8.4.1*).

Careful study of the topography of the adjoining fields indicated that the natural flood route involved overtopping the bank on the right side of the ford (looking downstream). This bank was carefully graded to blend with a discernible 'gully' down the field such that floodwater passing between the two walls could easily escape out onto the natural floodway again without causing undue stress at the ford. The arrow on *Figure 8.4.1* indicates this important floodway.

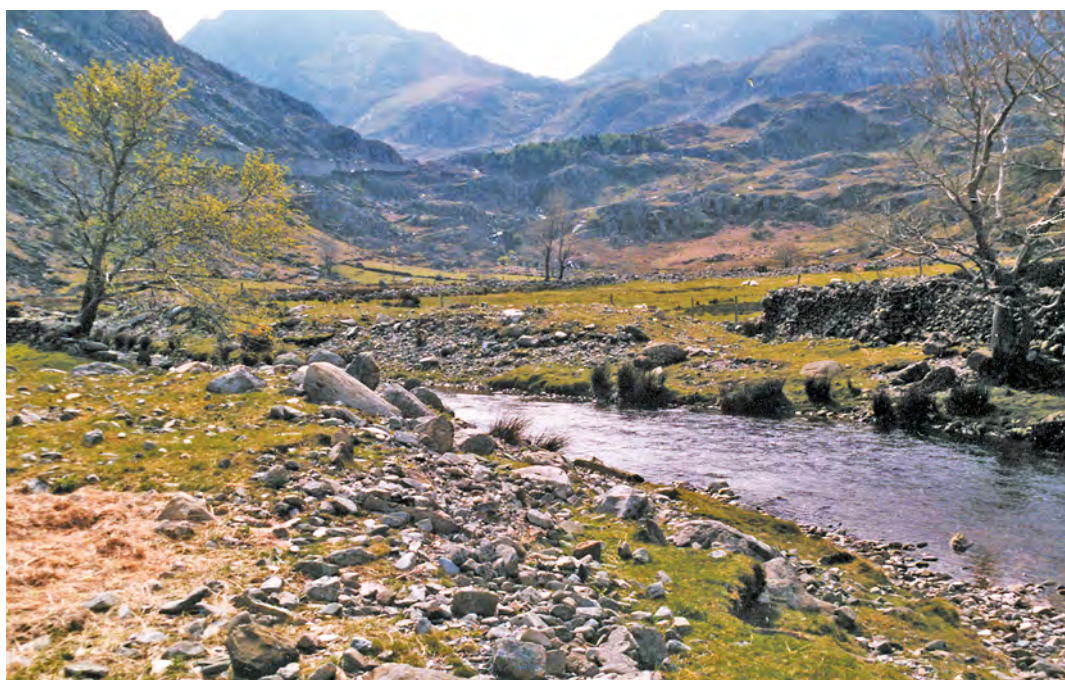
View across the deepened river at the old ford location

Old Ordnance Survey maps indicated a ford had existed prior to dredging but it had been removed during these works; see photo of conditions pre-restoration. The farmer was keen for the ford to be restored as a stock and vehicular crossing point.

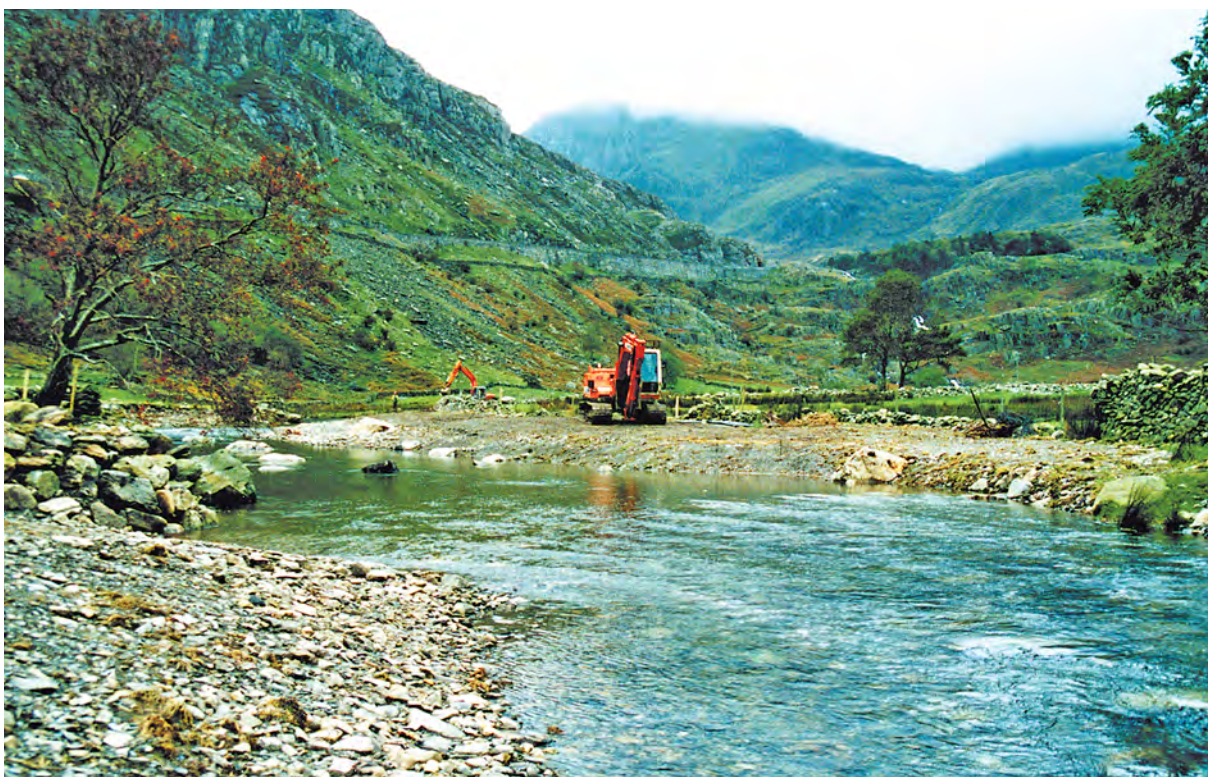
The restored ford, shoals and riverbed

The entire configuration of the ford, shoals, pools and runs has proved to be sustainable, with the ford in regular use by the farmer.

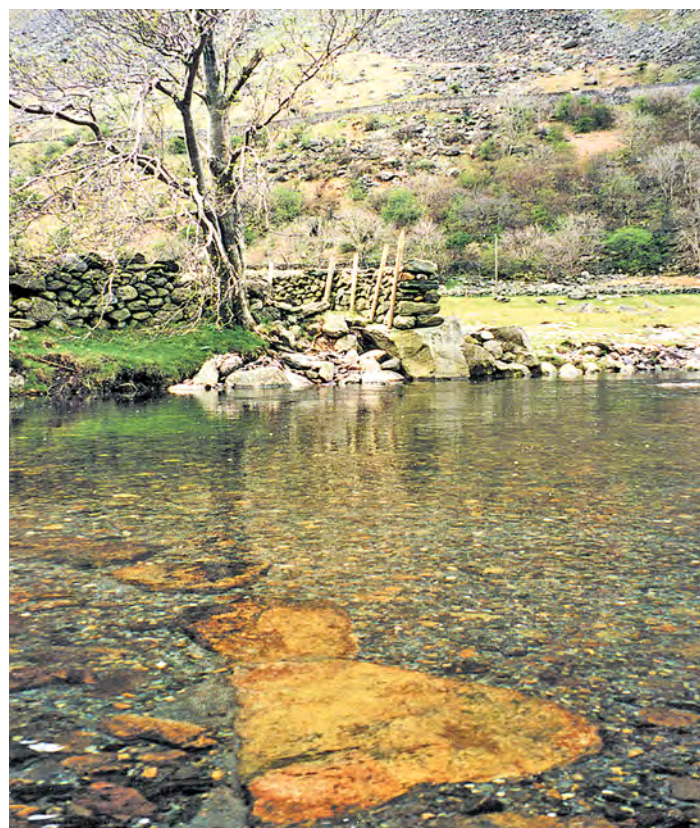
**Figure 8.4.2**  
SECTION THROUGH FORD

Downstream crest defined by boulders

It was decided to define the downstream edge of the submerged length of ford with a line of glacial boulders as shown on *Figure 8.4.2*. This provided the stable bed level that needed to be defined as part of the overall river bed restoration. It was not possible to completely restore the river bed elevations with gravel due to lack of suitable material (*see Technique 5.3*), so the

new ford might have washed downstream if the profile had not been fixed by the boulders. They also ensured a clear route across the river remained visible between the ramps on each side. The gravels that were available from previous dredging operations were utilised to restore the two important shoal profiles upstream and downstream of the ford. The river bed was also fully restored with gravel upstream and downstream of the ford with particular attention to the profiling of pools and runs that naturally form at opposing bends (*see Figure 8.4.1*).

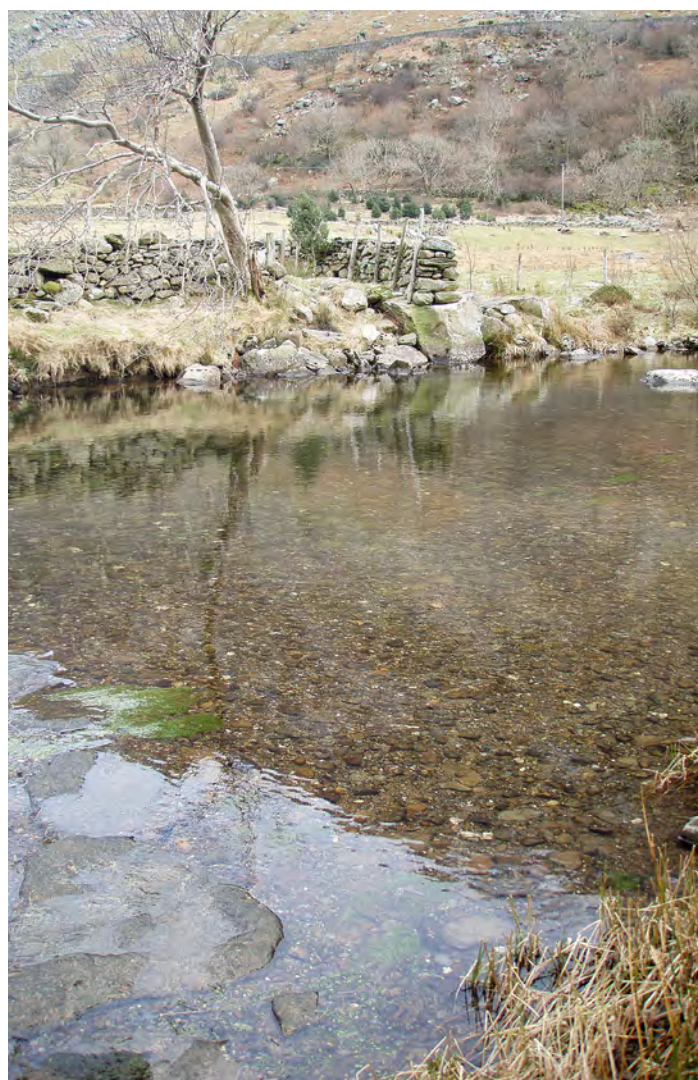
The ford remains in good condition with minimal disturbance to river morphology and has not required any repairs to date (March 2013). The ford is used occasionally by the tenant farmer who crosses the river in this location with his tractor.

The ford remains stable with the boulders used for the downstream crest remaining in position  
– February 2013
