the River Restoration Centre

River Don, Newcastle

Identifying Opportunities for River Restoration and Habitat Creation

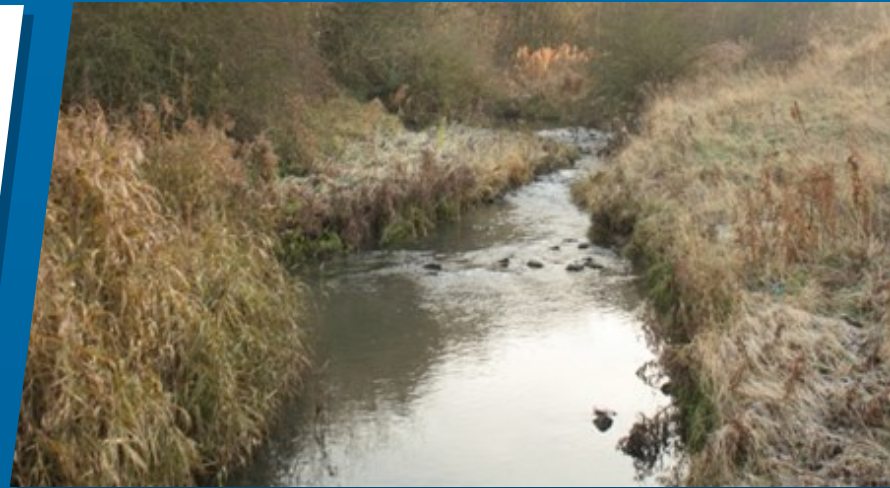
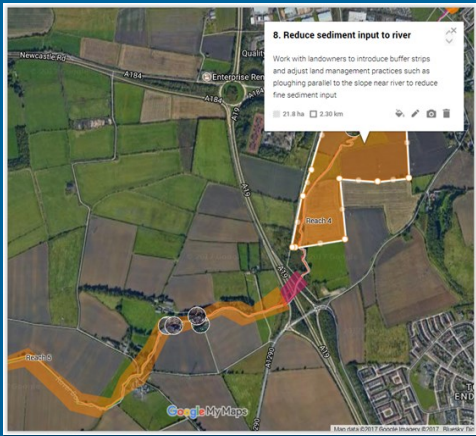
International Advanced Manufacturing Park development area
The IAMP covers parts of reaches 4 and 5 of the River Don. Given the potential opportunities associated with the development, the whole area has been looked at together here (shown as a pink polygon).

- Condition**
- On the eastern side of the area, the river is extremely over deep (almost 4 m), resectioned and slightly realigned with a reinforced bank toe (gabions, riprap)
 - Sandy bed, not much channel diversity
 - Riparian vegetation (trees)
 - Possibly some recovery from being over-widened – two staged channel appears to be developing with a natural beam narrowing the low flow channel
