JBA
consulting

River Blythe Restoration Plan

Draft for comment

May 2017

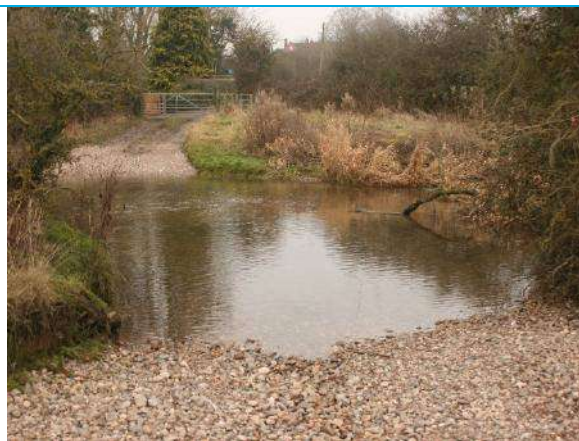
An over-widened section of the River Blythe

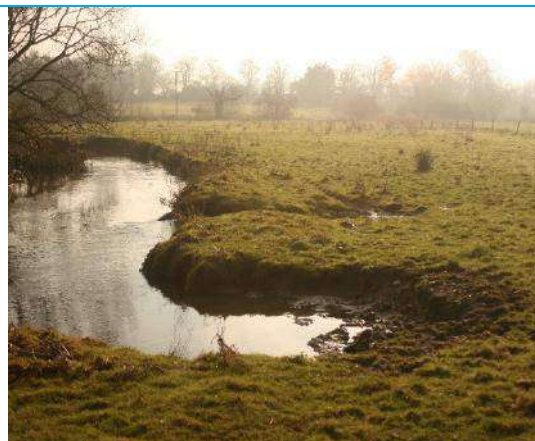
Active erosion enhanced by poaching

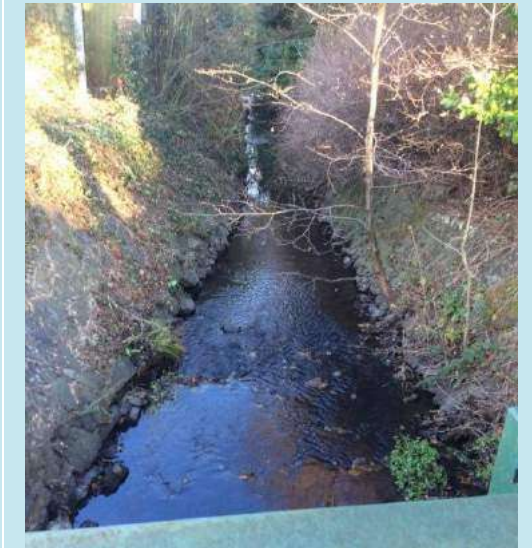
Concrete-lined, entrenched channel near Coppice Walk. Channel width is uniform throughout reach.

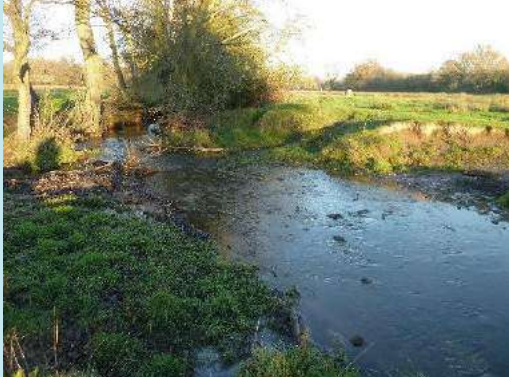
<p>Ford crossing over shallow, riffle, resulting in broken banks.</p>

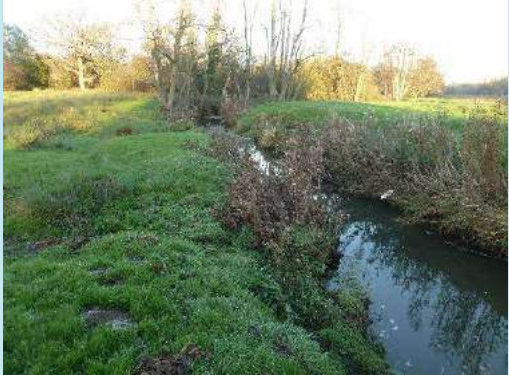
<p>In addition to riffles, there are also deep, slow-moving areas of the channel, in which some suspended silts are evident.</p>

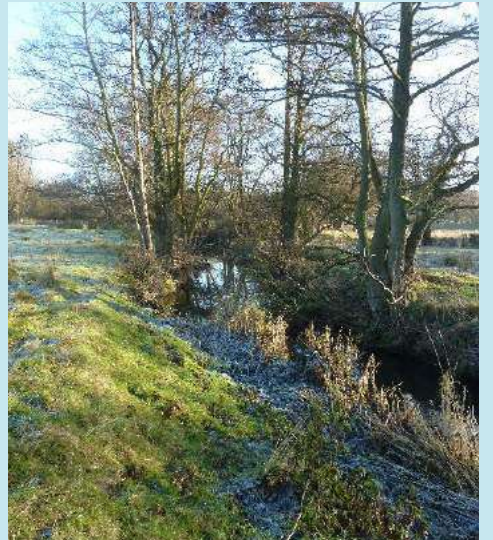
<p>Incised channel, Alder-lined for most of the reach with occasional Crack Willow pollards.</p>

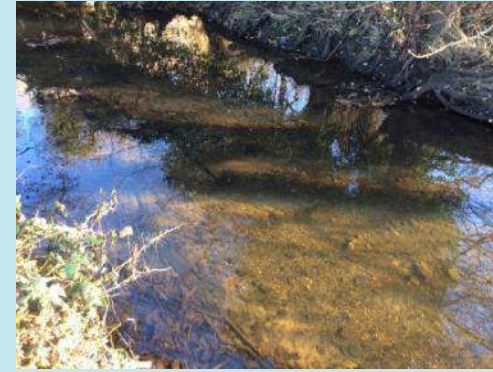
<p>Bed substrate in riffles and shallow sections is shown to be mostly armoured gravels with sandy deposits and some fine sediments, colonised by Water Crowfoot in places.</p>

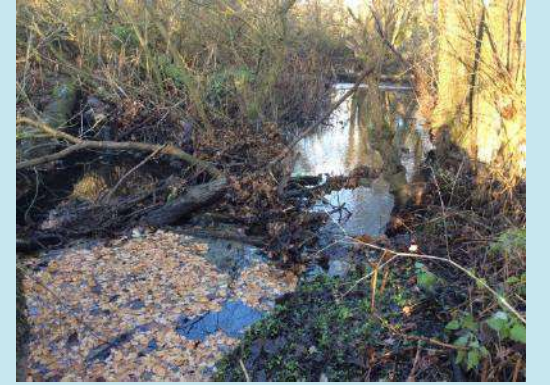
Through Halfmoon Coppice wood the channel is wide and slow-moving, owing to localised impoundment caused by natural dams. Floodplain connectivity is generally poor.

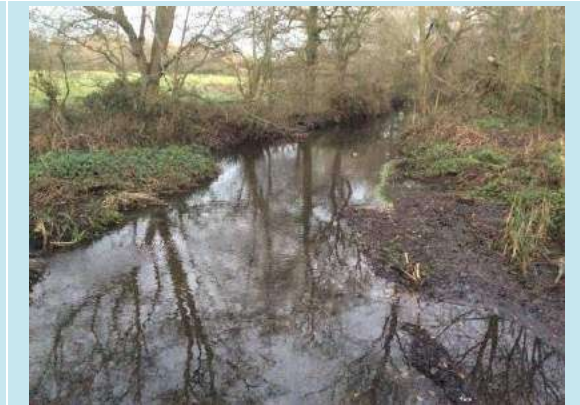
Wooded reach showing areas of deposition

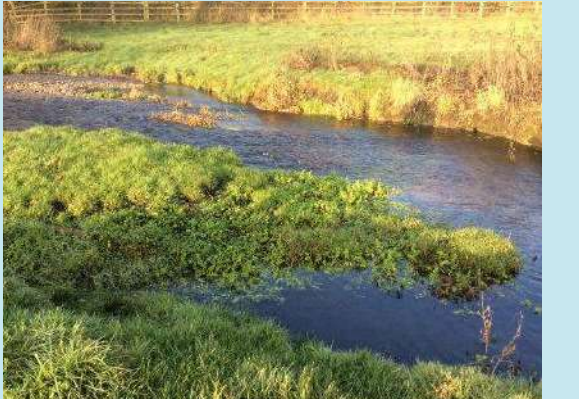
<p>Some deposition in the form of mid-channel bars and point bars.</p>

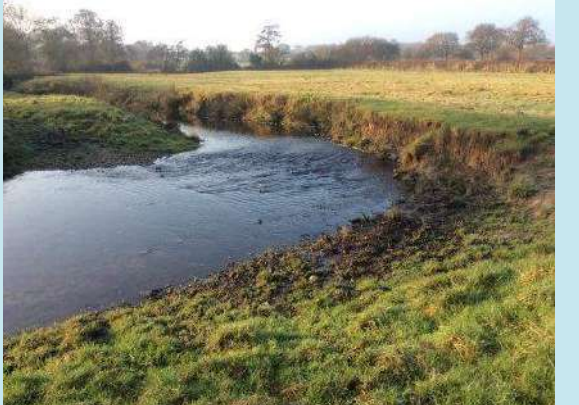
<p>Grazed banks, poaching and lack of trees in places is assisting with erosion.</p>

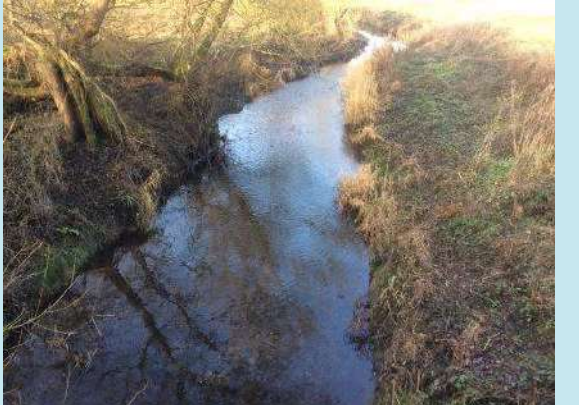
<p>Straightened section with sluggish flow.</p>

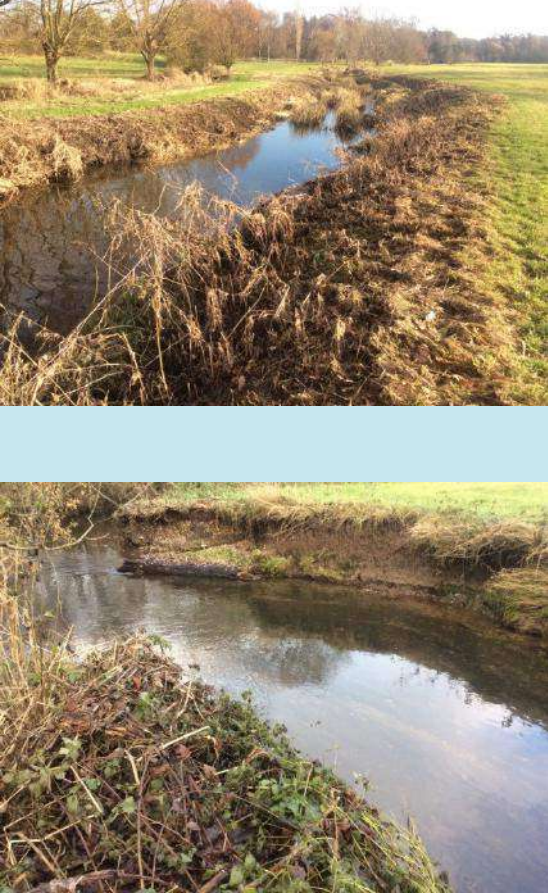
<p>Bank erosion and instability is evident in the reach.</p>

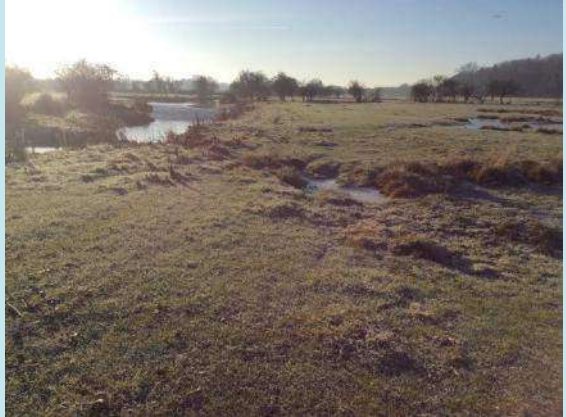
<p>Extensive network of paleo channels evident in floodplain, some of which contain Soft Rush..</p>

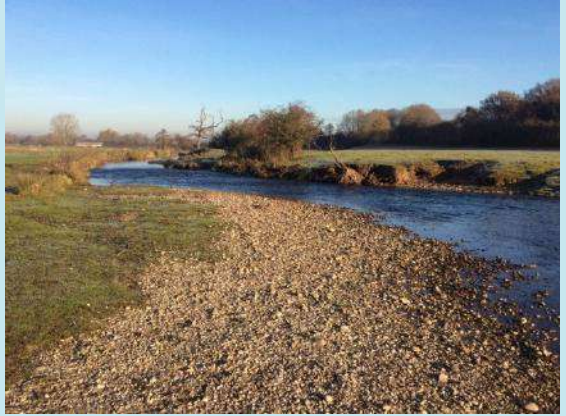
<p>Areas of active deposition being colonised by heavily grazed grassland.</p>

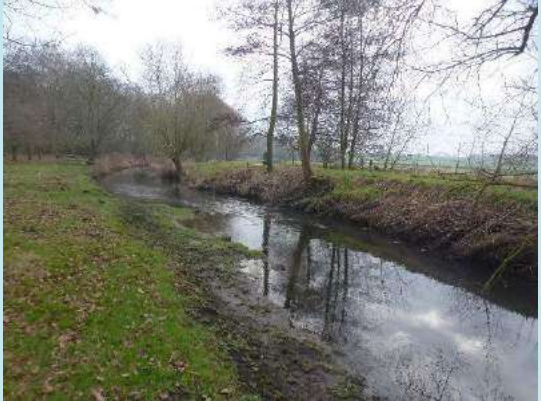
<p>Fine sediment deposition on relatively straight section. Different bank profiles resulting from differences in management practices.</p>

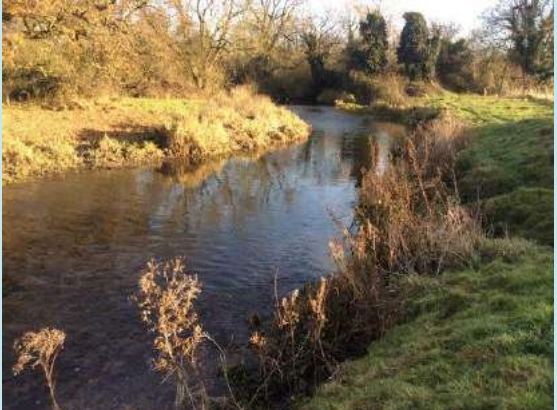
<p>Sequence of glide morphology leading into deeper pools. Clean but armoured gravels visible in shallower glides.</p>

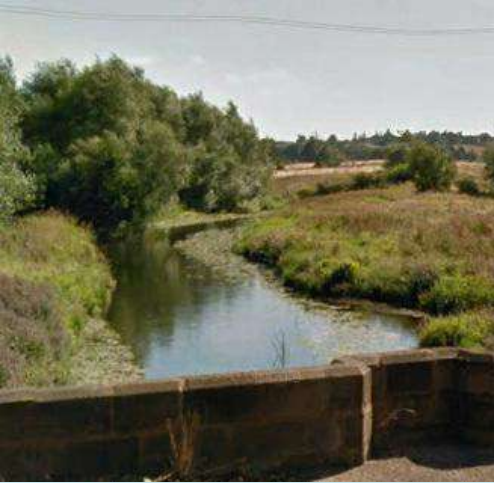
<p>Rushy pasture on the L bank and rich fen on the right bank looking South (upstream). Bridge Plantations represent virtually the only trees in this reach.</p>

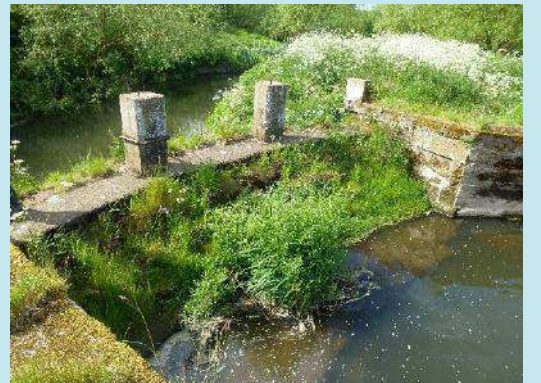
<p>Old sluice structure in channel</p>

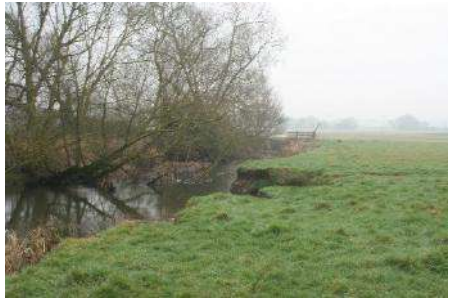
<p>Lack of Floodplain Connectivity</p> <p>Several factors contribute to this including embankments concentrating in channel flows and channel incision and entrenchment as the surrounding floodplain has been partly built up around the channel.</p>	<p>A reduction in the frequency of floodplain inundation means that fine sediment is deposited within the channel and not on the floodplain. Excess fine sediment within the channel will reduce spawning habitats and also decrease the quality of the substrate for some taxa. Ultimately, excessive fine sediment is a major cause of in channel habitat degradation and leads to poor ecological condition.</p>

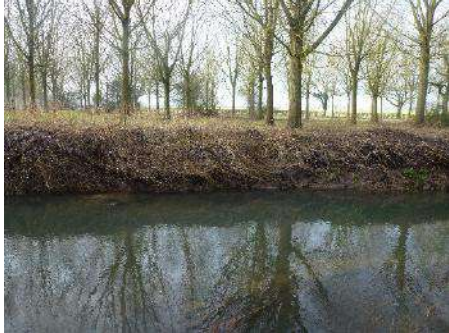
<p>Bank Instability and Livestock pressures</p> <p>Bank instability as a result of poaching from livestock, poor farming practices in places, and entrenchment of the channel.</p>	<p>Livestock have utilised the collapsed banks to gain access to the river in a number of locations leading to enhanced erosion of the banks (poaching).</p> <p>Arable farming, where carried out up to the channel edge, has limited riparian vegetation cover and exacerbated bank erosion.</p> <p>Increased input of fine sediment into the channel which leads to increase in channel siltation.</p> <p>A more uniform channel reduces the habitats within the river (i.e. fewer refuges for shelter).</p> <p>Limited bankside vegetation due to erosion and as a result a decline in habitat.</p>
