Longwater Lawn and Mallard Wood and Mead, New Forest

Techniques: Meander excavation & reinstatement; Drain blocking and infill

Project location: Longwater Lawn and upstream, near Ashurst

the River Restoration Centre Case Study Series

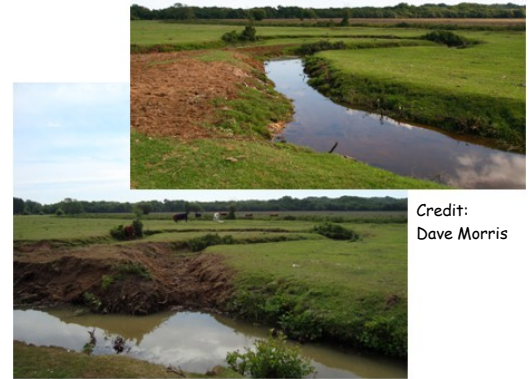
Reconnection of a meander on Longwater Lawn - the situation in July (below) and September 2010 (above)

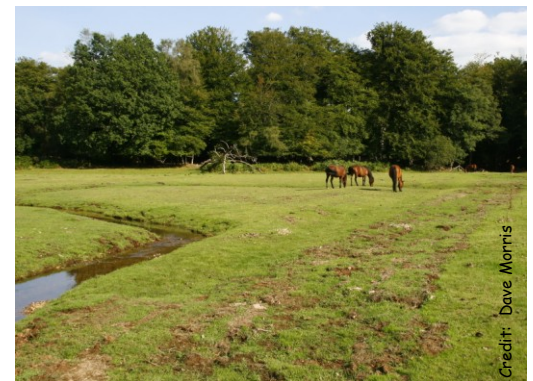
Restored (left) and old course (right) at Mallard Mead
