# Nar SSSI at Narborough Trout Fishery

## Techniques: In-channel pools and berm creation using existing deflectors

**Project location:** Downstream of The Maltings, Narborough

**River:** Nar

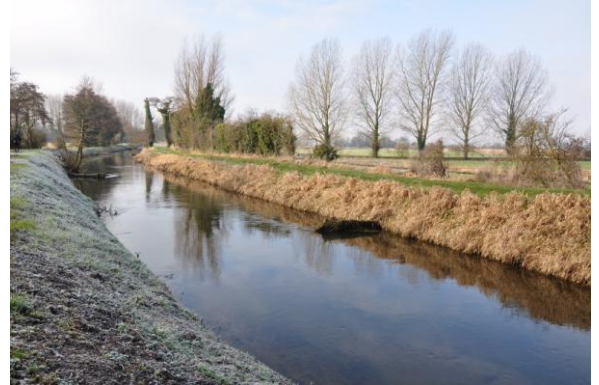
The river pre-project: wide, with slow and uniform flow.  
© 2010 Nigel Holmes

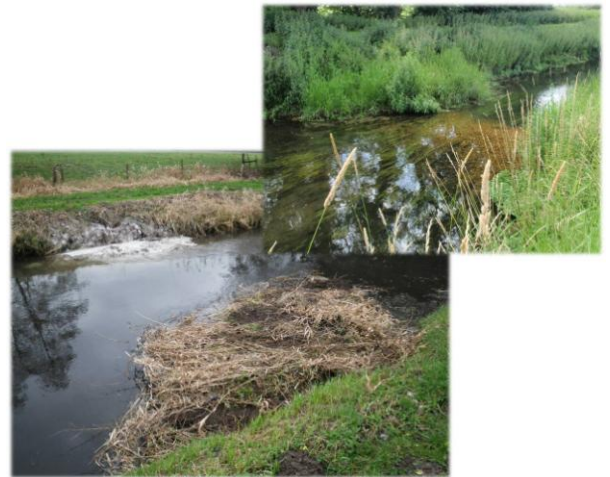
Double shoulders under construction (left, with far bank berm yet to be capped), and 4 months later (right).  
© 2010 Nigel Holmes and 2011 Chris Bell

Though early days, it seems that this has been a successful low-cost 'quick win' in a constrained site, creating both shallow, high-velocity and pool areas with very little gradient.

Material for the shoulders was taken from the bed of the river immediately downstream, and used to build out from the bank at just above average water level. This was compacted and capped with material scraped off the bank top, which contained a much *Phalaris* sp. Most berms were constructed around existing deflectors, which, together with the anticipated growth of the Canarygrass, helped secure the features - particularly when the bed material turned out to be peat, rather than chalky clay. A gap between the existing bank and the shoulder was maintained to avoid blocking vole burrows. The narrowing was designed to maintain a scouring flow to sustain the downstream pools. In most cases, the bed was raised slightly between the shoulders and topped off with gravel. The work was carried out over just a few days using the Environment Agency's in-house team.
