Removing or Passing Barriers

12.5 Replacing a weir with a rock ramp

RIVER NEB

LOCATION - GLENFABA, ISLE OF MAN SC24648287

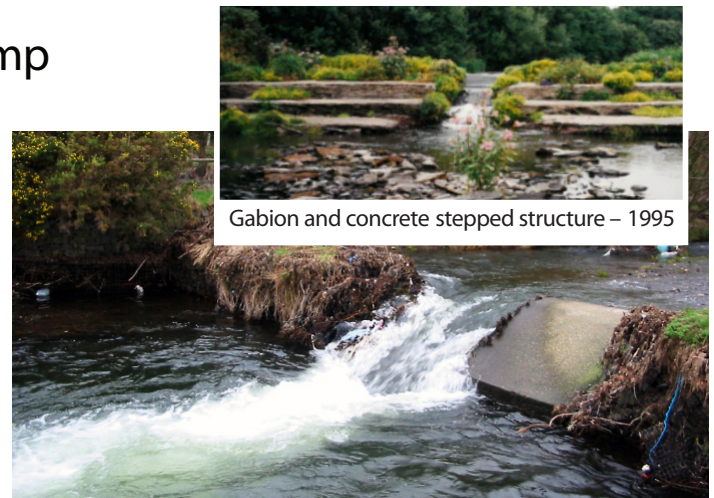
Collapsing weir with deep scour hole used for swimming – January 2004

to be passable by all life stages of Sea Trout. The large deep scour pool was being used as a swimming pool but contained boulders and loose gabion wire that presented a safety issue.

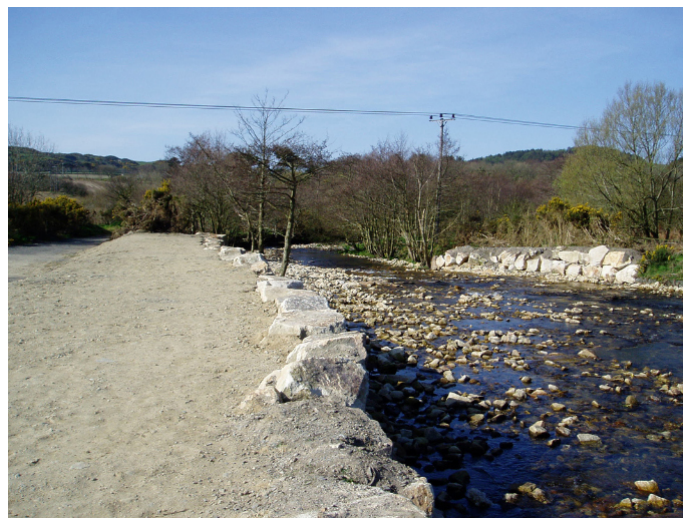
Nearly completed rock ramp, embankment and vertical blockstone edge prior to storm - 2007

At this point, when the works were 80% complete, a large storm event occurred breaching the new left bank embankment and bypassing the rock ramp, flooding the left bank floodplain and scouring and redistributing the rock ramp material.

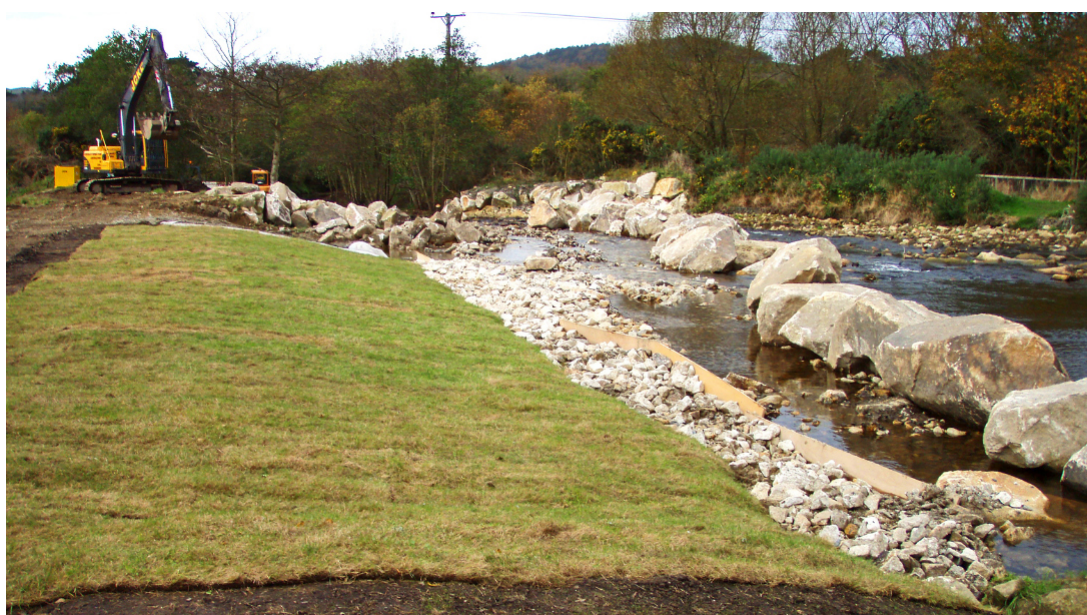
Removal of the vertical edge stones and modified to a turfed shallow slope following the breach event. Stones used to form the ramp extension – Nov 2007

7. The vertical rock face was removed and the embankment was regraded to a slope of 1 in 4 from the 2m footpath top width down to the water's edge, creating a gentle vegetated slope with additional high flow capacity.
8. Turf and coir geotextile provided vegetation cover and initial protection. There was also addition of a Lintobent impermeable clay core liner to solve continued leakage within the narrow upstream end of the embankment.

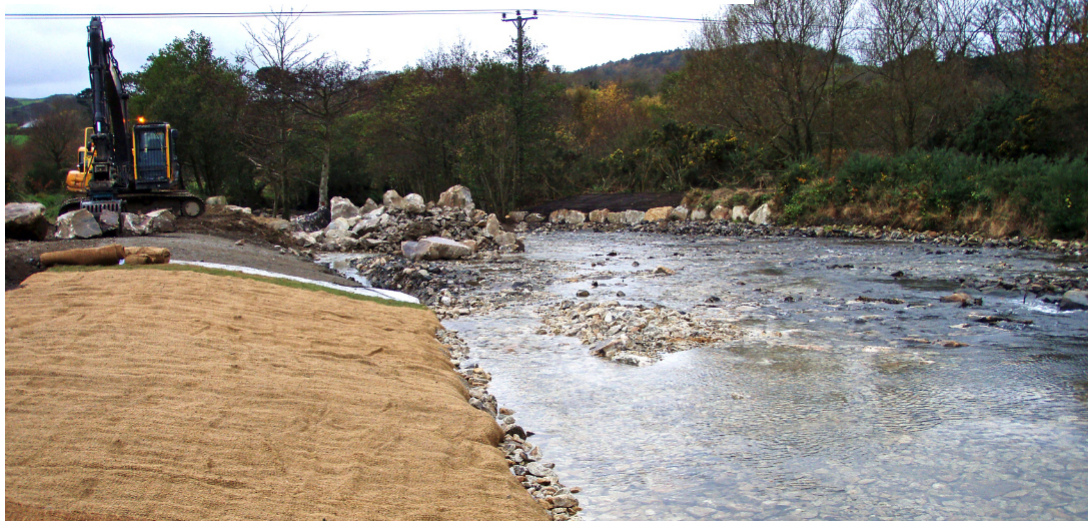
Coir matting laid over the turf to provide initial protection
- Nov 2007

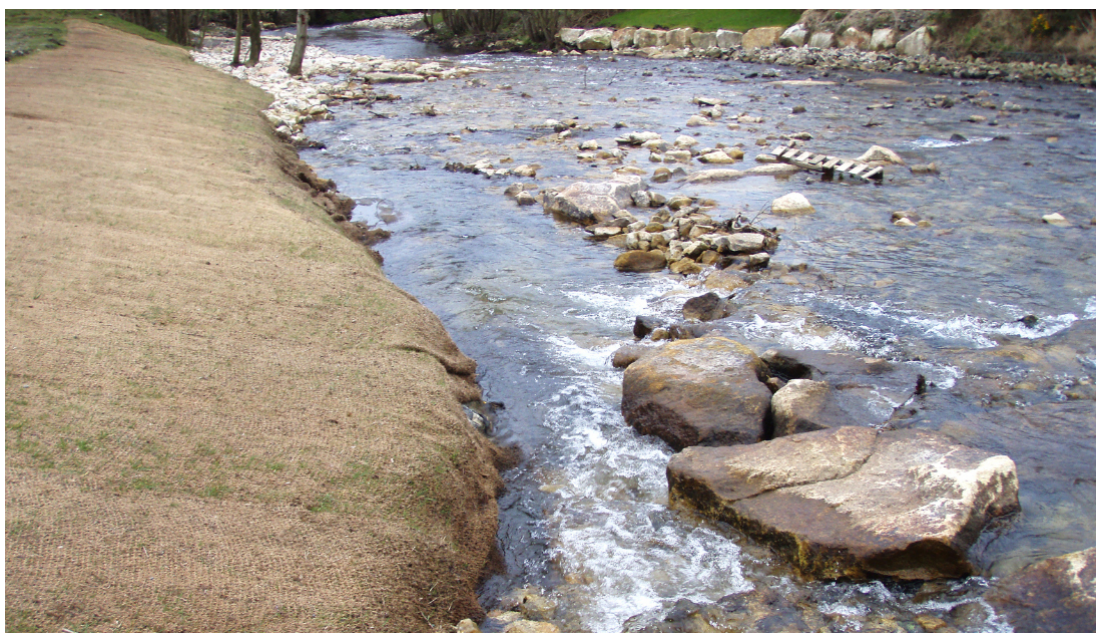
Initial movement of stone at the bank edge, but the turf and coir remained intact. Preferential route then filled. – March 2008

There was movement of the smaller rock (500mm down) as it settled and moved with subsequent flow events. Some adaptive management was required early on to fill in preferential flow routes that developed close to the embankment edge, due to settlement and scour.

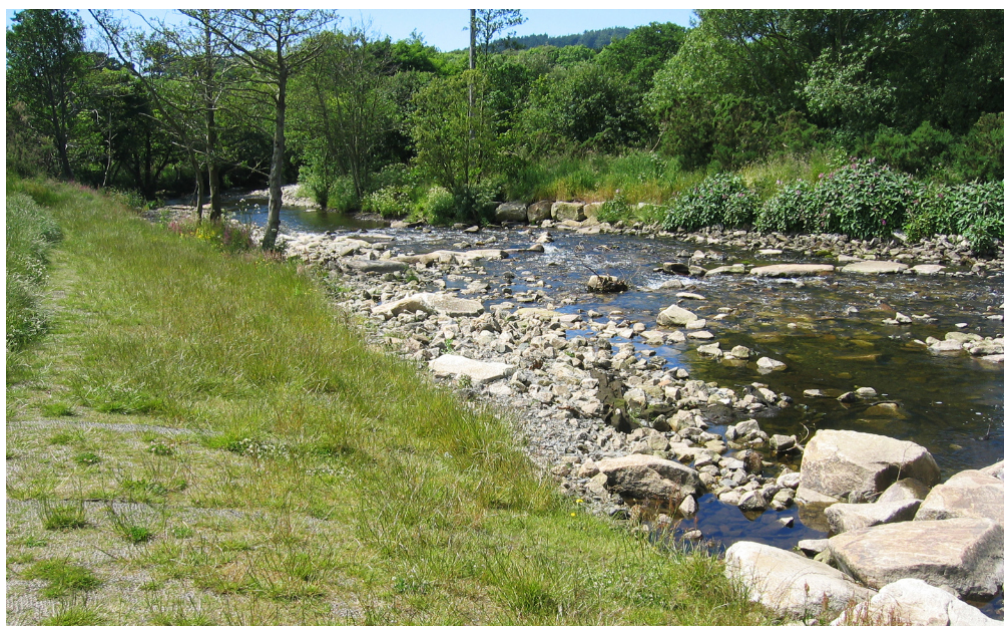
Settlement of the ramp and embankment. – 2009

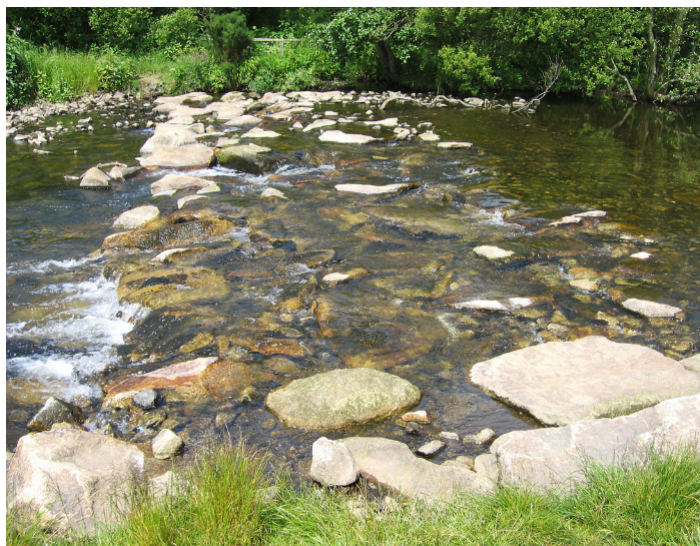
Wide, shallow rock ramp crest also provides fish habitat – 2009

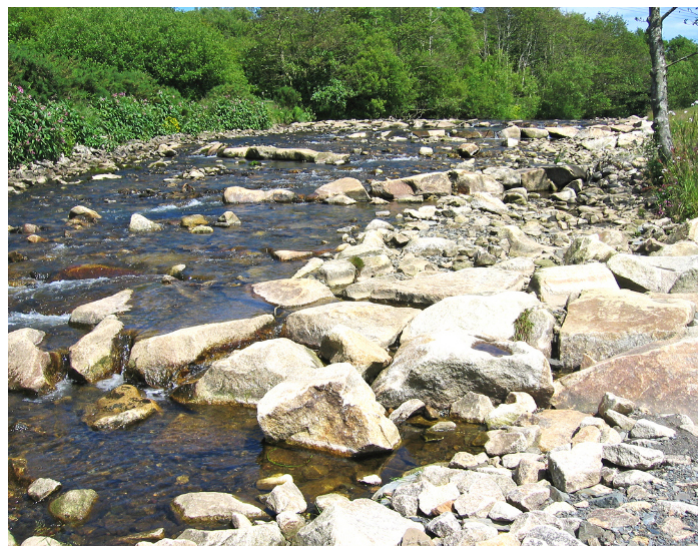
Rock ramp looking upstream towards its crest and showing the extent of habitat available to juvenile fish – 2009

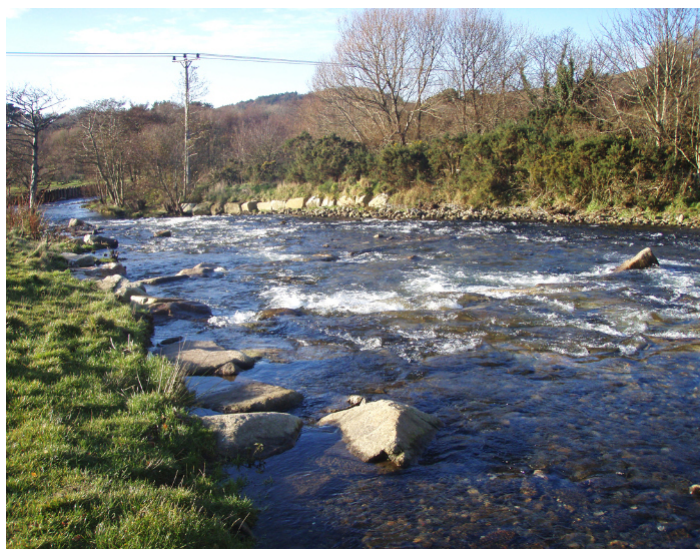
The ramp is working well under higher flow conditions – 2010

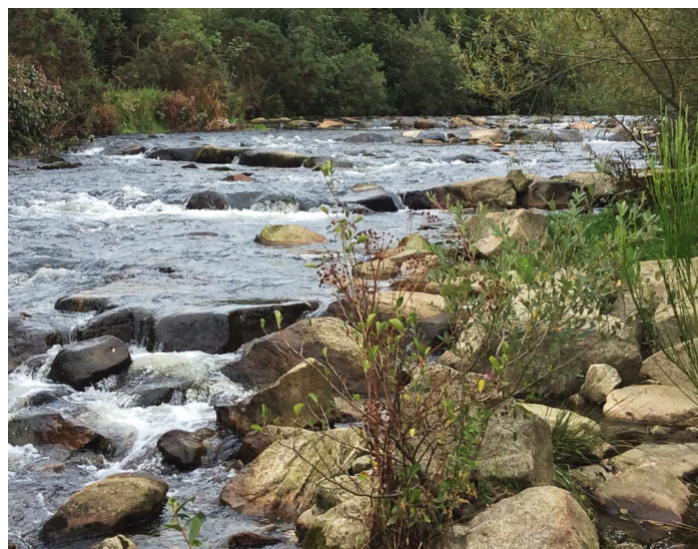
Still working well and providing habitat after 13 years – 2019
