12.7 Bypassing fixed crest weir

RIVER CAM

LOCATION - BYRON'S POOL, GRANTCHESTER, CAMBRIDGESHIRE TL436546

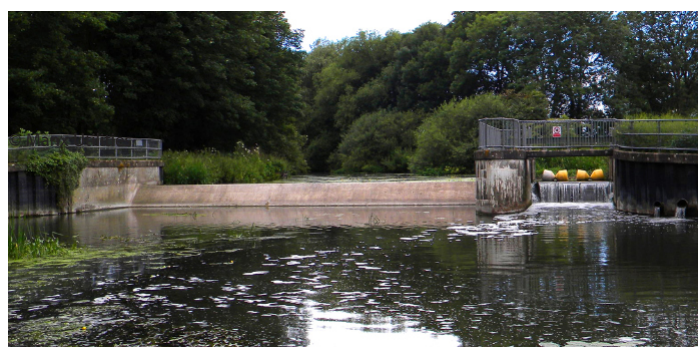
Byrons Pool radial sluice gate and fixed crest weir. The structure is a complete barrier to fish passage upstream and the weir is completely dry in normal flows – May 2011

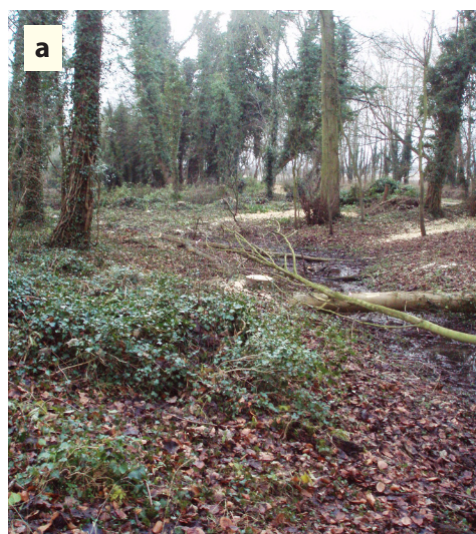
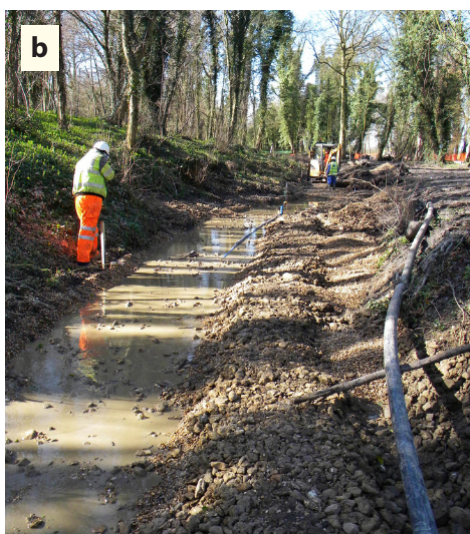
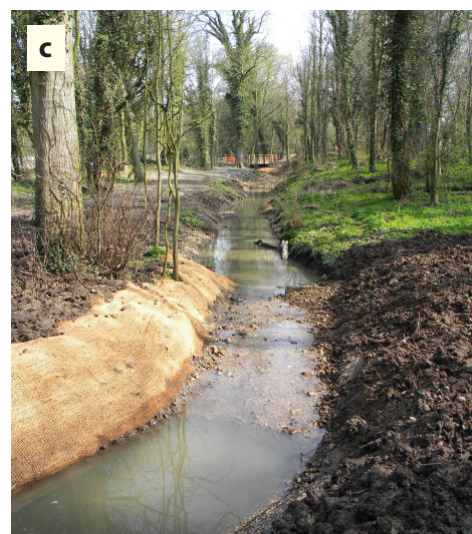
Before (a) during (b) and immediately after (c) construction. The absence of a suitable bed material was overcome by using imported gravels to create a series of pools and riffles along the channel. Jute (hessian) matting was installed to provide erosion protection along the newly created banks – November 2010

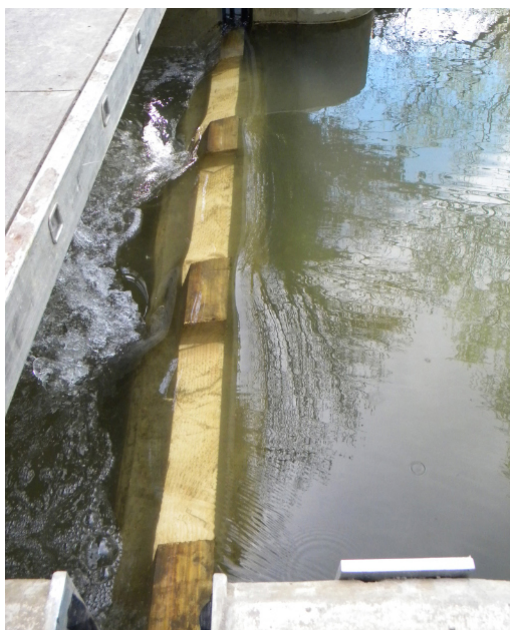
An additional stop log installed on top of the side weir structure and turreted – April 2011

Initial discharge through the channel was excessive, swamping the riffles and producing a highly turbulent flow at the downstream entrance to the pass. An additional board was installed to the side-weir to reduce the flow entering the pass. However, this created a head difference of approximately 300mm between the 'exit pool' and the upstream water level such that minnows (*Phoxinus phoxinus*) were observed failing to swim over. To resolve this, three sections (450mm wide by 100mm deep) were cut out of this board reducing the head difference by 100mm. Even then, the flow through the 'turreted' board was still too high for minnows to negotiate so additional stone was added downstream of the exit pool using 200-300mm angular granite. This successfully raised the water level in the exit pool thereby eliminating the head difference.

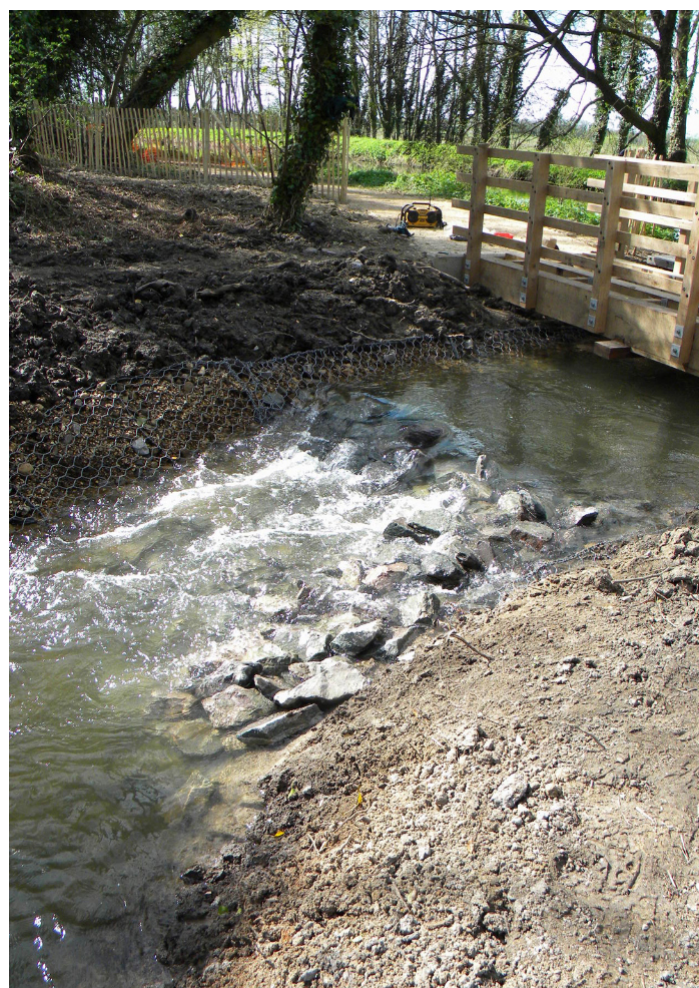
Additional riffle built using granite to allow minnows to exit the pass – April 2011

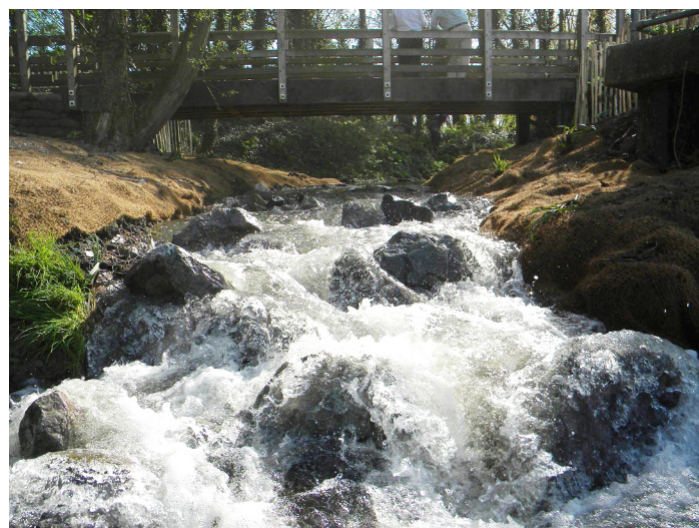
The water level at the pass outflow was initially very shallow (<100mm) and the water velocity was identified as potentially exceeding the maximum swimming performance of some of the fish species found in the River Cam. So a combination of gabion rocks and larger 300-450mm perturbation boulders were placed between the lower entry to the pass and the first riffle to baffle the flow, producing areas of slack water for fish to rest in whilst ascending into the pass. Flow velocity was later measured and was well within the maximum velocity parameters of 2m/s for the species present in the Cam.

Gabion rocks and perturbation boulders installed at the downstream entrance to the pass, to baffle the flow – April 2011

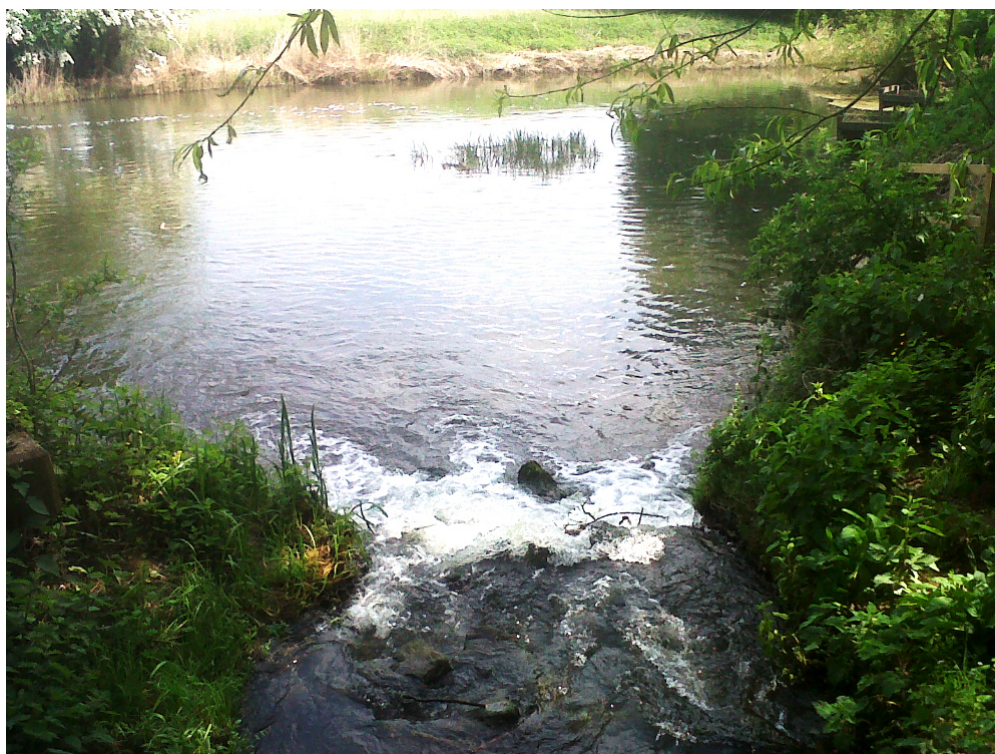
Entrance to the bypass channel, looking downstream towards the weir pool. The perturbation boulders have remained in position and marginal vegetation has colonised the banks – February 2013

Over the past eight years high flows and the accumulation of woody material has contributed to some vertical adjustment of the mattresses and movement of the perturbation boulders in the lower entrance to the pass. The stone mattresses should only have been used on the 'at risk' bed and lower banks, perhaps in-combination with green bank protection techniques.
