Presentation 1 – Shaw, Janet

INSTREAM BARRIERS ASSESSMENT – A MULTIDISCIPLINARY APPROACH

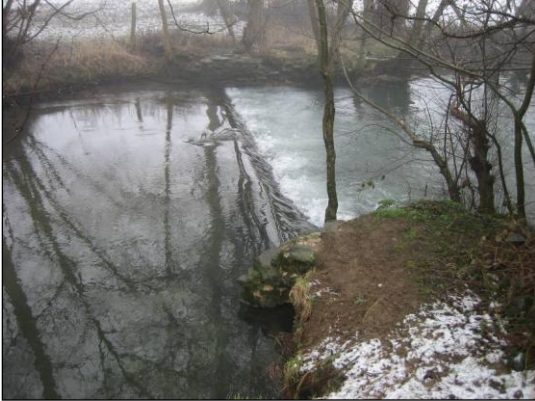
Figure 1 Example 1 - Unamed weir on the River Lugg, near to Prestigne (Powys) – Weir height approximately 0.5m, channel width at the weir 5m

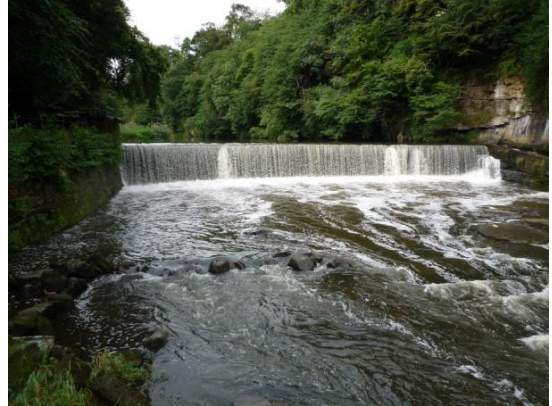
Figure 2 Example 2 - Peggies Mill weir on the Lower reaches of the River Almond (Cramond near Edinburgh) – Weir height 3.5m, channel width at the weir 30m

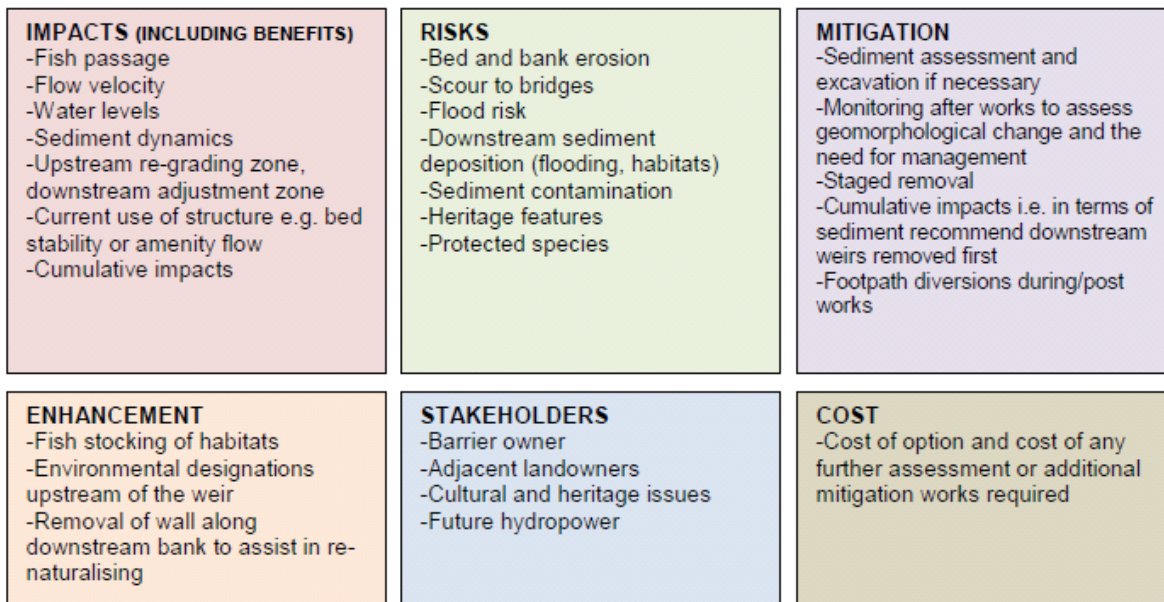
Figure 5 Options appraisal - generalised examples of aspects considered for each option

The do-nothing provided a baseline appraisal against which the other options could be assessed. For each option there was a consideration of aspects under 6 factors, identified during the options appraisal process. These are shown in Figure 5.

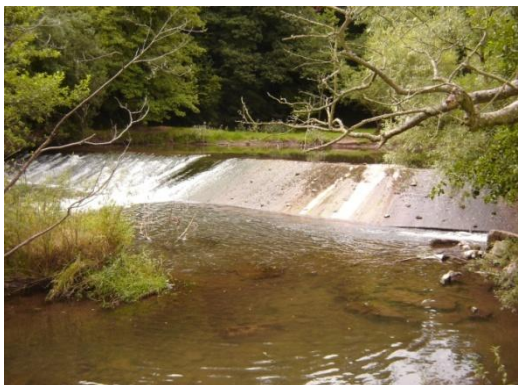
Figure 6 – Kentchurch Weir, River Monnow

Kentchurch weir: Stone/concrete faced with concrete apron of 1.7m height and 35m width, 5m length. A central section of the weir had been lowered. Originally constructed to provide water to an estate gardens.
Location: 25km upstream of Monmouth, on the River Monnow, a tributary of the River Wye.
Landuse: Arable/grazed farmland

- Benefits would be fish passage and natural sediment dynamics would be reinstated.
- Channel re-grading and adjustment would occur up and downstream of the structure.

- There is a risk of erosion to the right bank upstream of the weir which has areas of no vegetation. However, there are no risks to structures e.g. upstream bridges.
- Flood risk - low to medium
- Potential for right abutment collapse and right bank avulsion, which could lead to a change in planform for the channel.
- Sediment transport and downstream deposition with risk to habitats from fine sediment smothering.

- Ongoing monitoring and management by fencing to allow vegetation rejuvenation to stabilise the right bank.
- Sediment assessment to determine quantities.
- Abutment removal to reduce unpredictability of collapse.

Preferred option = full weir removal

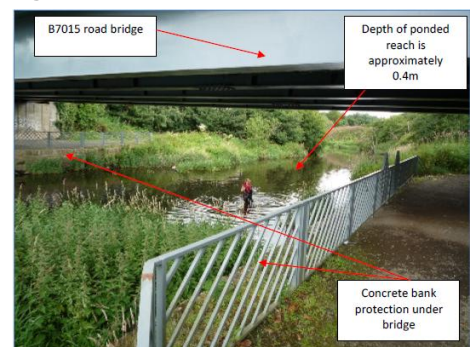
Figure 8 - B7015 road bridge 200m upstream from weir

- Risk of losing a culturally important asset.
- Significant risk of upstream channel bank erosion, especially to the right (higher and steeper) bank, which could impact on the business park car park.
- Significant risk of erosion to the foundations of the 200m upstream B7015 road bridge in the short-medium term.
- Risk of increased erosion within the pool below the weir site. Protection on the left bank to may be undercut which increases the risk of undercutting the foundations for the footpath and bridge within the Almond Valley Heritage Centre.
- Risk of erosion further downstream where property is located near to the channel banks.
- Flood risk – Increased conveyance through the reach leading to increased risk of flooding downstream.
- Sediment transport and downstream deposition with risk to spawning habitats.
