Delivering River Restoration: Recipes for Success

13TH ANNUAL NETWORK CONFERENCE

Coordinated monitoring of the Mayesbrook Park Restoration Project

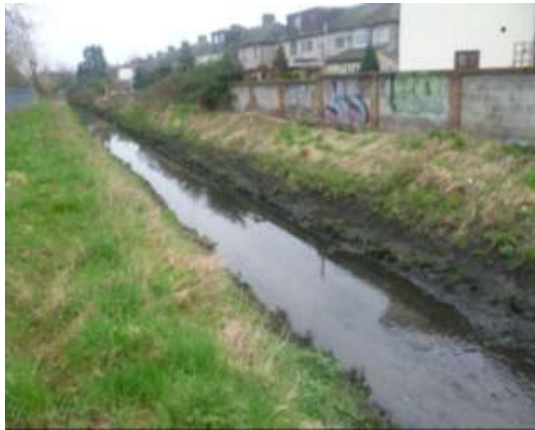
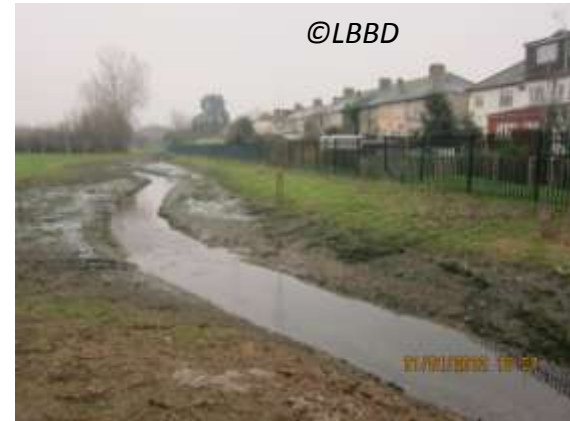
Reach 4

River restoration now complete

March 2011

January 2012

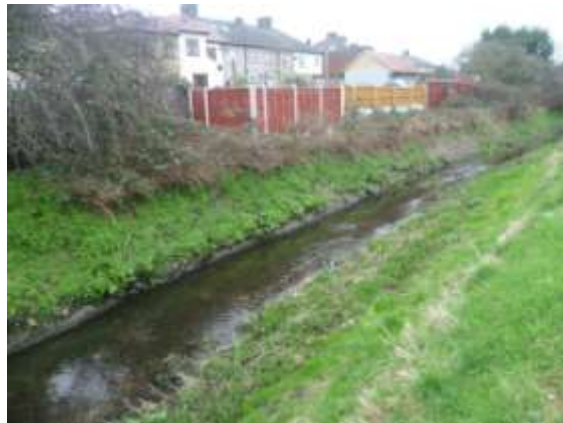
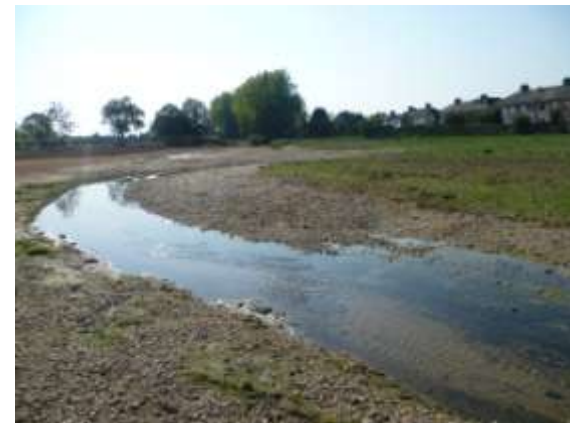
Reach 3

March 2011

October 2011
