Delivering River Restoration: Recipes for Success

## 13<sup>TH</sup> ANNUAL NETWORK CONFERENCE

# Byron's Pool nature-like fish pass, highlighting the need for a 'hands on' approach

**A CASE STUDY ON THE DESIGN, CONSTRUCTION AND EFFECTIVENESS OF A NEW NATURE-LIKE FISH PASS AT BYRON'S POOL ON THE RIVER CAM, HIGHLIGHTING THE NEED FOR A 'HANDS ON' APPROACH**

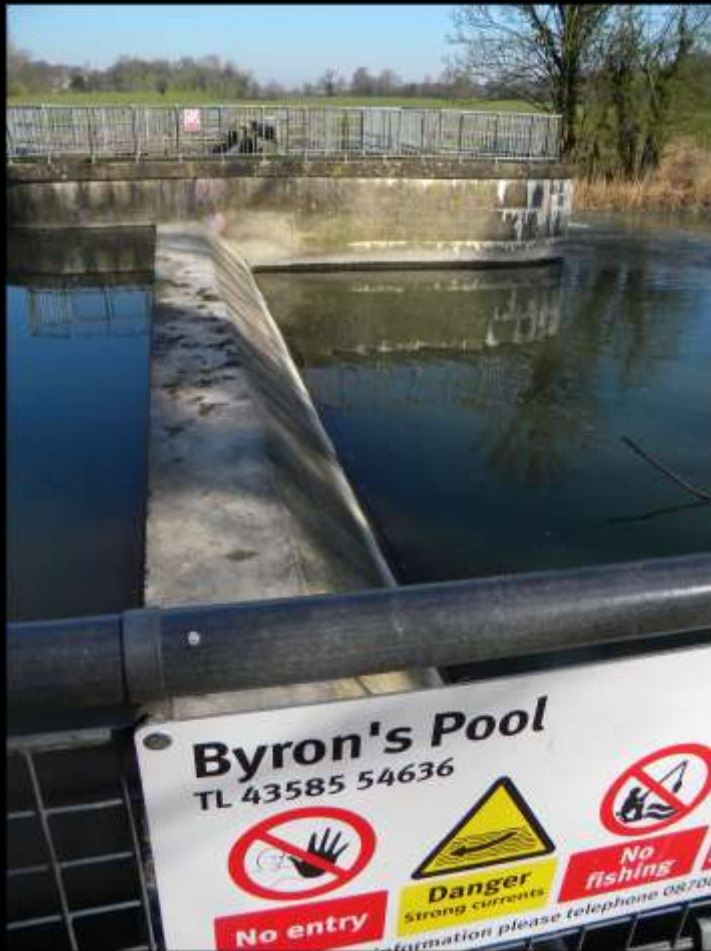
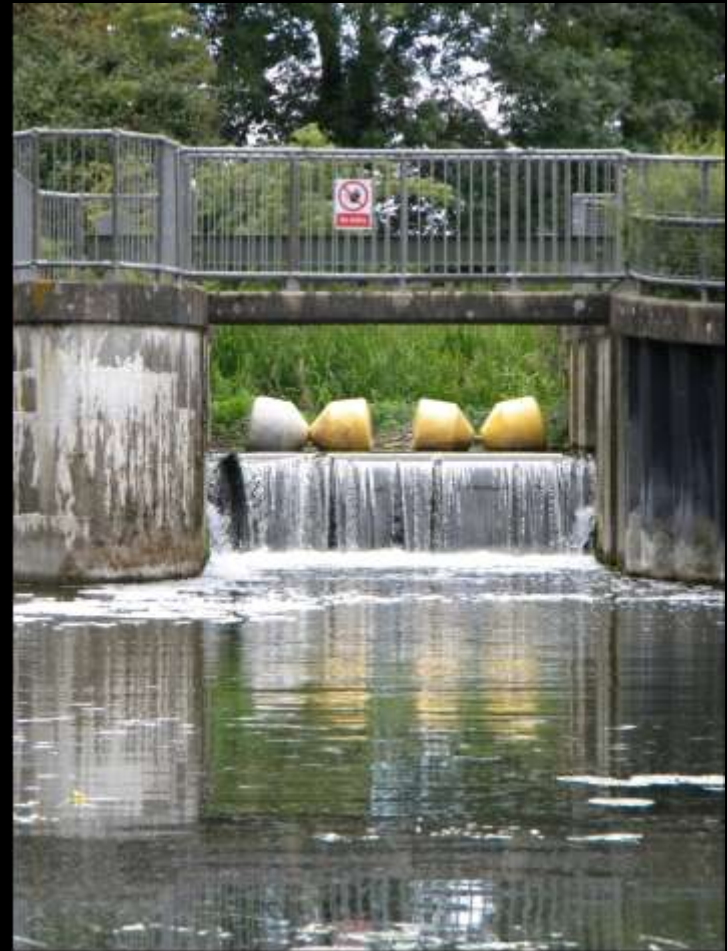
# The problem- a complete barrier!

The considerable head difference, broad width and dry weir crest represent a complete barrier to fish migration as defined by SNIFFER criteria. (Coarse-resolution rapid assessment) (Kemp *et al*, 2008). Upstream migration physically impossible and are beyond the leaping abilities of both Salmonid (Bell 1986, cited in Saila *et al*. 2005; Larinier *et al*. 2002; Kemp *et al*. 2008), and Non-salmonoid species (Winter and Van

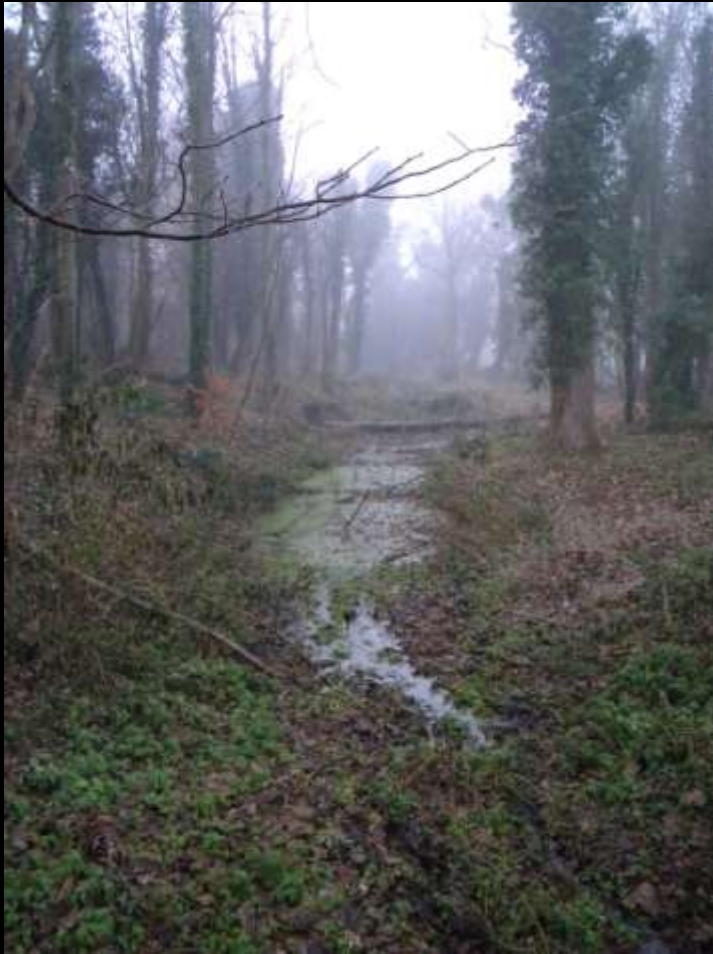
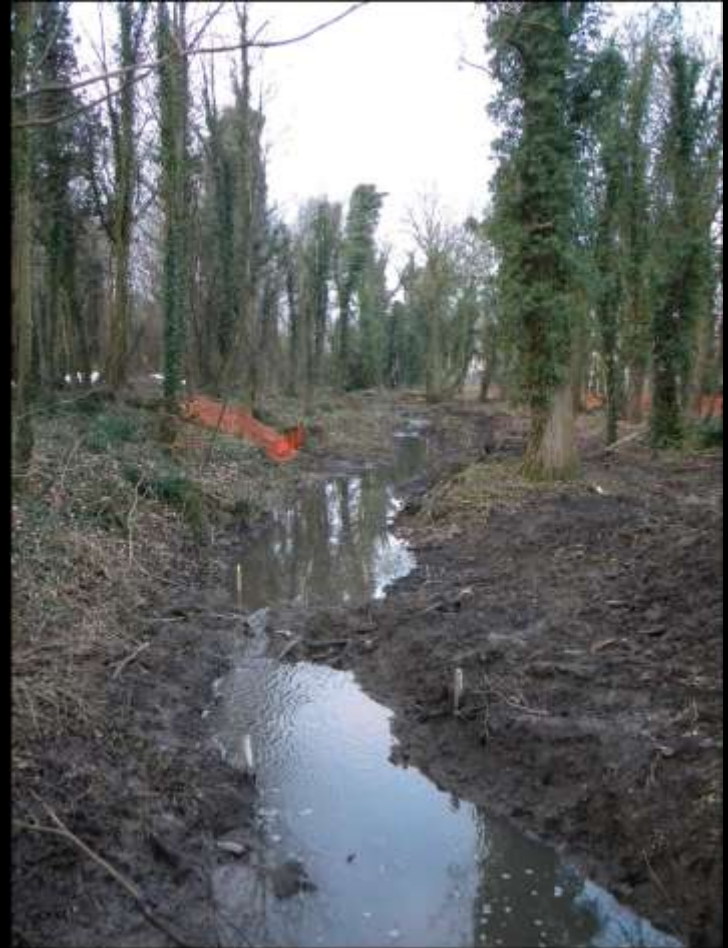
# Construction starts-at last!

Problem- No hard bed level

**Problem-** During excavation of the channel the hard bed level identified in the topographic survey was not found. This meant that the channel could not be formed as designed and that if constructed as is, the channel morphology and heterogeneity of flow characteristics would be lost the moment the pass became operational!

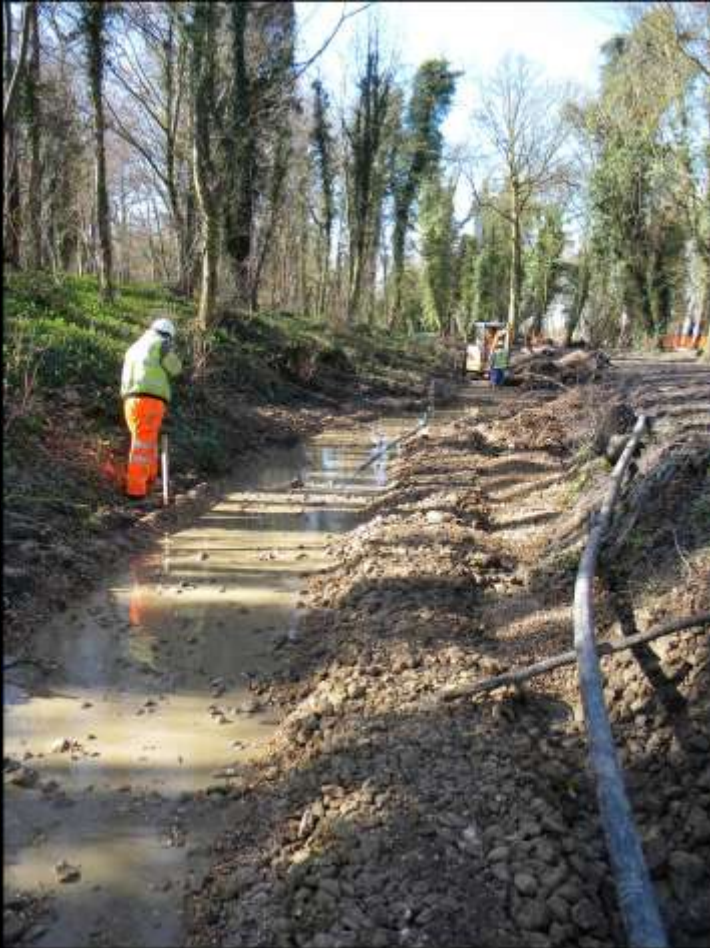
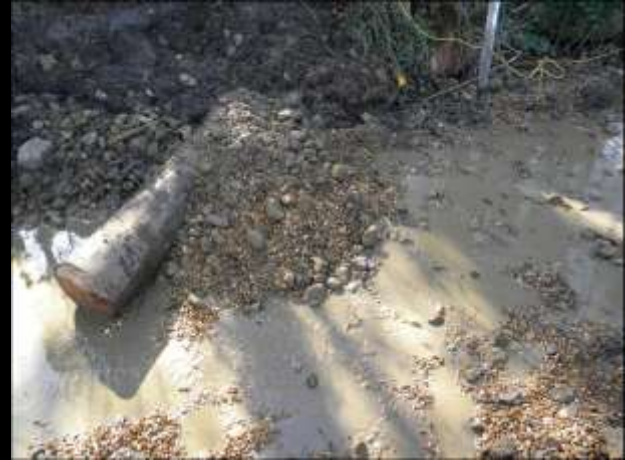
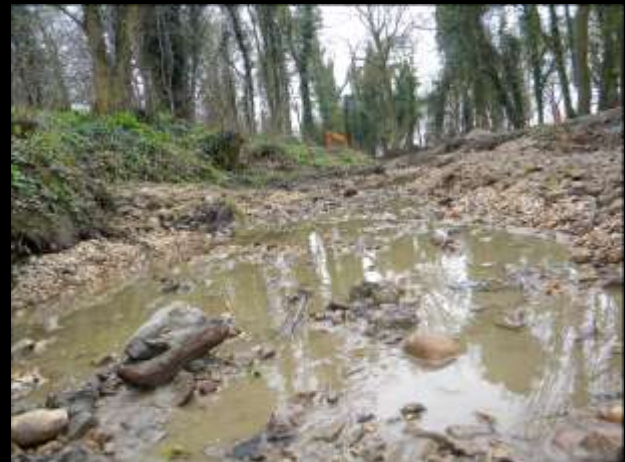
# Construction modifications

## Solution-Import additional gravel

**Solution-**To form the channel to the dimensions as designed an additional mixed fill of claybound rejects, ranging from 20-100mm, and graded gravel 10-20mm was imported. This material was also used to infill areas which had become unstable during the removal of silts from the main channel. This provided the opportunity for shallow gravel margins alongside the main channel diversifying the habitat.

I also placed woody debris and individual angular gabion stones (up to 200mm) randomly in the channel to provide suitable refuge for fish such as Bullhead *Cottus gobio*. Further piles of gravel and gabion stones were left on the bank so that I could tweak the riffles once operational.

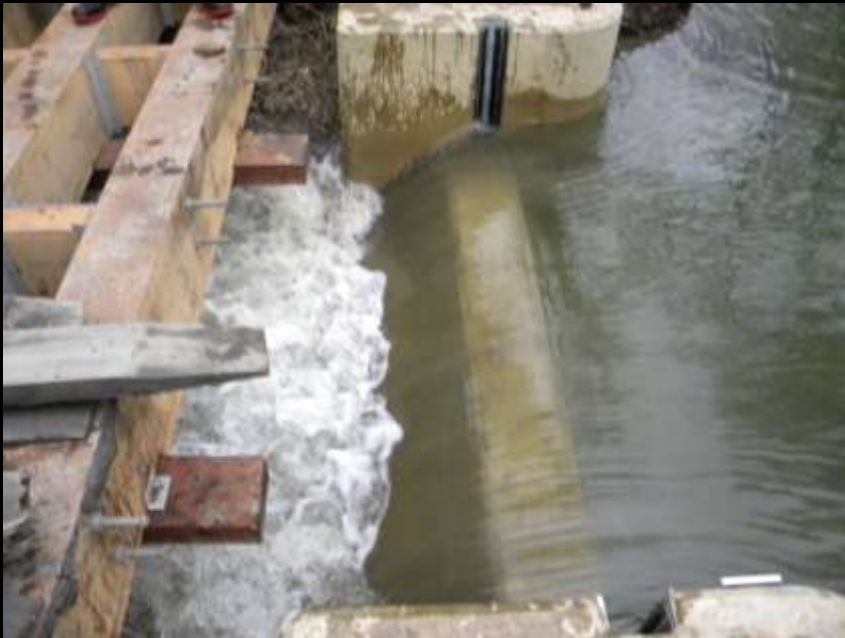
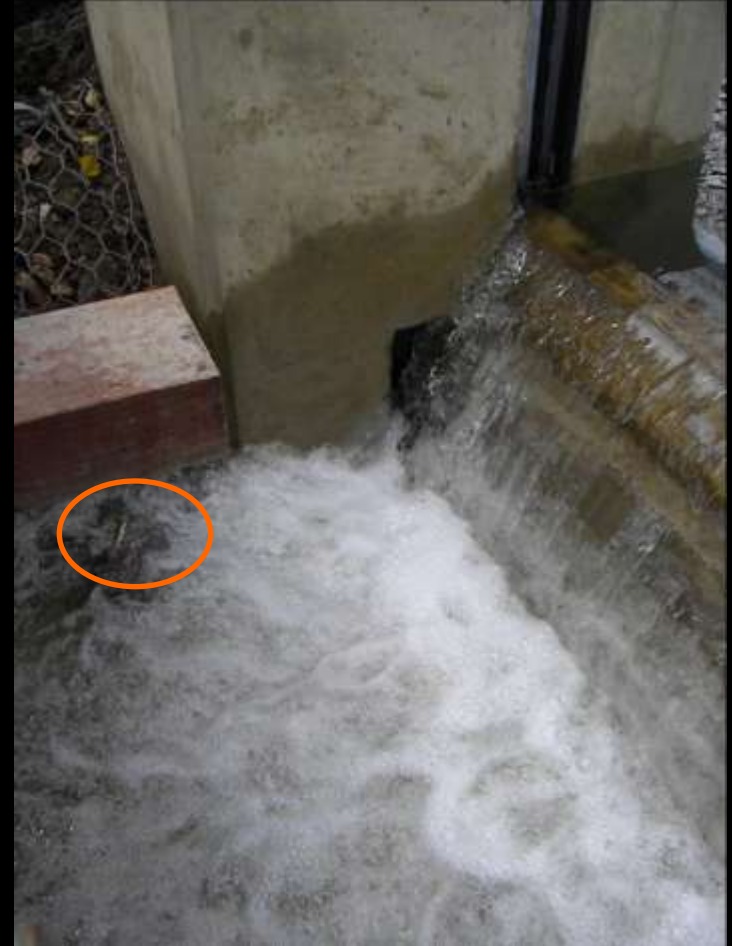
# Operational modifications

Problem-Excessive water velocity

**Problem-** When the temporary dam and stop logs were removed the flow was highly turbulent swamping the riffles and producing a flow beyond the designed parameters. This was in part due to downstream water levels on the main river being c.200mm lower than average due to exceptionally low rainfall between March and May, the driest 3 month period on record (since 1910), resulted in river flows on the Cam being 42% of the Long Term Average (Environment Agency 2011b).

**Initial solution-** To avoid the washing out of gravel from the constructed riffles I put one of the stop logs back in to reduce the flow entering the pass, however this created a head difference of c.300mm between the exit pool and the upstream water level. A couple of days later after the channel was operational, Minnows *Phoxinus phoxinus* were observed failing to leap over the obstacle.

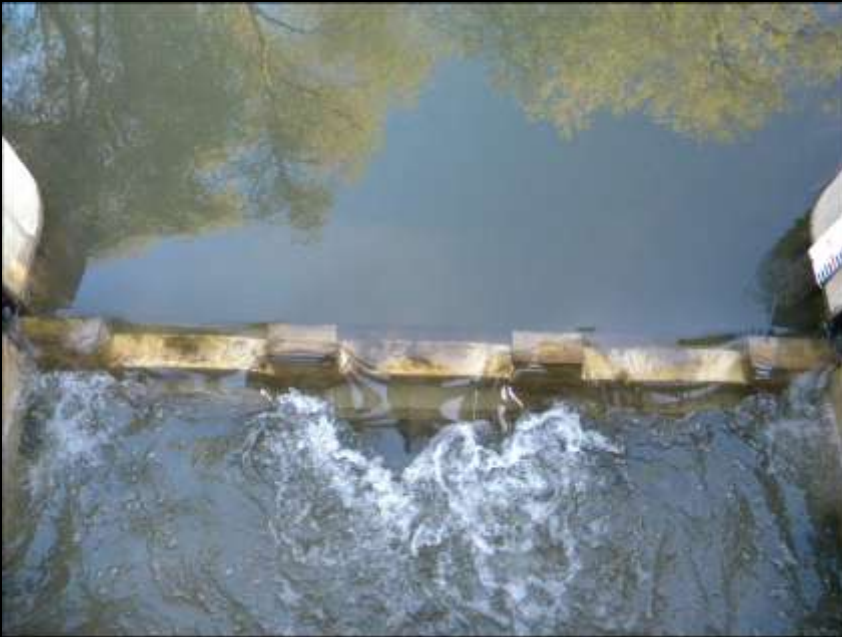
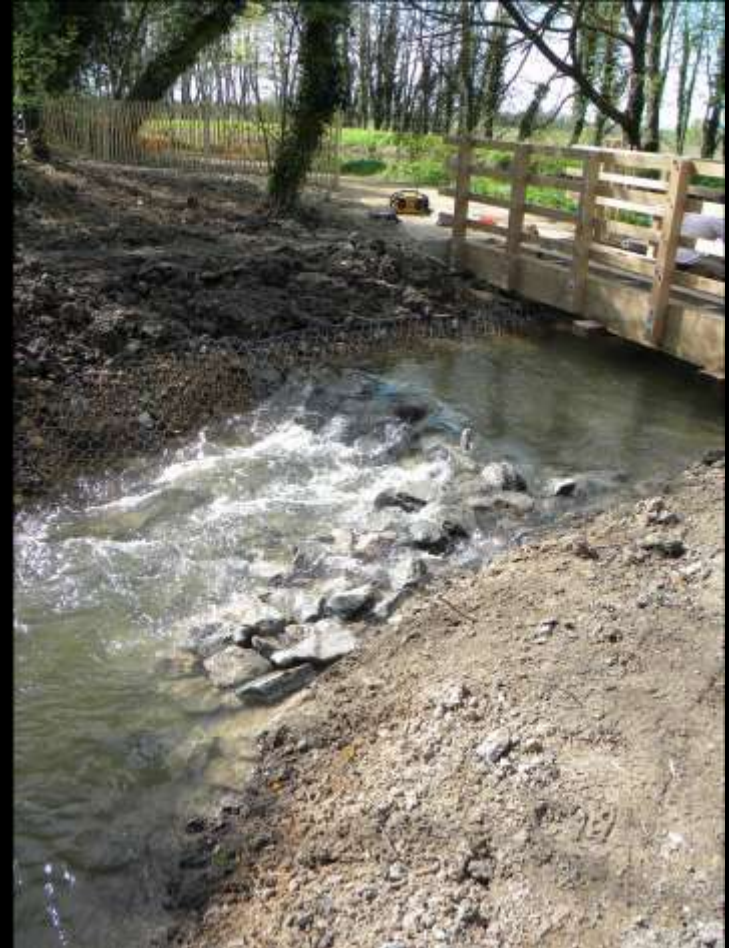
# Operational Modifications

Solution- turreted stop log and additional riffle

**Solution-** I cut three sections (450mm wide by 100mm deep) out of the retained stop log to try and resolve this. The head difference was reduced by c.100mm however the flow through the turreted log was still too high for Minnows to be able to negotiate the structure.

I needed to raise the downstream water level and the solution was to effectively dam-hold back the water by installing an additional riffle downstream of the exit pool using 200-300mm angular granite rocks. This worked with the head difference eliminated and within minutes several Minnows were observed successfully exiting the pass. The pass worked at last!

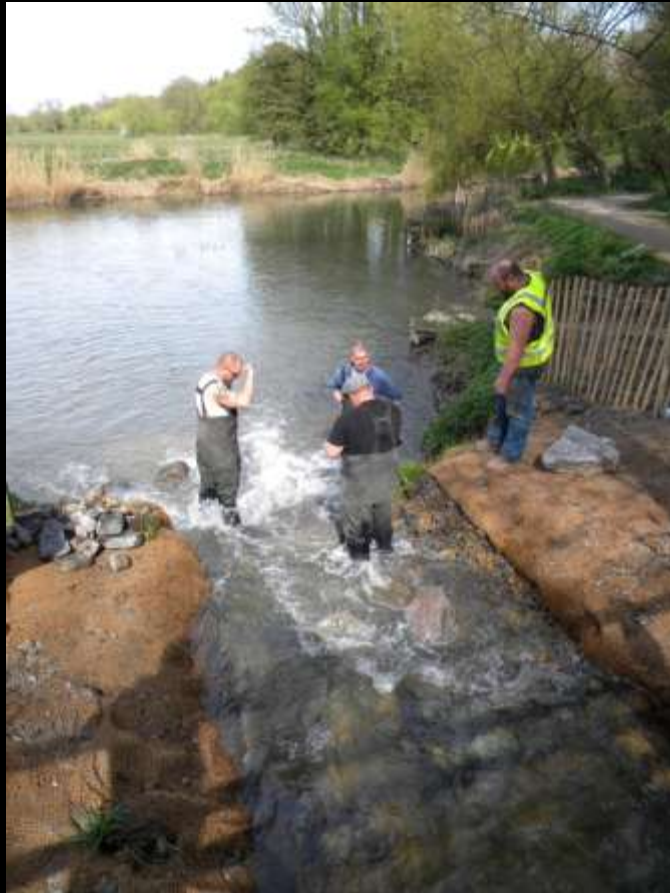
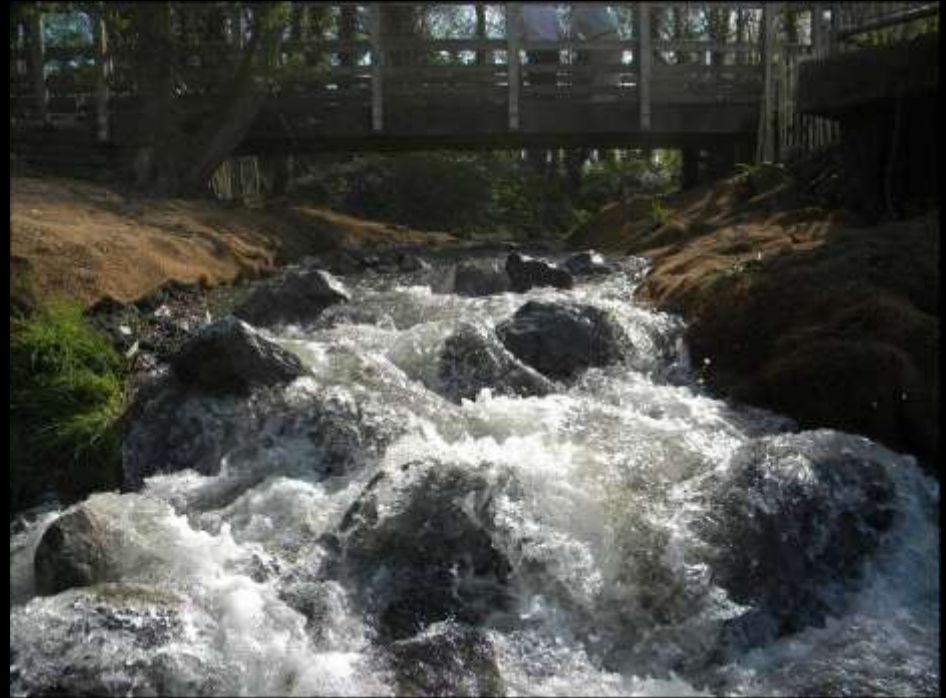
# Operational Modifications

## Solution- Perturbation boulders

**Solution-** With assistance I placed a combination of gabion rocks and larger 300-450mm perturbation boulders (Heimerl & Wurster 2006) in to the entrance of the pass and the first riffle to baffle the flow, producing areas of slack water for fish to rest in whilst ascending into the pass.

Flow velocity was later measured at a maximum of 1.2m/s, 10cm below water level (water depth c.25cm), well within the recommended maximum velocity parameters of 2m/s for passage of fish (FAO/DVWK 2002).

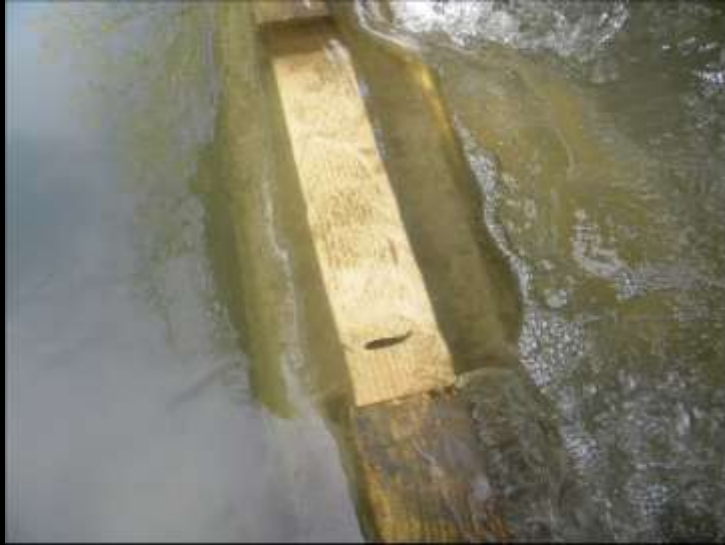
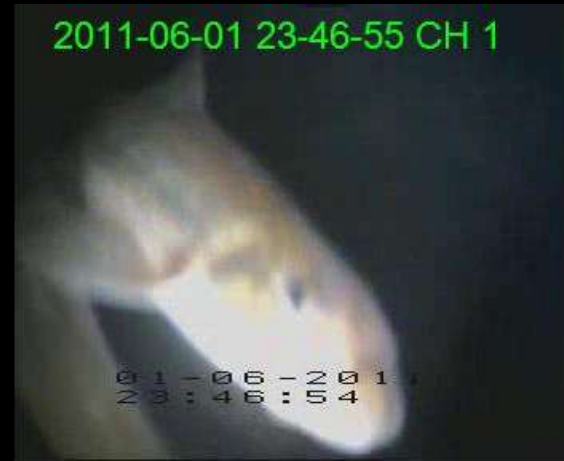
# Did it work?

*Yes but only after these modifications were made.* Even operational at historic low flow on the main river the combination of surveys conducted in first 3 months of operation proved that the pass was effective both in terms of the presence of fish within the channel (utilising the habitat) and passage of fish able to migrate upstream beyond the physical barrier.

- visual surveys- minnows negotiating pass/ spawning activity (Minnows, Gudgeon and Chub)
- Remote camera- (small sample out of hours of footage) showed 244 fish observed successfully existing the pass, 88% of all fish did so at night.
- Electrofishing- Over 700 fish caught >99mm, 11 species of fish recorded (including Minnow, Gudgeon, Bulhead, Brown Trout, Chub, Spined Loach). At average density significantly higher than previously recorded in Upper Cam.

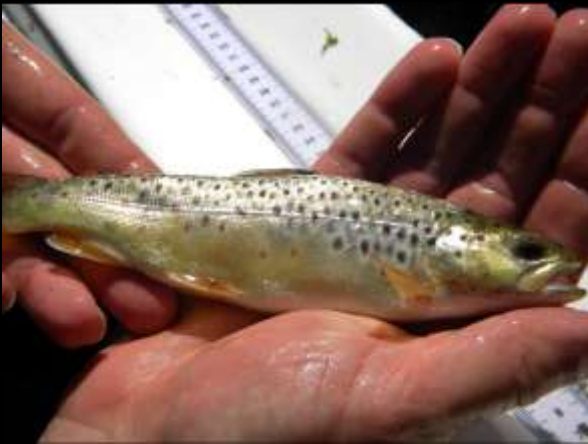
Free passage- connecting  
isolated and fragmented aquatic  
systems

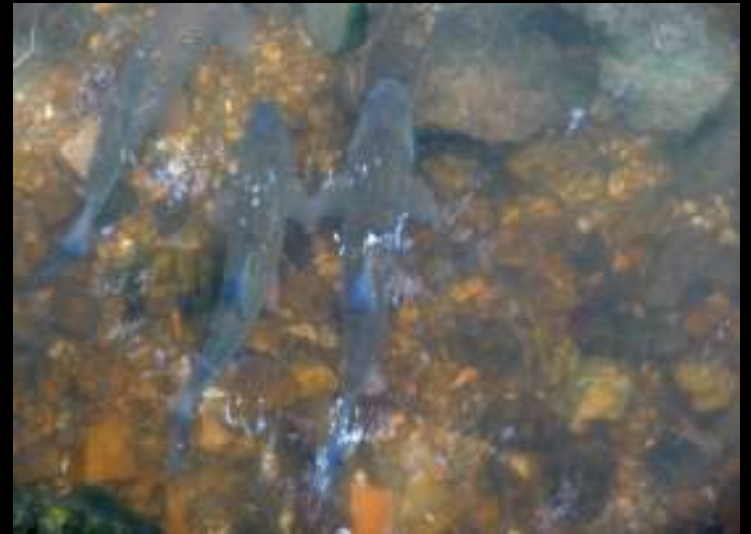
Creating valuable habitats-  
lost on our regulated rivers

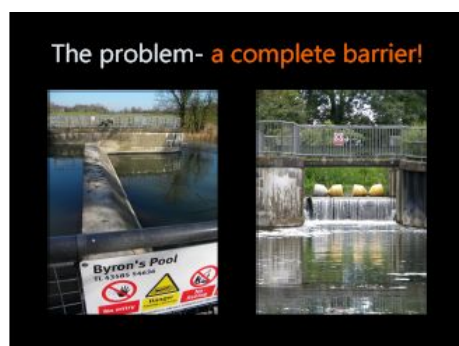
The Cam has been historically controlled at this location since the Domesday Survey with the current fixed crest weir and radial sluice gate constructed in 1949 to control discharge downstream and to retain upstream water levels for recreational and conservation.

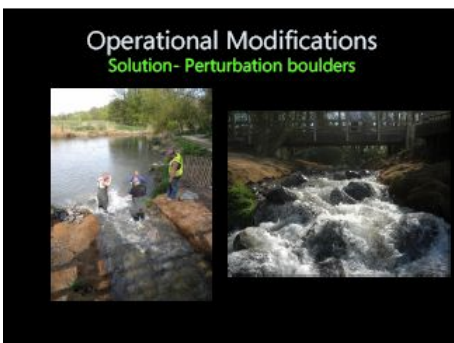
**Problem-** I was concerned about the impact the low water levels on the main river and how this might affect the ability of a range of fish to negotiate into the pass. The water level at the pass entrance were very shallow (<100mm) and the water velocity was potentially too high- exceeding the maximum swimming performance (Armstrong *et al.* 2010) of some of the fish species found in the Cam. It also could potentially restrict access for larger fish.
