# Restoring the Yorkshire River Derwent

## Technical Report

Final report  
June 2010

Document title River Derwent Geomorphological  
Assessment & Restoration Plan  
Technical Report  
Document short title River Derwent Technical Report  
Status Final Report  
Date June 2010  
Project name Favourable Condition for the River Derwent  
Project number 9T5336  
Client Environment Agency  
Reference 9T5336/R/303521/Lond

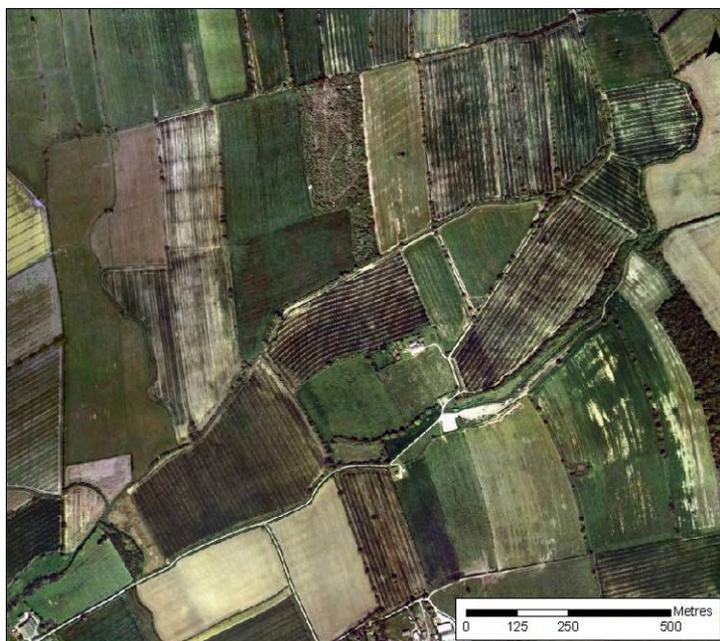
**Figure 5.9: Tilled land adjacent to Dyon Drain**

Aerial photographs clearly show large areas of heavily tilled and bare ground adjacent to the drainage channels throughout the study catchment, and, in some cases, directly adjacent to the main river channel (**Figure 5.9**).

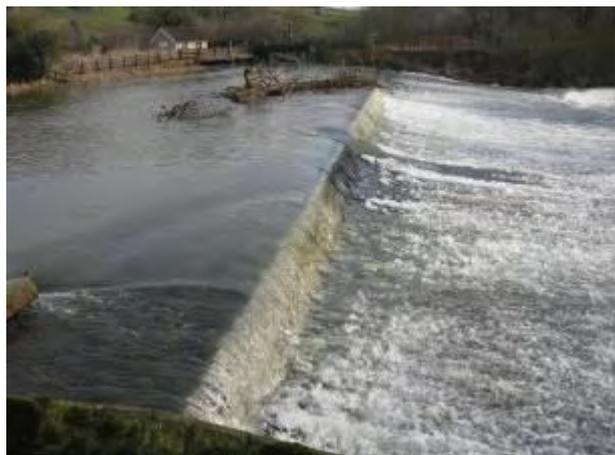
View of weir from right bank. Fish pass out of shot in foreground. Note low flow weir in middle of shot and sluice structure at rear left.

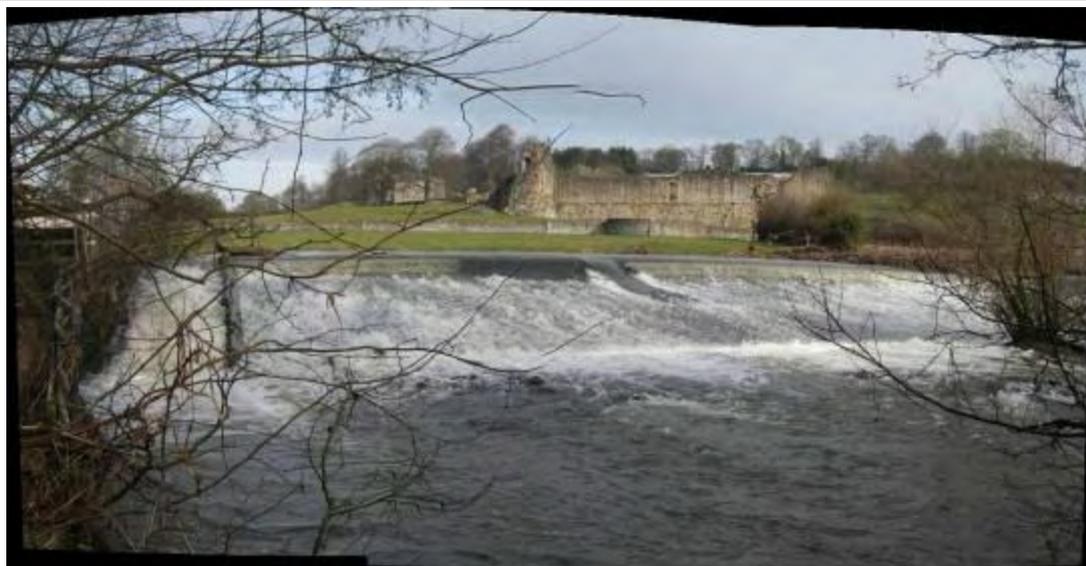
Panoramic view of weir from downstream, with fish pass visible on left of shot and low flow section visible in centre.

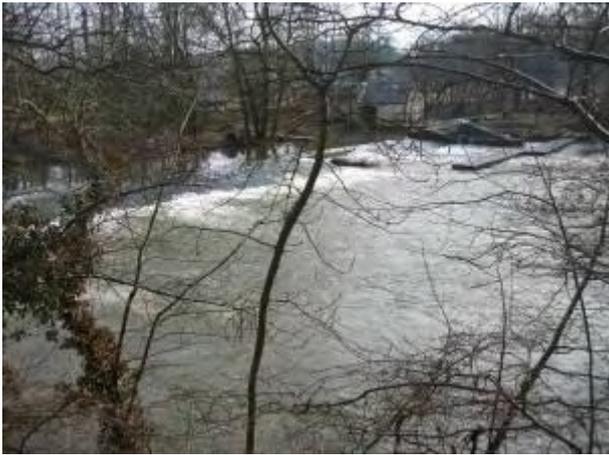
General view of weir from right bank

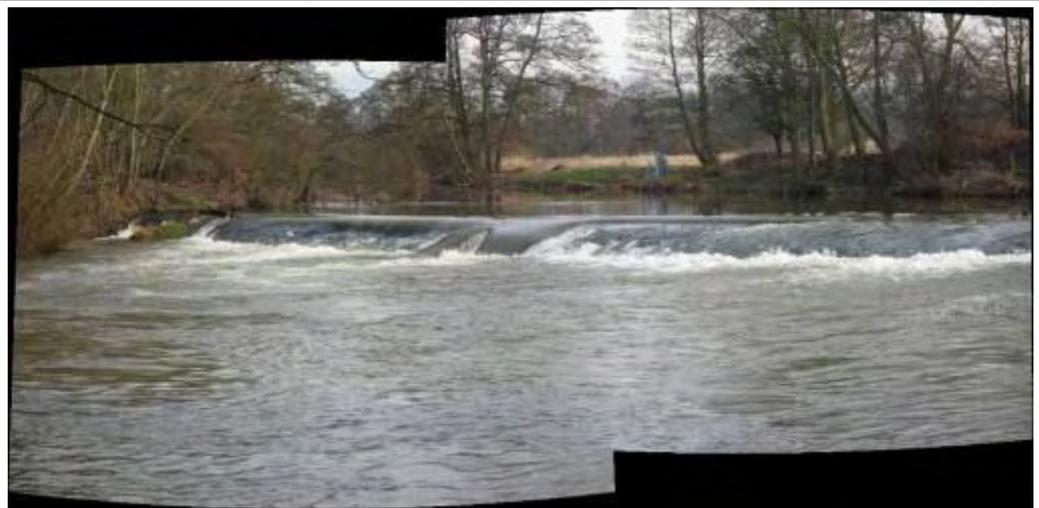
View of right hand portion of weir

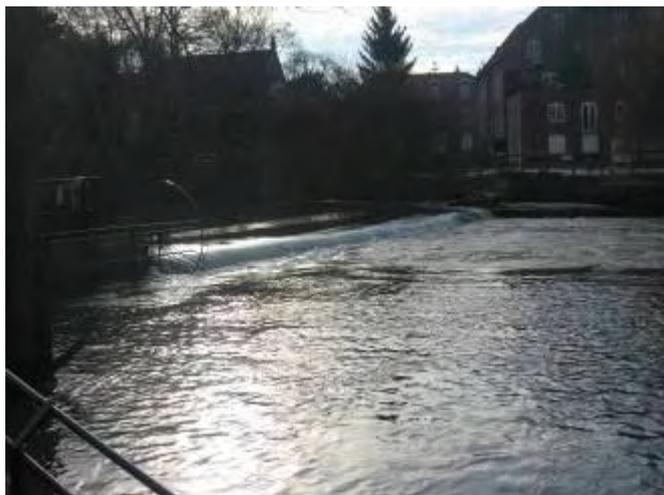
Stamford Bridge weir, viewed from right bank caravan park

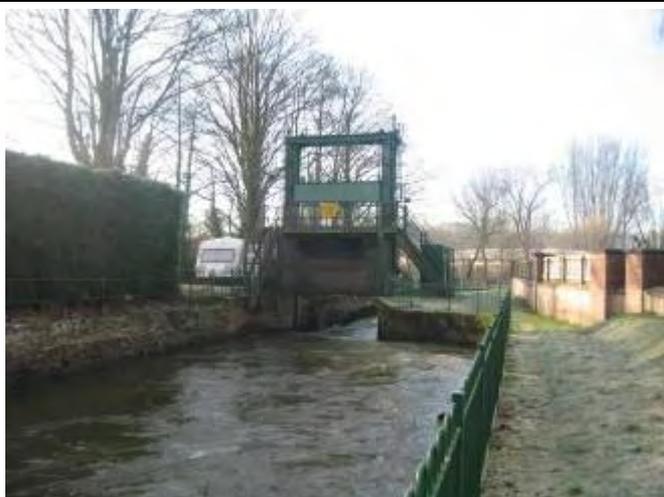
Sluice at upstream end of old lock

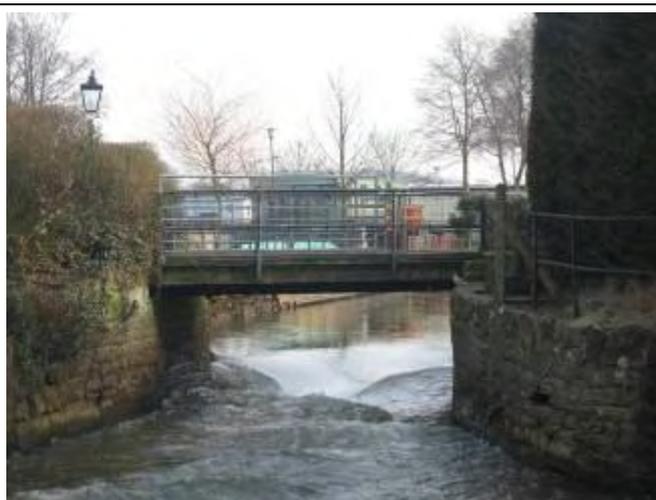
View of hydraulic jump under caravan park access bridge
