Restoring Meanders to Straightened Rivers

1.10 New meanders replacing a lined urban channel

BRAID BURN

LOCATION - INCH PARK, EDINBURGH NT277711
 DATE OF CONSTRUCTION - LATE 2008 – MID 2009
 LENGTH - 310M
 COST - £110,000

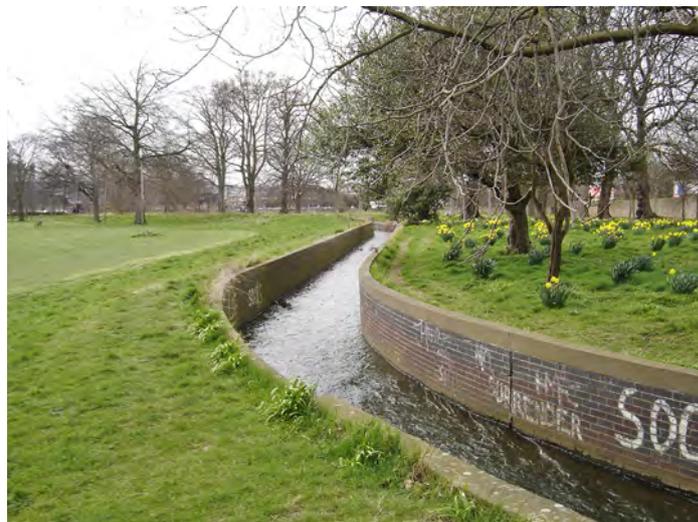
Prior to works part of the channel through Inch Park was brick lined – April 2006

None of the brick and concrete sections of the existing channel were incorporated into the new design. These were all broken down and in-filled. Densely graded rock (lumpstone) of 0.075m to 0.3m was imported and used to form the riffles and shoals. Gravels for the new channel were recovered and re-used from the sections of the old course which were to be in-filled. It was deemed that over time natural processes would transport substrate, invertebrates and flora to the new sections of the burn. The hydraulic conveyance of the new naturalised course is at least as great as that of the lined channel, ensuring no increase in flood risk upstream.

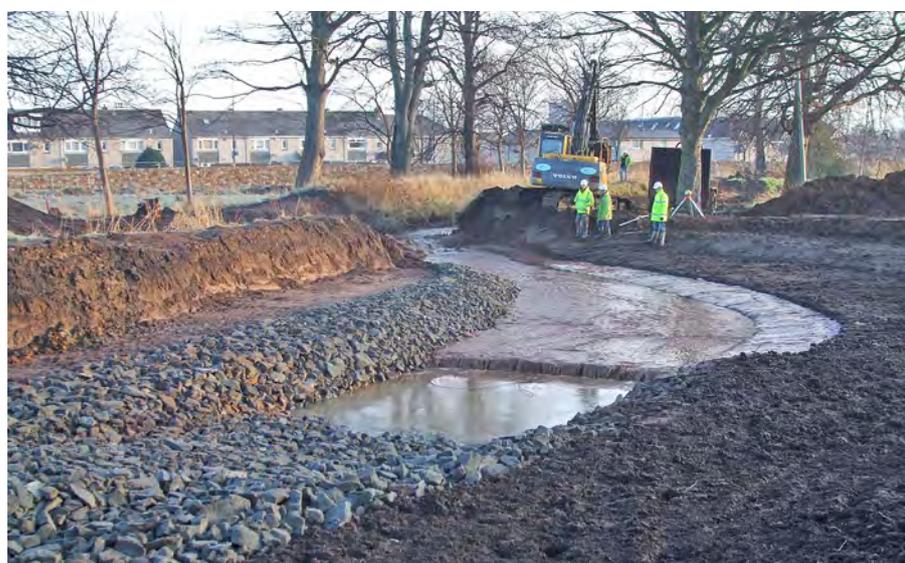
New meander channel cut off-line. 0.075 – 0.3m lumpstone was used to create the riffle and shoal base to prevent excessive bed scour – January 2009

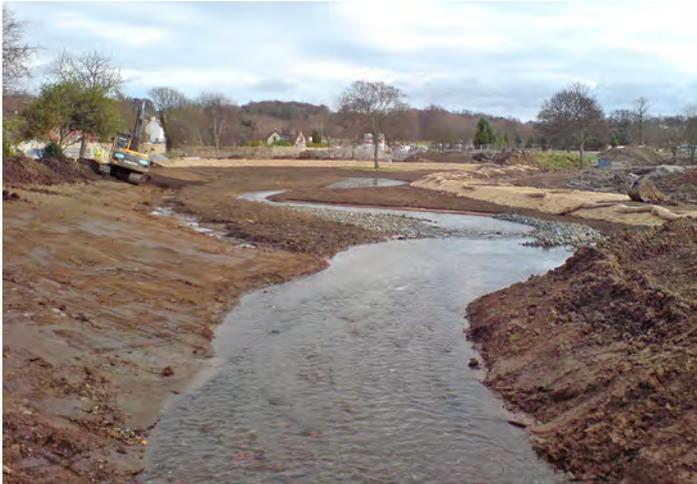
The gently sloped banks provide additional capacity and promote the natural processes of sediment transport and vegetation colonisation – February 2009

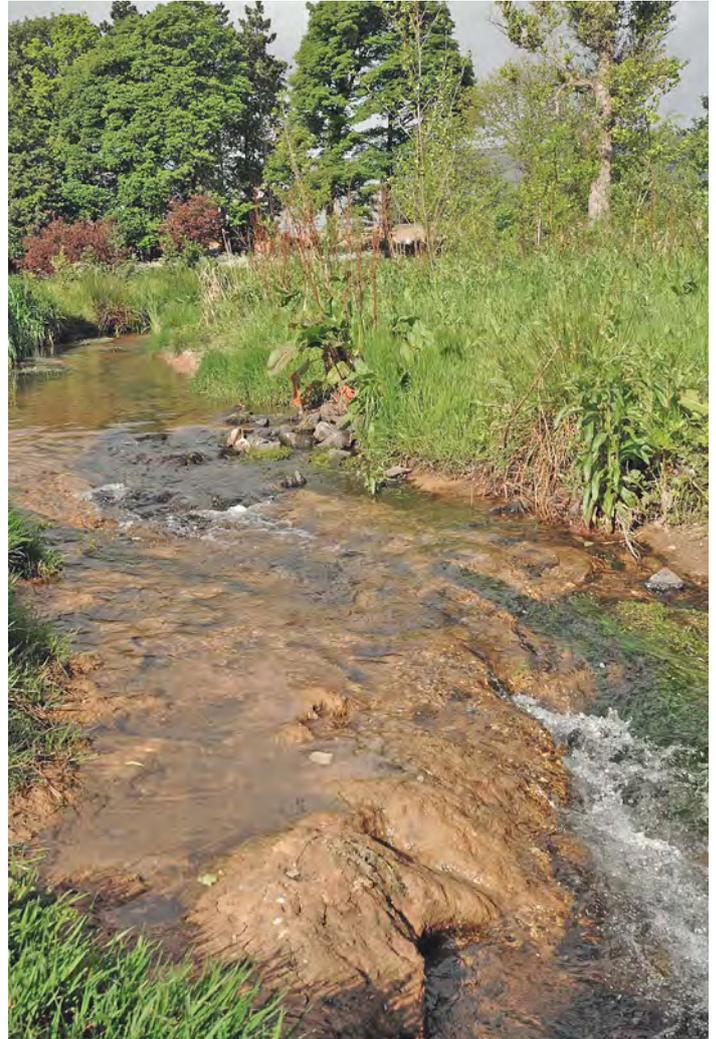
Eroded clay forming a stable cascade and adding to the diversity of features within the channel – May 2011

The shoals around the meanders have trapped significant quantities of fine silt during high water events and vegetation has begun to colonise the sediment, disguising the lumpstone structures. Gravel has been transported out of some parts of the new meanders and replacement with gravel transported from upstream has been slow. At one location a less dense lens of sandy clay within the channel has eroded to form a small cascade and pool.

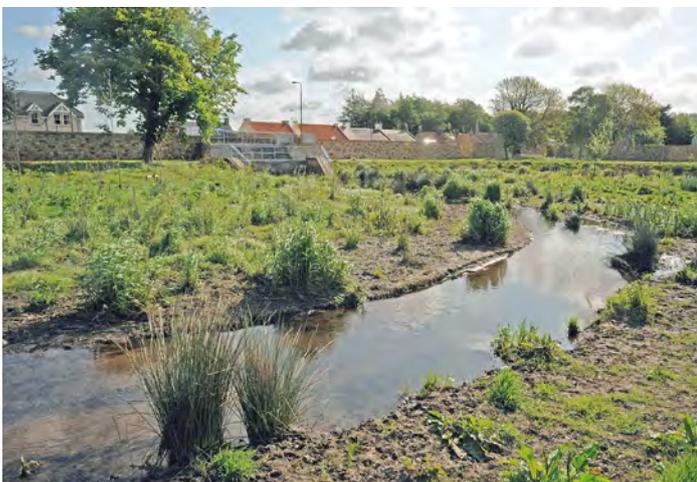
Wetland area at low flows. The height of the floodwall demonstrates the flood storage capacity within the park – March 2010

A debris screen was installed at the downstream outlet structure as part of the flood protection scheme to intercept floating debris and help prevent blockage of downstream culverts. A wetland has been created in a low-lying area adjacent to the outlet. The wetland is covered during higher flows enabling fine sediment and nutrients to be retained.

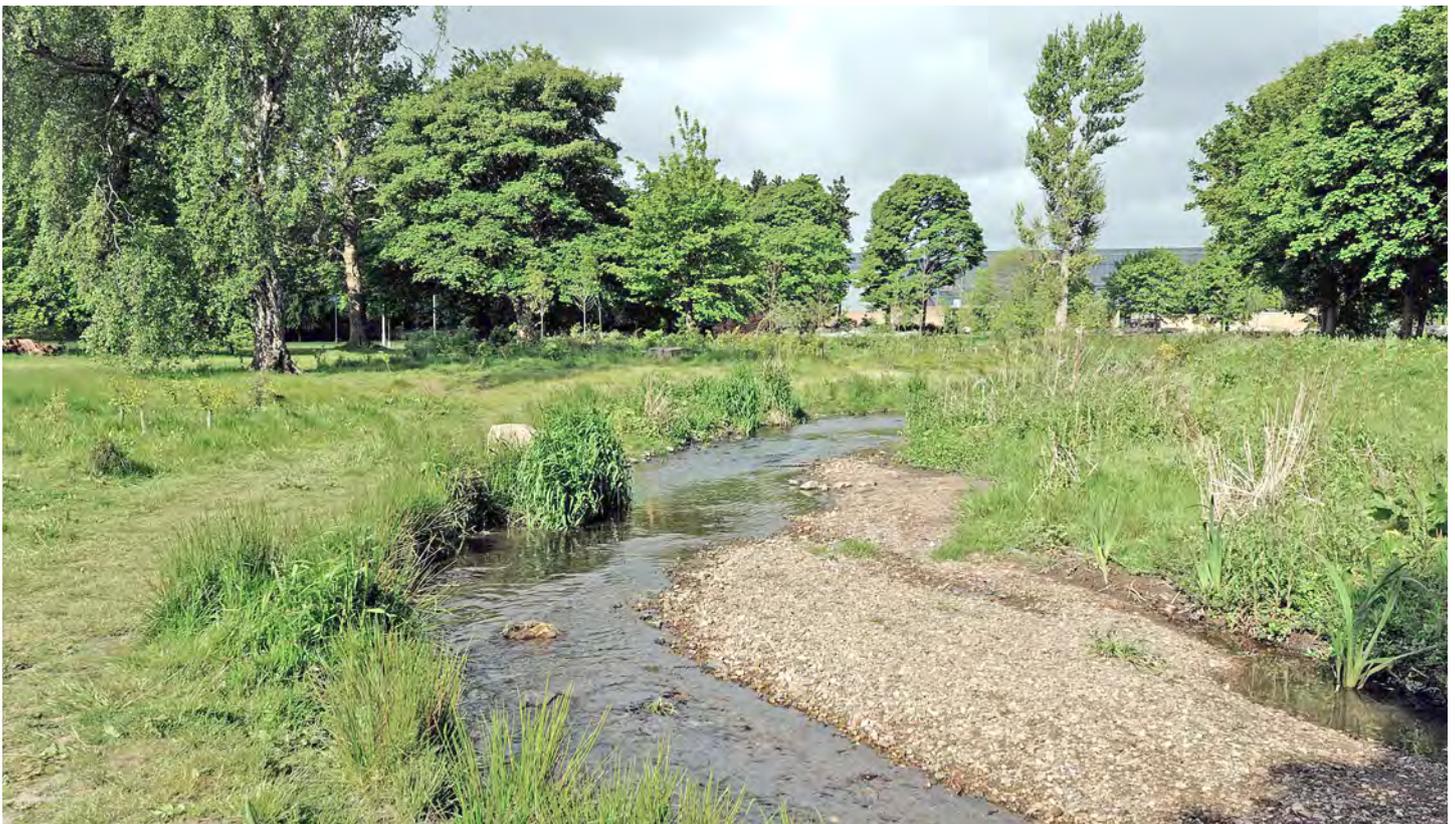
The new course of the Braid Burn through Inch Park after two years. Marginal vegetation has established well and natural processes have enhanced the in-channel morphological features that were created – May 2011

Following the works the river corridor is significantly wider, with a sinuous channel and more natural appearance. Riparian vegetation has colonised the banks and wider corridor, which now has a diversity of height, form and texture that was not present prior to the works.
