Enhancing Straightened River Channels

3.5 Narrowing of an over-widened channel using low cost groynes

RIVER AVON

LOCATION - STRATFORD-SUB-CASTLE, SALISBURY, WILTSHIRE SU127327

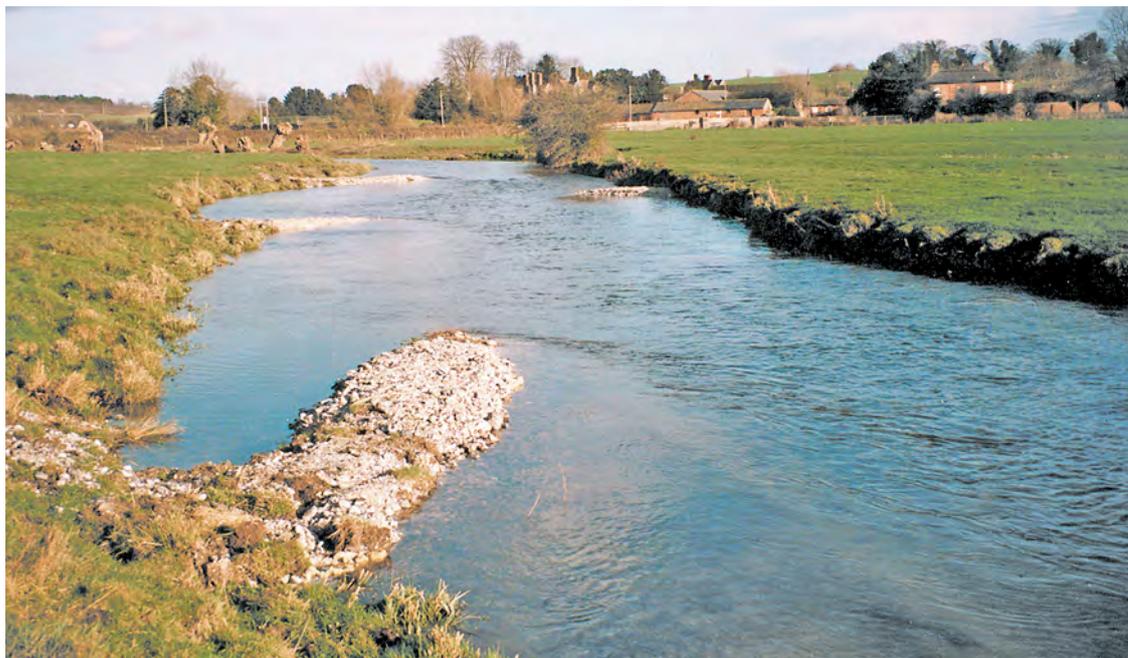
Completed chalk groynes

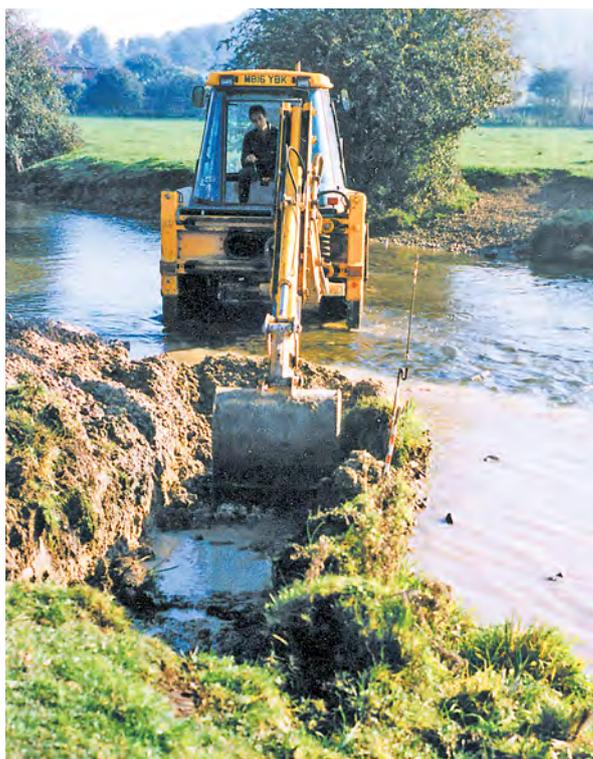
Figure 3.5.2
SECTION THROUGH CHALK GROUYNE

After marking out the area with pegs a JCB dug a trench 0.5m deep and 1-2m wide, with the excavated bed and bank material placed to one side. The trench was cut into the existing bank to anchor the completed groyne. The trench was then filled with either chalk or faggot bundles to provide reinforcement and stability and the excavated material from the original trench replaced on top.

During construction of the chalk groynes the chalk was rammed down with the JCB bucket. For the faggot groynes the stakes were hammered in by hand, and the JCB bucket was used to hold down the faggots whilst they were wired in place.

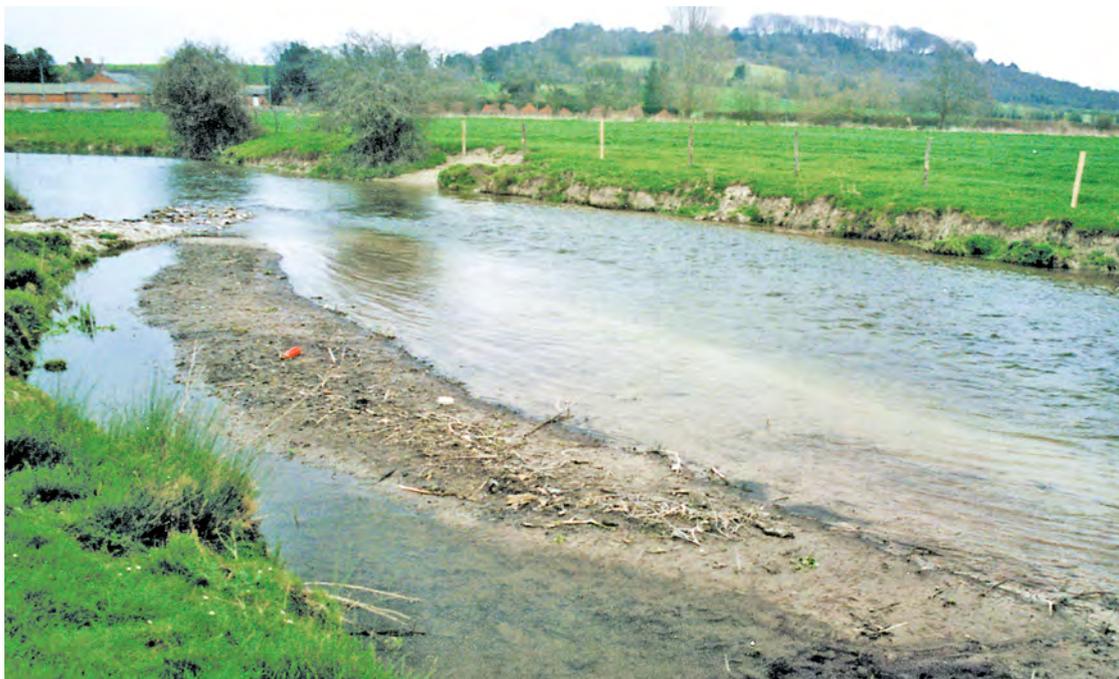
Type B deflector before planting

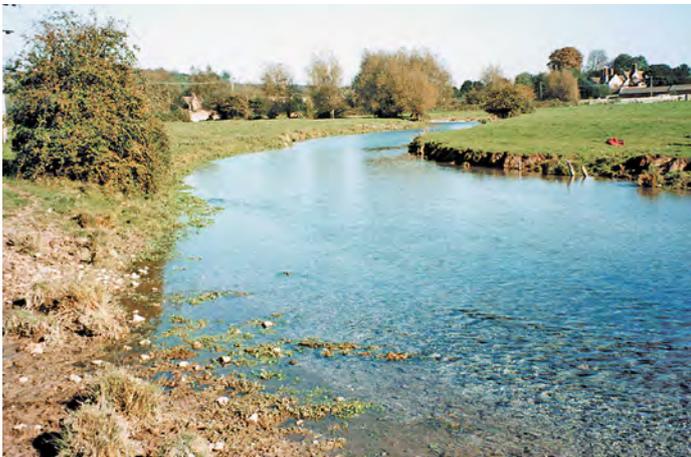
Cattle poached, wide and shallow

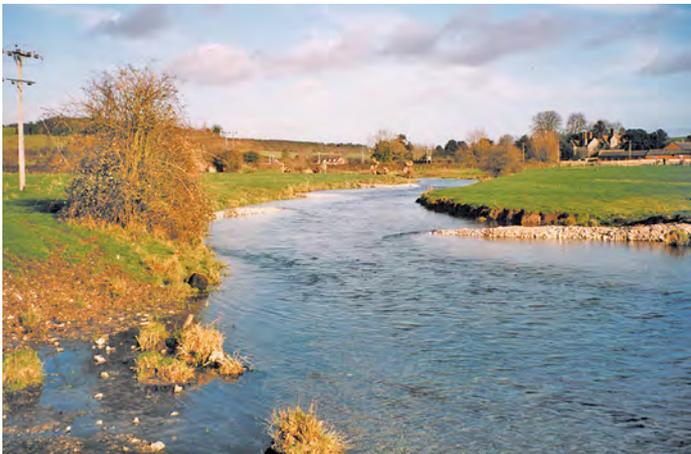
Groynes in place already increasing flow diversity

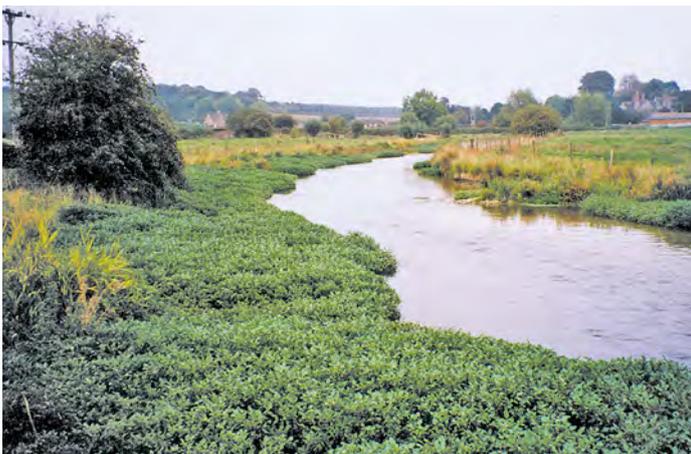
Silt deposits were quickly colonised and the river narrowed

Following the works rapid siltation occurred, resulting in channel narrowing. In the 2007 survey an approximately 30% reduction in channel width was observed compared to pre works. The variations in flow characteristics observed in 2002 remain the same.

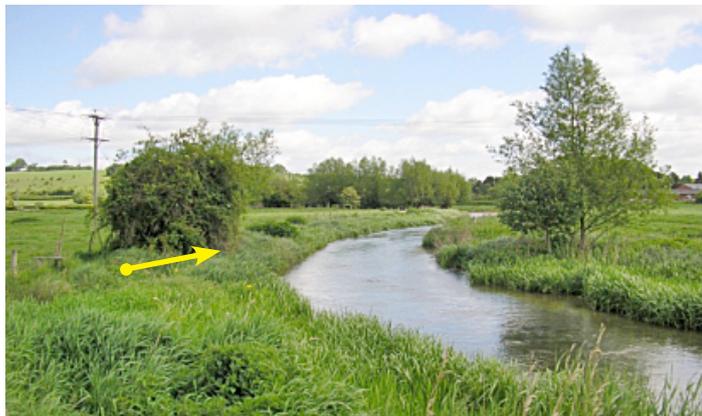
The narrowed channel – May 2007
(Arrow indicates location of 2012 photograph)

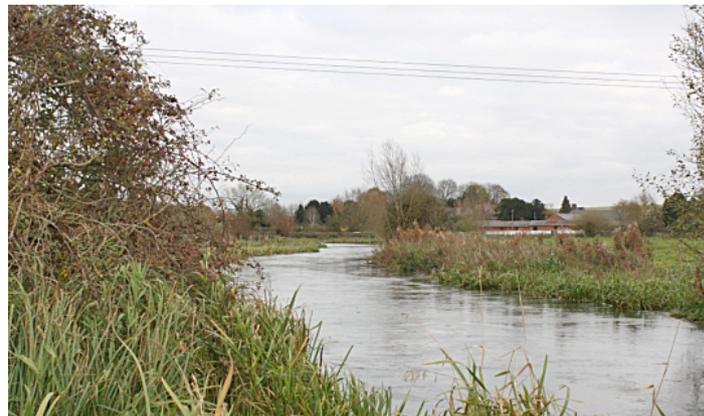
The site after 15 years showing the development of vegetation – November 2012
