Revetting and Supporting River Banks

4.4 Plant roll revetment

RIVER SKERNE

LOCATION – DARLINGTON, Co DURHAM, NZ301160

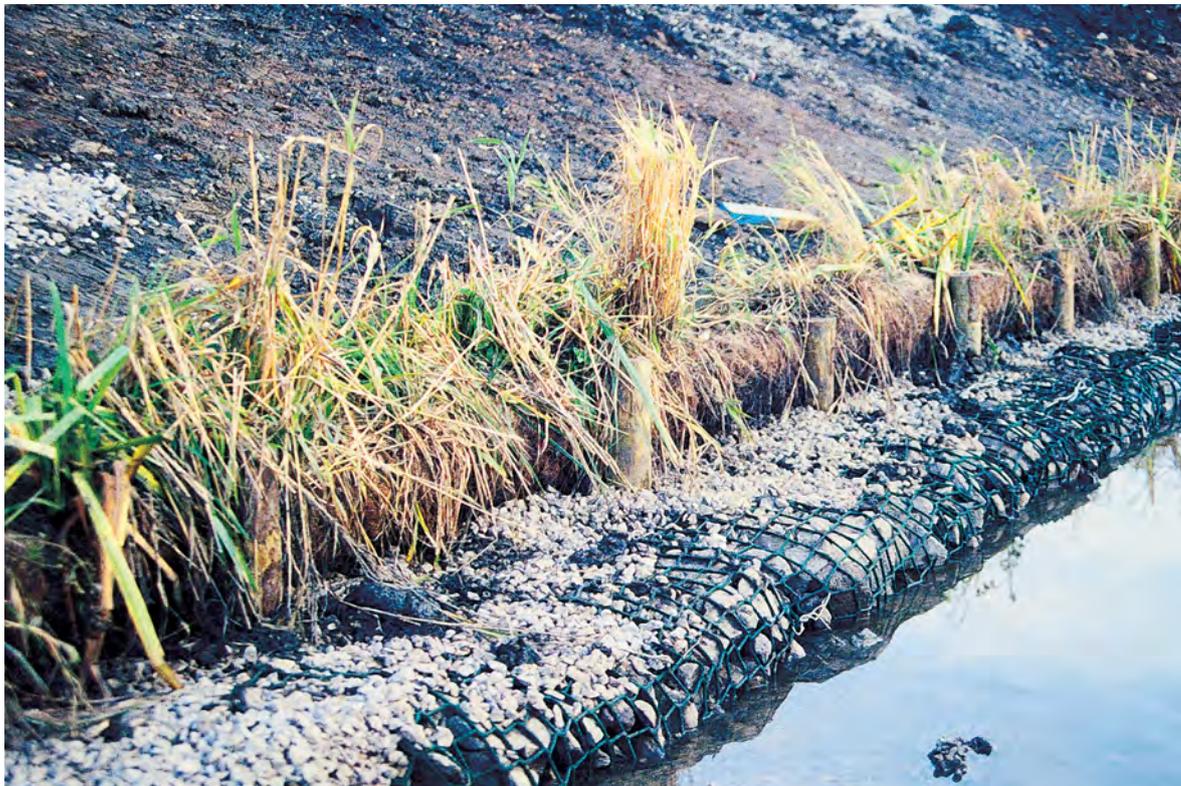
Transitional revetment at installation (water level artificially low in photo)

Rock rolls are set out below water on ledges cut to suit and secured by driving posts through the netting. Long term stability and flexibility is achieved by pulling the rolls tight against the posts using twist wires anchored to stakes set well back.

Plant rolls are set out at low water level and wedged tight up against the rock rolls by driving stakes at a suitable angle along the rear of these.

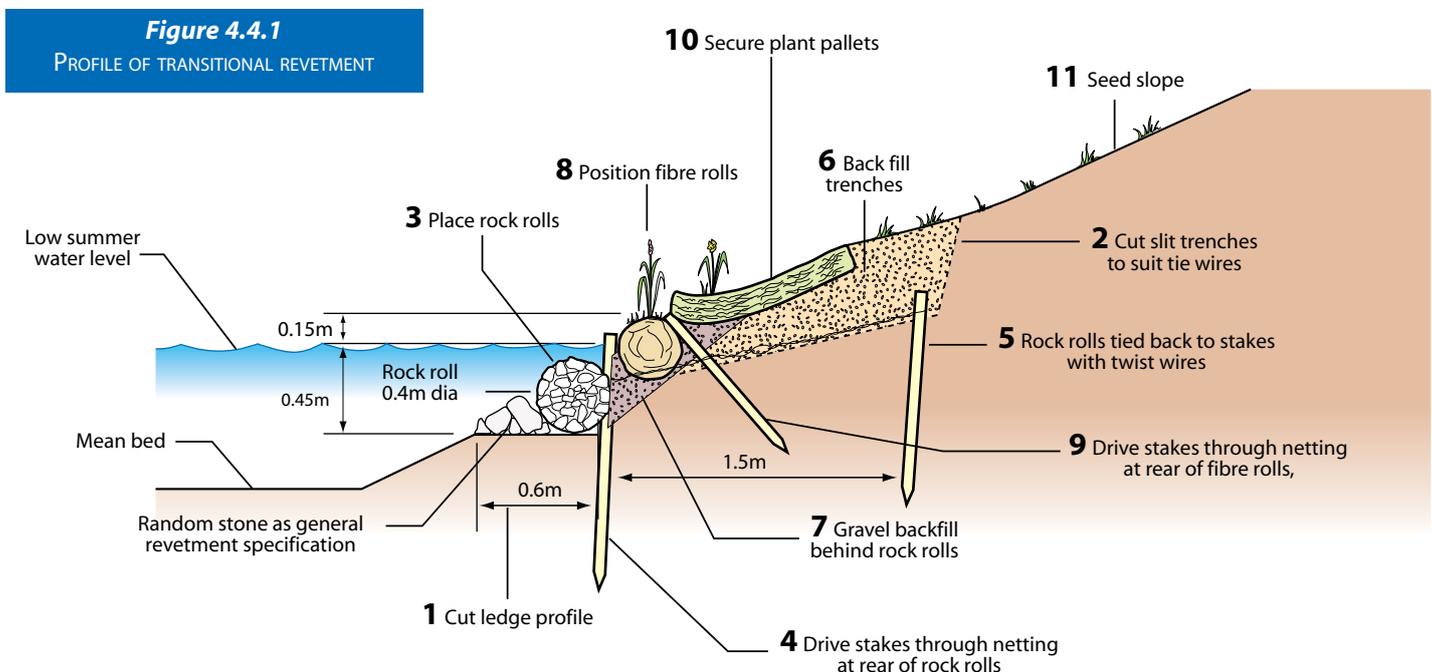
Several lengths of this revetment were installed in various alignments, e.g. entry and exit of bends and in backwaters. All have established well with reed canary-grass proving to be the most dominant plant best suited to the habitat niche created. Growth is generally limited to within 500mm of river level where the bank is damp. Above this the pallets have been colonised by ruderal plants such as himalayan balsam, which is being controlled by mowing before seed heads form.

Children walking along the bank toe, behind the plant rolls, have created ledged paths, which are stable, and are accreting significant amounts of silt due to eddy currents set up as floods pass over the stands of reed grass. This desirable situation contrasts with the erosion of river bank toes that typified pre-works conditions in the straight trapezoidal river.
