6.4 Breaching a flood bank to reconnect active floodplain processes

BURN OF MOSSET

LOCATION - FORRES, MORAY, SCOTLAND NJ04955727

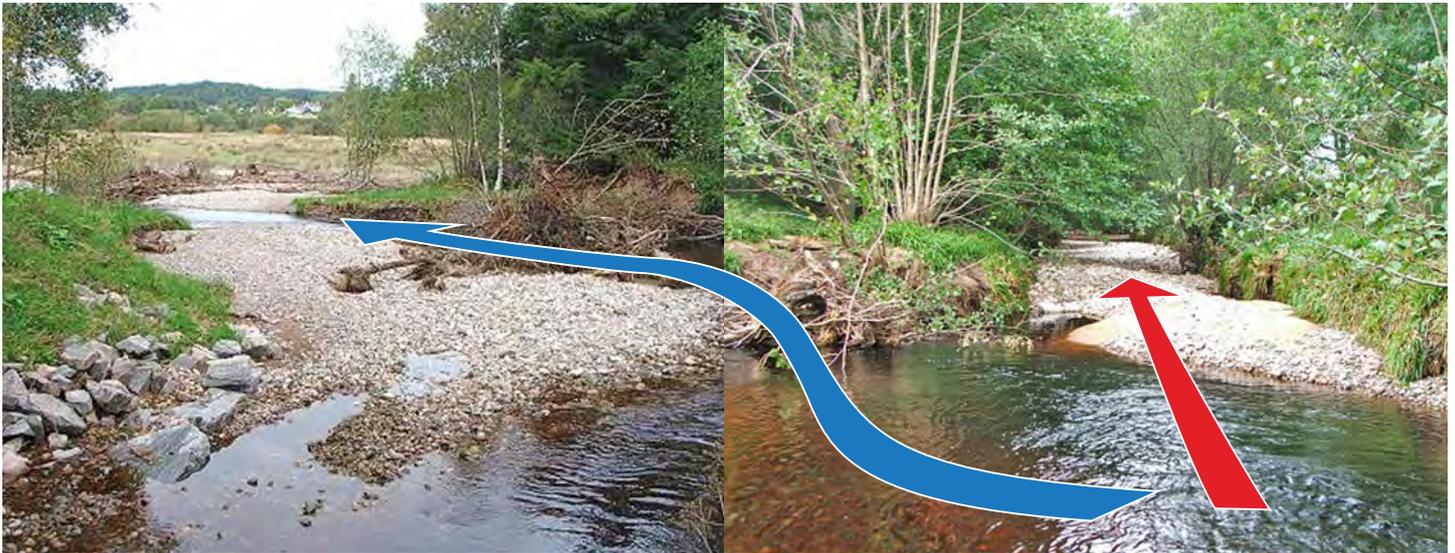
The upstream breach two years post construction: widening of breach and gravel deposit to the left; abandonment of the old course on the right (blue arrow=new route. red arrow=old route) – 2010

Approximately one year after the banks were breached in September 2009 the channel experienced an estimated 30m³/s flood flow (of the order of a 1 in 10 year event). The stone protection at the upstream breach was partially washed out, as anticipated. The breach enlarged such that the majority of the flow was diverted along the new route after the flow subsided. The result was rapid development of river features, including the formation of an outwash fan (see *Figure 6.4.1*). Some ecological degradation has occurred in the short term, as the old channel is now dry except during very high flow events.

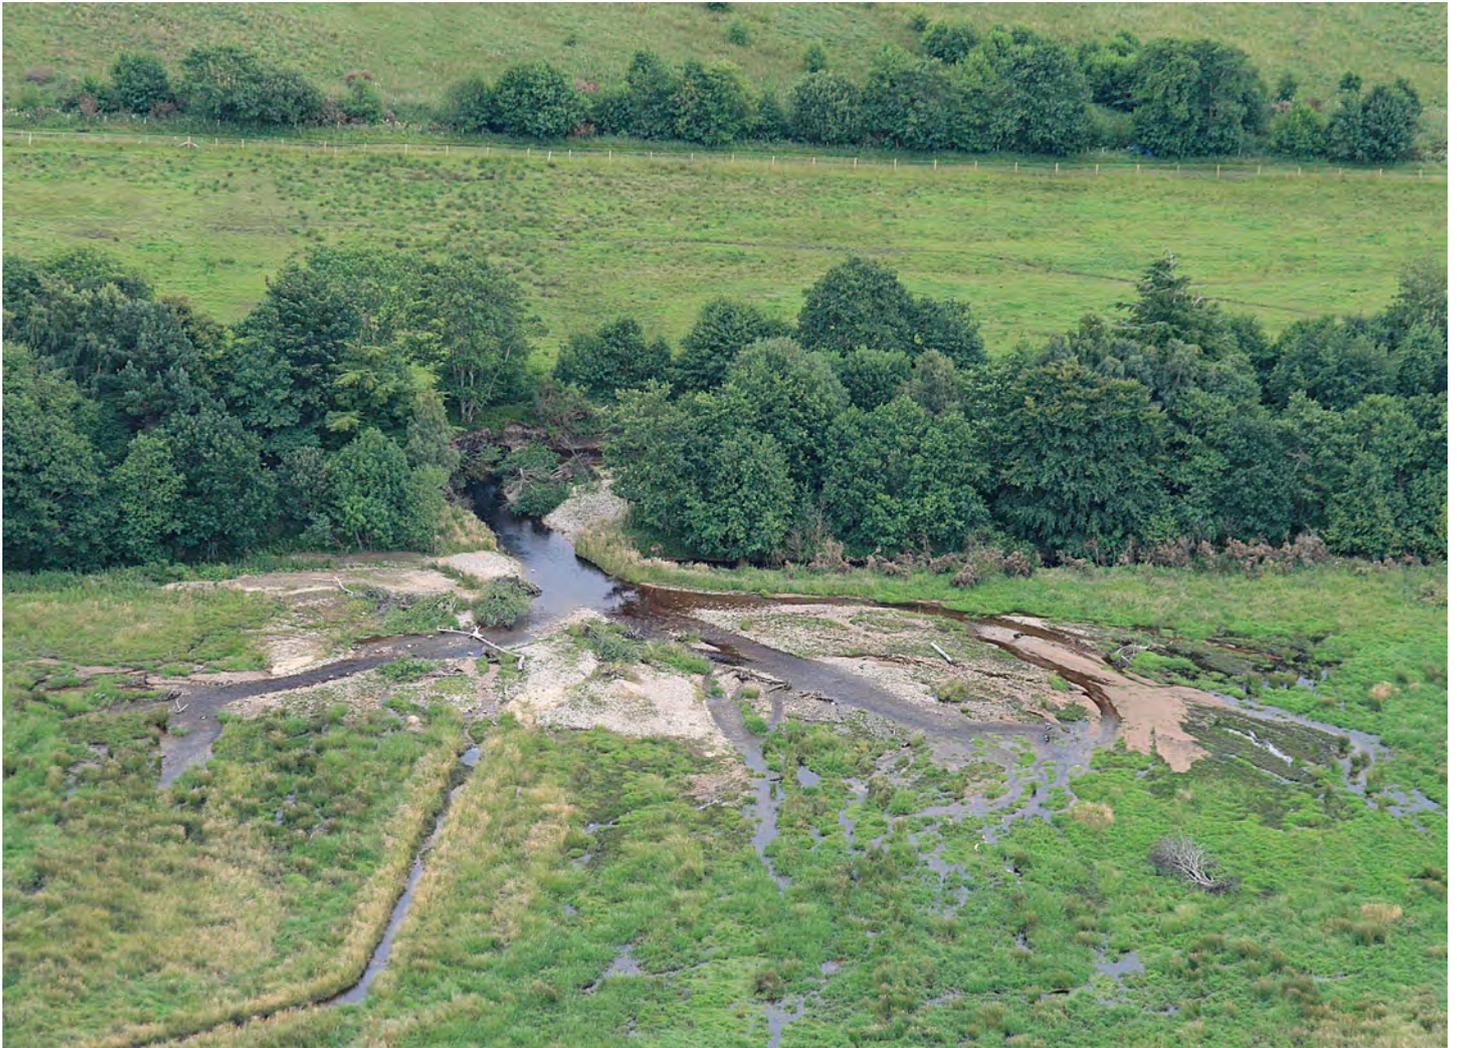
Sediment accretion area/outwash fan has developed at the upstream breach – July 2011

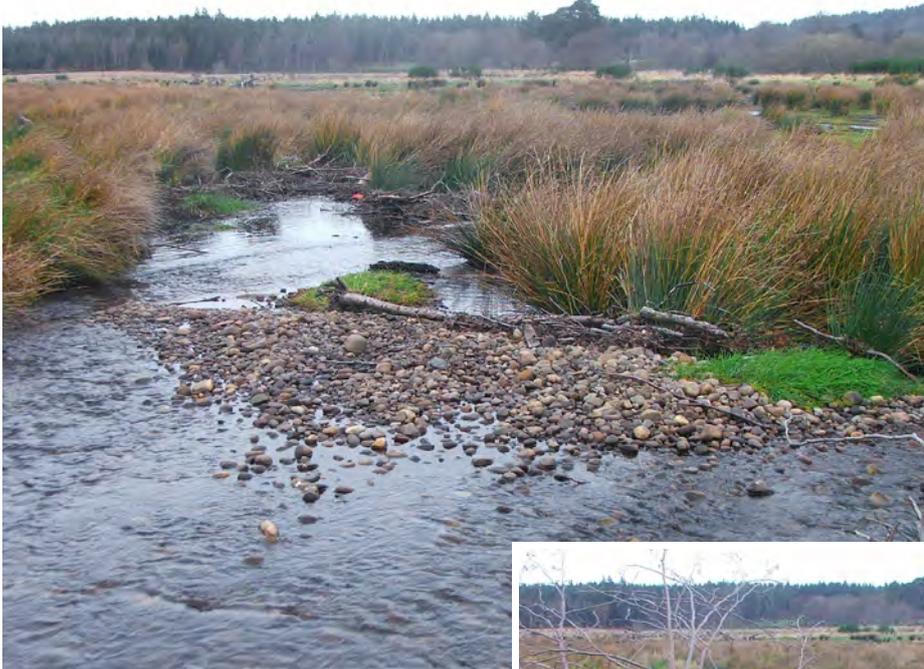
Channel development. The accretion area is storing woody material and river sediments – March 2012
