# Creating Floodplain Wetland Features

## 7.1 Floodplain scrapes

### RIVER SKERNE

LOCATION - DARLINGTON, Co DURHAM NZ301160

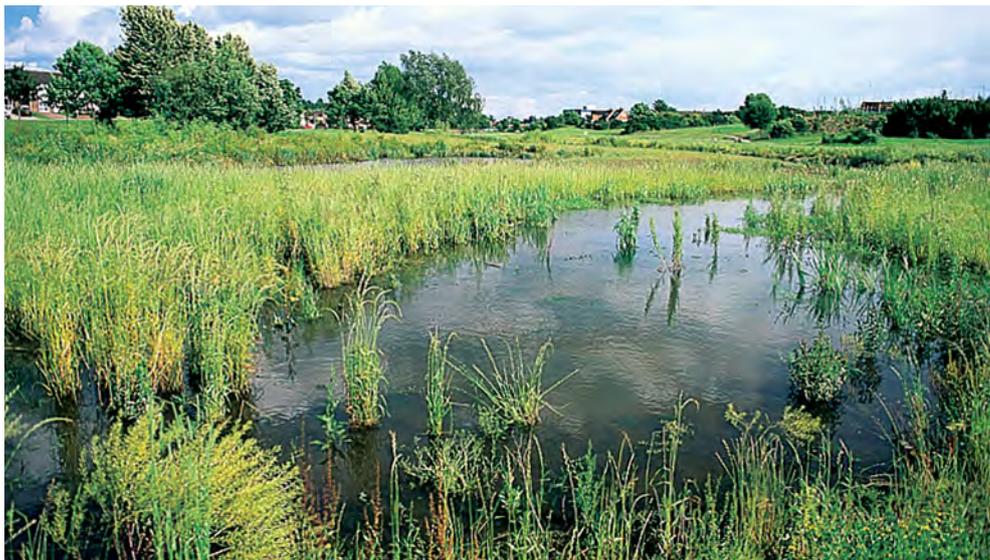
Completed spring-fed scrape

The south side of the floodplain is partially overfilled with industrial waste contained within a clay bund. Clean water was observed to be seeping from the toe and to be sustaining a lush growth of grass (mown) all year round. A scrape was excavated within this area of low artesian water pressure so that full advantage could be taken of the opportunity to introduce a significant wetland feature to the floodplain (*Figure 7.1.1*).

The irregular shape fits comfortably within the limited area available and the depth has been limited to 0.3m in the interest of public safety, as well as to suit the emergent and marginal aquatic vegetation sought. The side slopes are very shallow for similar reasons. No overspill was built. In very wet periods excess water seeps towards the river over the grassed area alongside.

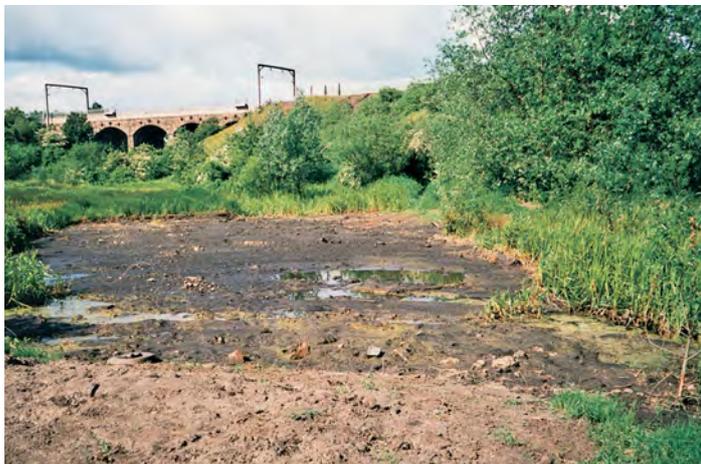
View of Rockwell scrape site after removal of rubble piles

Some piles were cleared from site and the ground taken down to expose historic floodplain soils, although these were found to be interspersed with deposits of dumped foundry sand. These sands were also evident throughout the restored floodplain, marking Darlington's industrial history of iron works.

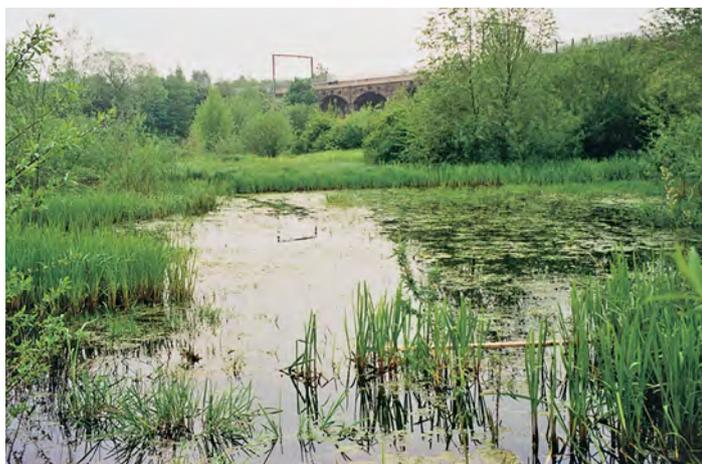
Comparative view of  
Rockwell scrape after  
work completed

Working closely with the local Wildlife Trust, a new scrape was then excavated and the spoil removed from site. The scrape is about 50m<sup>2</sup> in area and slopes gently down from one side to a maximum depth of 1m where it returns steeply to ground level forming a small cliff that is overhung by pre-existent willow carr.
