Bed lowering at Boscastle

The bed lowering challenge

- Man made channel
- Formed of soft slate layers and hard quartz
- Salmonid (Atlantic salmon & sea trout), eels and bullheads
- Lower the river bed by 1m for 300m

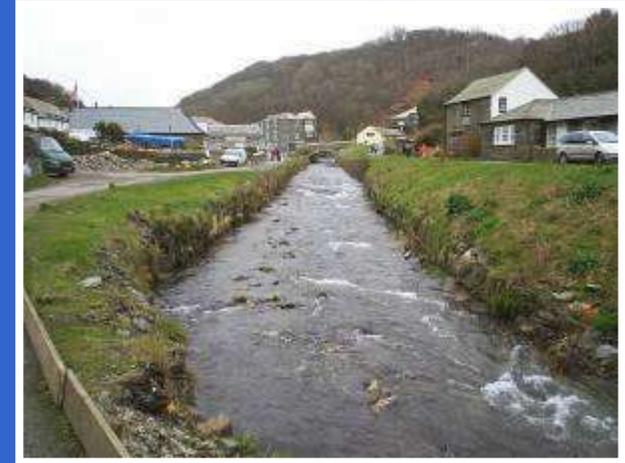
Bed Lowering Design Objectives

- Avoid deep 'geometrically uniform' channel
- Improve flood capacity and sediment conveyance
- Work with the bedding planes of the river
- Work 1m away from historic walling and buildings to avoid damage
- Incorporate cascades and pools, and cover for fish
- Incorporate low flow channel for ecology and visual amenity

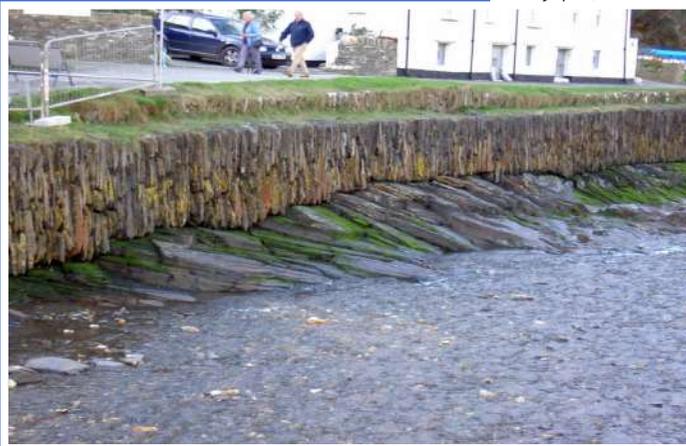
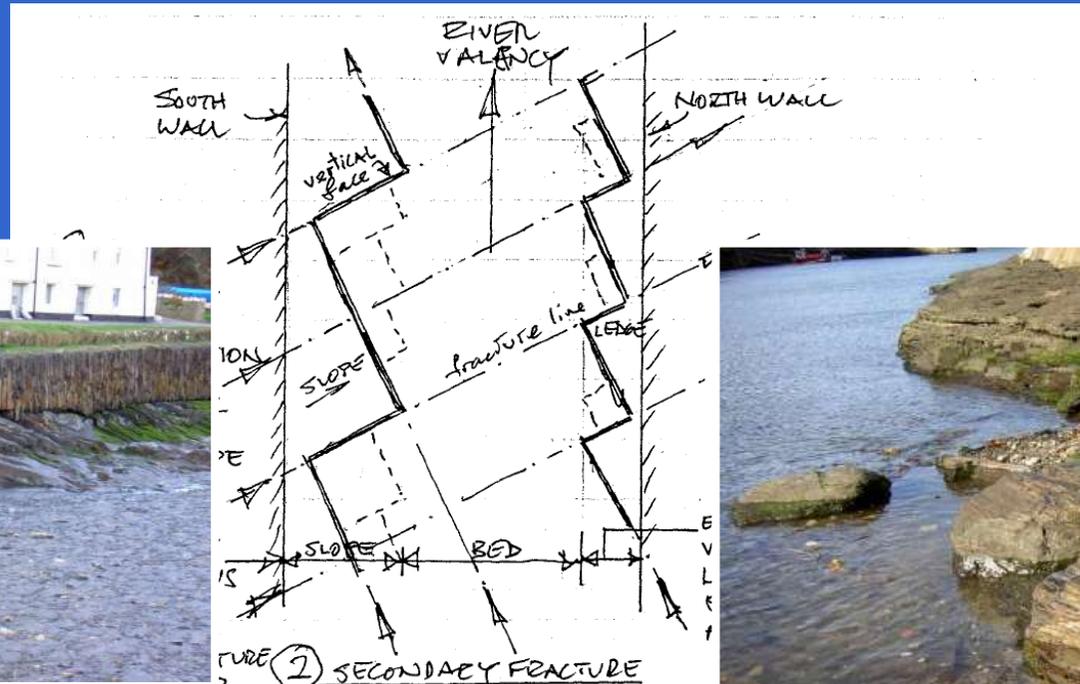
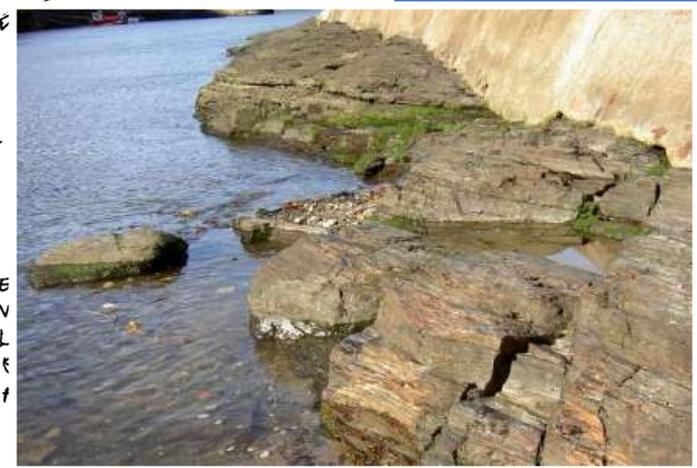
Design principle: analyse bed rock

FIGURE 2. SECONDARY FRACTURE LINES INDIRECTION OF THE NATURAL STRIKE OF THE ROCK (AT RIGHT ANGLES TO DIP SLOPE)

A
SIMPLIFIED PLAN OF RIVER CHANNEL SHOWING THE EFFECT OF NATURAL FRACTURE LINES WITHIN THE ROCK BREAK.

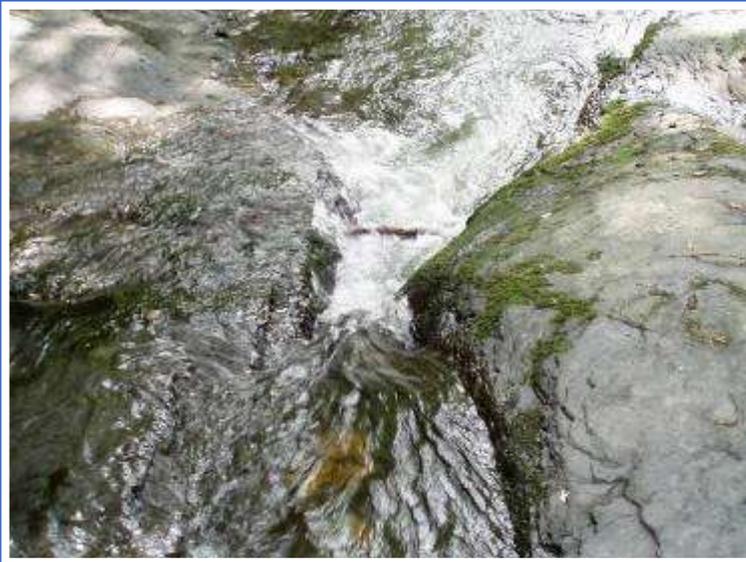
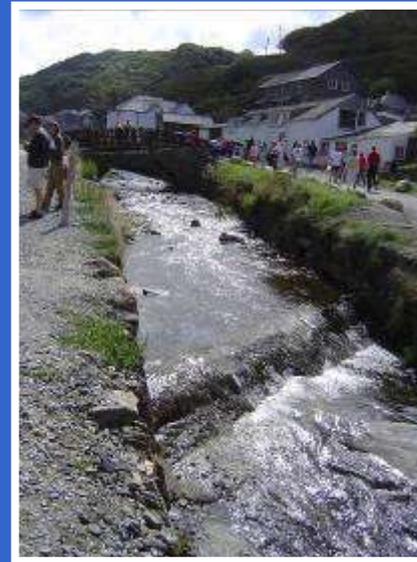
Design principles: fish passage

- Chutes into pools to attempt to keep pools free of gravel
- Embayments for fish to rest out of current
- Removal of obstructions to fish passage

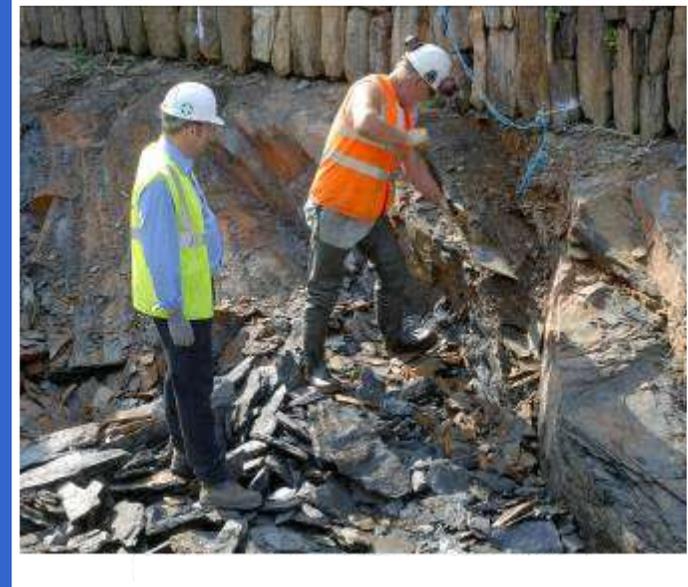
Approach to the excavation

- Fish rescue and removal of gravels
- Information boards for the public
- Trial excavation to test machinery and properties of rock
- Toolbox talk for digger driver with visual references
- Hydraulic excavation followed by architectural excavation
- River Restoration Centre (RRC) and Fisheries provided site supervision
- Sign off from all stakeholders

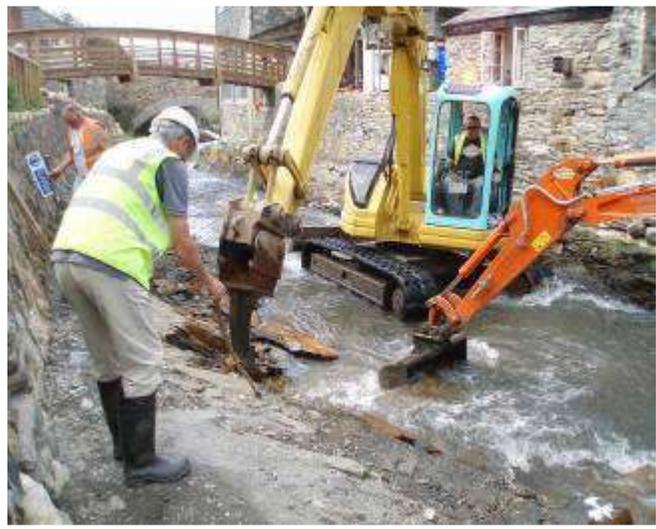
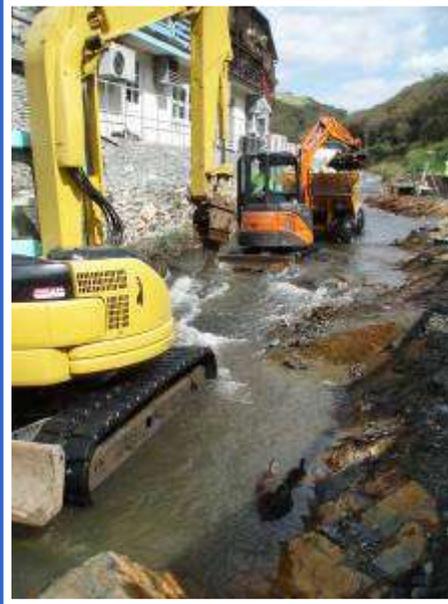
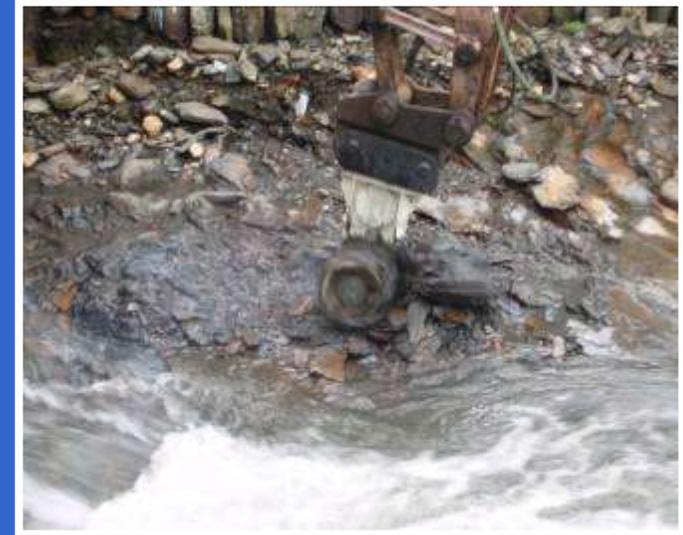
How did we break out the rock?

- Bucket, tooth, milling machine and by hand
- Worked into the flow so sediment moves downstream
- Worked with the natural bedding planes and fault lines of rock

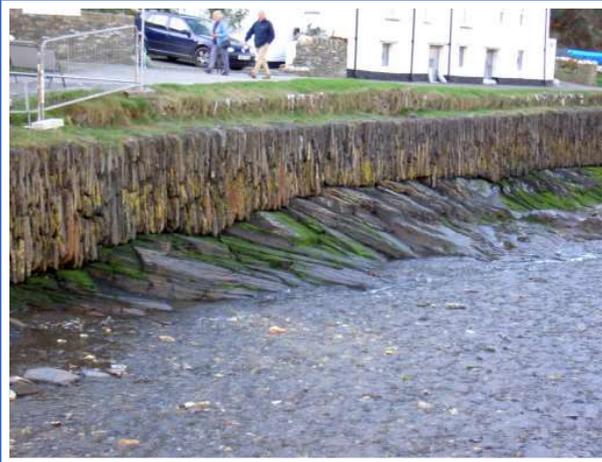
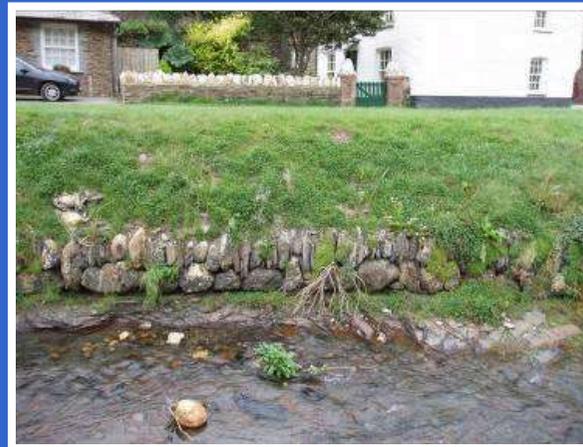
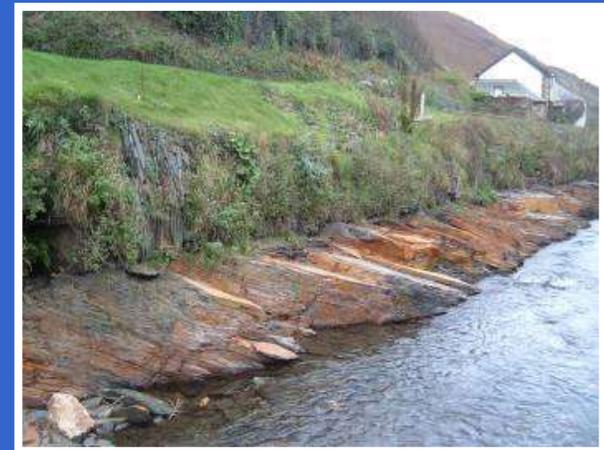
Result of architectural excavation

Left bank
reference
in harbour

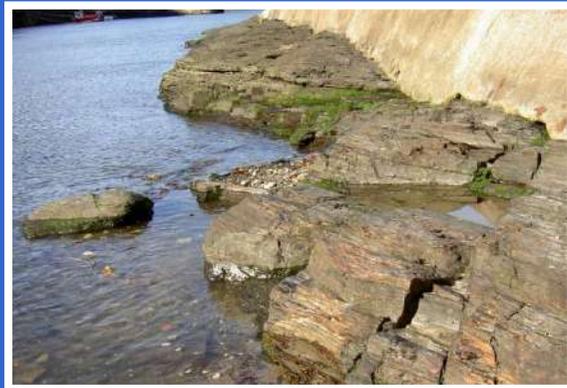
Result of architectural excavation

Right bank
reference
in harbour
