Braid Burn at Inch Park, Edinburgh, Scotland

Techniques: Creation of meanders and wetland areas, bank re-profiling and an engineered two-stage flood defence to create flood storage/alleviation space

the River Restoration Centre Case Study Series

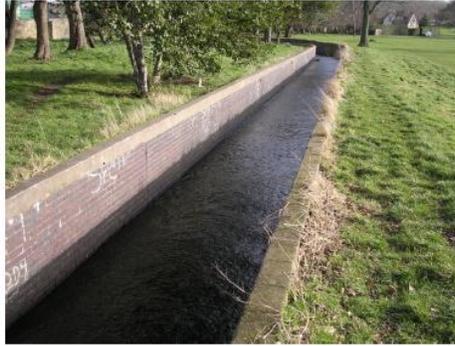
Braid Burn before the Flood Prevention Scheme

The Braid Burn rises in the Pentland Hills to the south-west of Edinburgh, and flows in a generally north-easterly direction through the city before discharging into the Firth of Forth at Portobello, east of the City Centre. The catchment is 30.5km² and Inch Park is one of the sections of the project where environmental improvement to the burn corridor was carried out in conjunction with reducing the risk of flooding. The artificial burn corridor had little character and habitat was very poor with low diversity in species, and extensive stands of Himalayan Balsam.

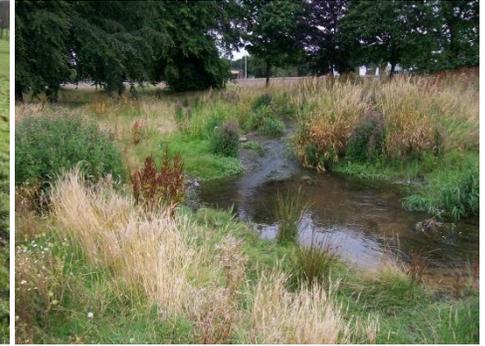
Braid Burn Summer 2010

The works comprise a two stage flood defence scheme with the first stage being a low bund to retain up to 20% AEP (1 in 5 year) event. The second stage works involved the construction of clay embankments and sheet pile and concrete walls clad in stone recovered from the park's boundary wall creating 190,000m³ of flood reservoir storage. Environmental improvements included lowering artificially raised banks and the concrete channel was replaced with sinuous meanders to restore the watercourse. Wetland areas were created to provide habitat variety.

The biodiversity value of the Park has been significantly increased with more variety in plant species and habitat than existed previously. Otters have returned to the reach and dippers, grey wagtails and other bird species have been observed feeding and gathering nesting materials immediately following the project. The flood defences were tested in March 2010 and despite heavy rain over an extended time period, flooding was limited to areas designated for frequent flooding, preventing flood damage to properties which would have been otherwise at risk.

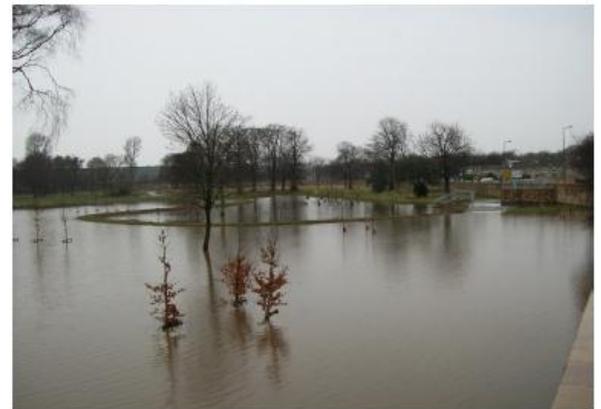
Braid Burn Flooding, Inch Park, March 2010
