# Highland Water at Warwickslade Lawn, the New Forest

## Techniques: Recreate 'lost' meanders, Clag Plugs to block drain and Tramway

**Project location:** Warwickslade Lawn  
**River:** Highland Water  
**County:** Hampshire  
**Project start date:** June 2009  
**Proposed project end date:** November 2009  
**Length:** 3km  
**Cost:** £3,000 (on average £1,000/per km)  
**Upstream grid reference:** SU275065

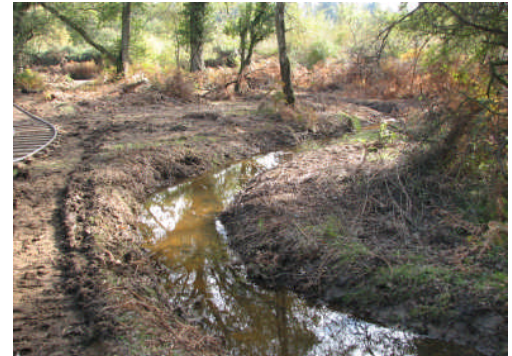
A new meandering section within Warwickslade Lawn

Historical forest maps were referred to, to plot old, 'lost' watercourses including a 1789 map of the forest and WW2 military reconnaissance photographs. Where this was not obvious, levelling and 'construction by eye' within reasonable limits, allowed for inherent stream variability. No pre-hydrological monitoring was used. Some pools were accentuated and gravel was transferred to encourage spawning and seasonal refuge. Clay plugs of hoggin and heather bales were used to block isolated stretches. Turves on the stream edges consolidate and provide immediate channel stabilisation. Upstream, a pool has been widened to accommodate greater flow conveyance near the A35 at the upstream limit. A custom made and innovative tramway system to meet the logistical needs of the project was hatched and created within five weeks. This prevents traditional dumper truck damage, permits work to continue even when the ground is wet and by reducing fuel consumption, similarly reduces carbon footprint by 75%

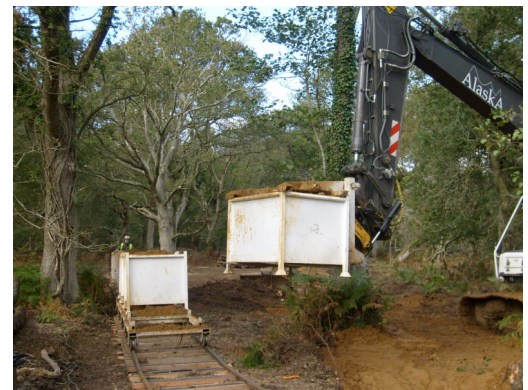
Alaska's innovative and logistical tramway operation
