# River Rother at Shopham Loop, West Sussex

### **the River Restoration Centre Case Study Series**

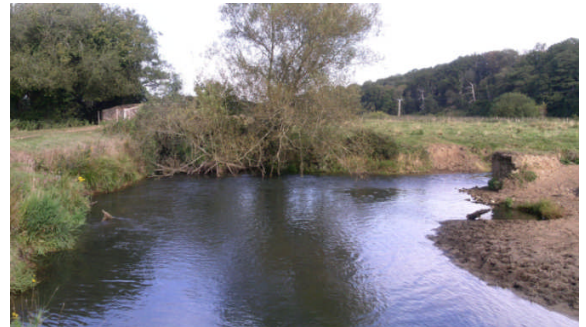
Downstream end of Shopham Loop with the cut blocked.

Shopham Loop is a section of the river Rother, West Sussex between Coultershaw Bridge and Shopham Bridge. A cut was created in the 18<sup>th</sup> century to bypass the meander and enable passage of boats upstream. However after navigation ceased, the locks were removed and the cut became the main river course with the meander (Shopham Loop) remaining as a backwater. Land use change to an intensive agricultural regime in turn led to shallower soils and increased siltation and the loop entrance became blocked with deposits preventing any flow from the Rother.

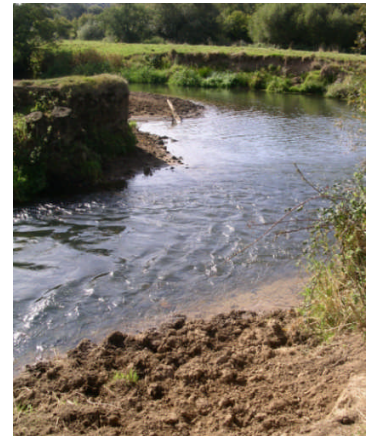
Stone riffle downstream of the loop to prevent acute gravel scour.

The old meander loop was reinstated and designed to a bed level that enabled reconnection of the flow to the floodplain during flood events. Initially the banks were cut fairly steeply with the view that these would react to natural processes and form more natural bank profiles overtime. A large backwater, shallow ponds and wader scrapes were also created. A bund was built upstream of the loop to prevent flow entering here during construction and when later deconstructed, the material was moved to protect the old lock, a site of archaeological interest. Discussions occurred over whether to lay gravel to improve fisheries but in the end a conscious decision was made to let the stream settle. Downstream of the loop, a stone riffle was formed to prevent acute gravel scour.
