**River restoration:  
Benefits for integrated catchment management**

**UK monitoring programme  
Year 1 (1994) Interim Report**

LIFE project: 93/DK/A25/INT/2504

February 1995

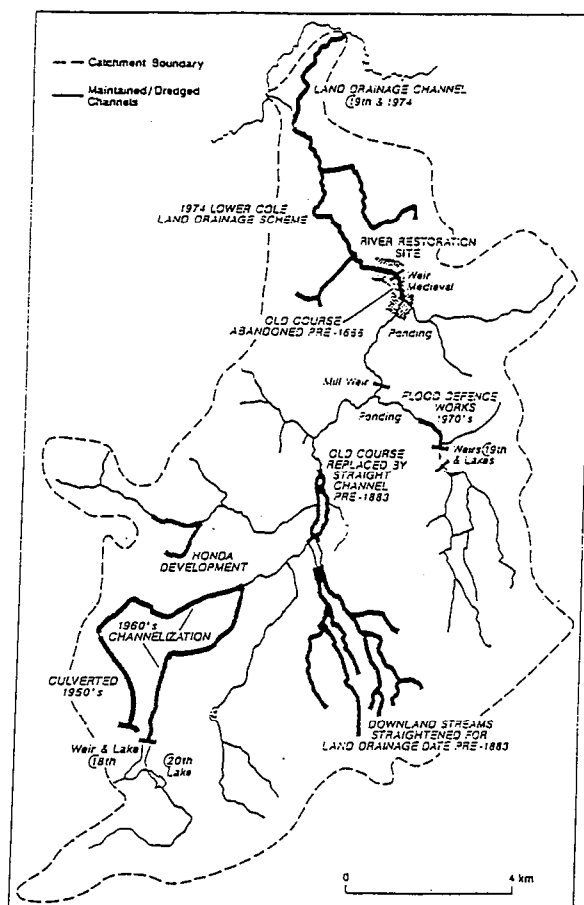
**Figure 3.1** River channel modifications and impacts on the riverine environment in the catchment of the R.Cole

Time		Pre 1600	1800-1900	1900-1930	1930's	1940's	1950's	1960's	1970's	1980's	1990's	Future
Climate	Floods						1959	1968	1971 1979	1984	1993	
	Droughts								1978			
Capital Works							Urban Flood Storage Areas					?
									1974 Lower Cole Land Drainage Scheme			
									Land Drainage			
River Maintenance		Drain Clearance / Pollarding									Light Weedcut	
							Desilting / Weed Cutting /					
Channel Change					Natural Planform Stability							
					Piecemeal Channelization / Mill Structures			Urban Culverting / Land Drainage Dredge				
											River Restoration	
Land Use Change		Water Meadows / Livestock Farming						Urbanization (Swindon)			(Honda)	
									Arable Cropping		Community Forest	
											Stewardship & Setaside	
Water Quality Change									Oil & Urban Runoff			
					Removal of STW				Increasing Suspended Solids			
Fisheries Change			'Good' Course Fishery							Fish Stocks 'Decimated'

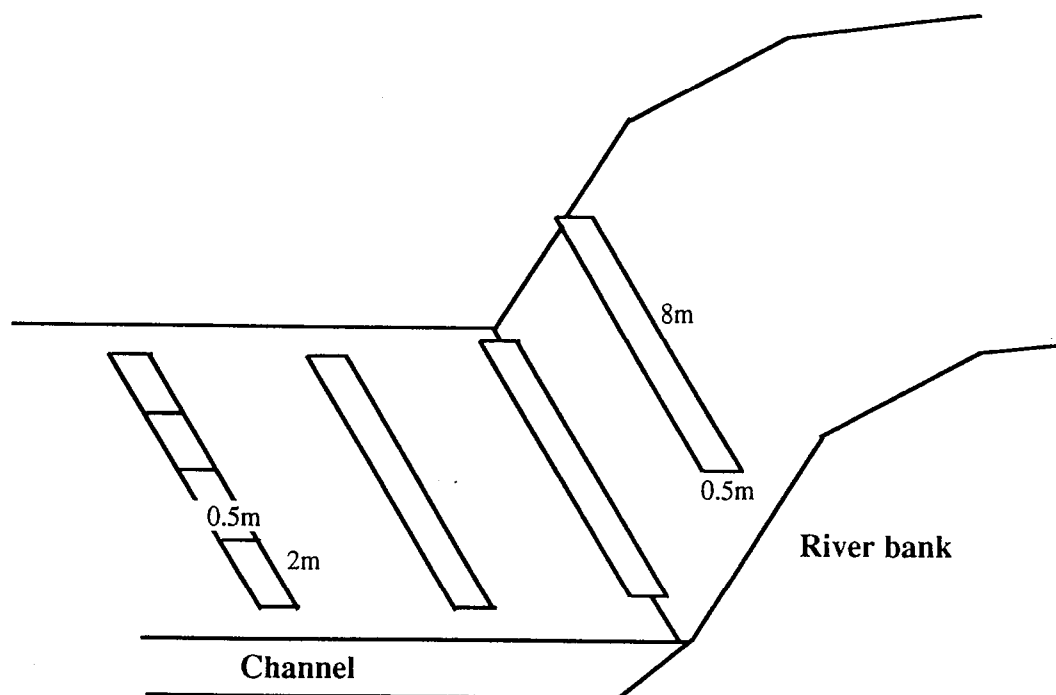
**Figure 7.2** Location of plant monitoring quadrats used for quantitative assessment of vegetation change

Quantitative monitoring of changes in river channel vegetation has involved the establishment of a total of 36 permanent 2-m<sup>2</sup> quadrats which provide transects along nine sections of the R. Cole. Four of these transects lie within the restoration area, with two control transects upstream and three downstream of the restoration area. Where possible, the location of the transects was chosen to correspond with the 100-m sections surveyed for the aquatic macroinvertebrate monitoring.

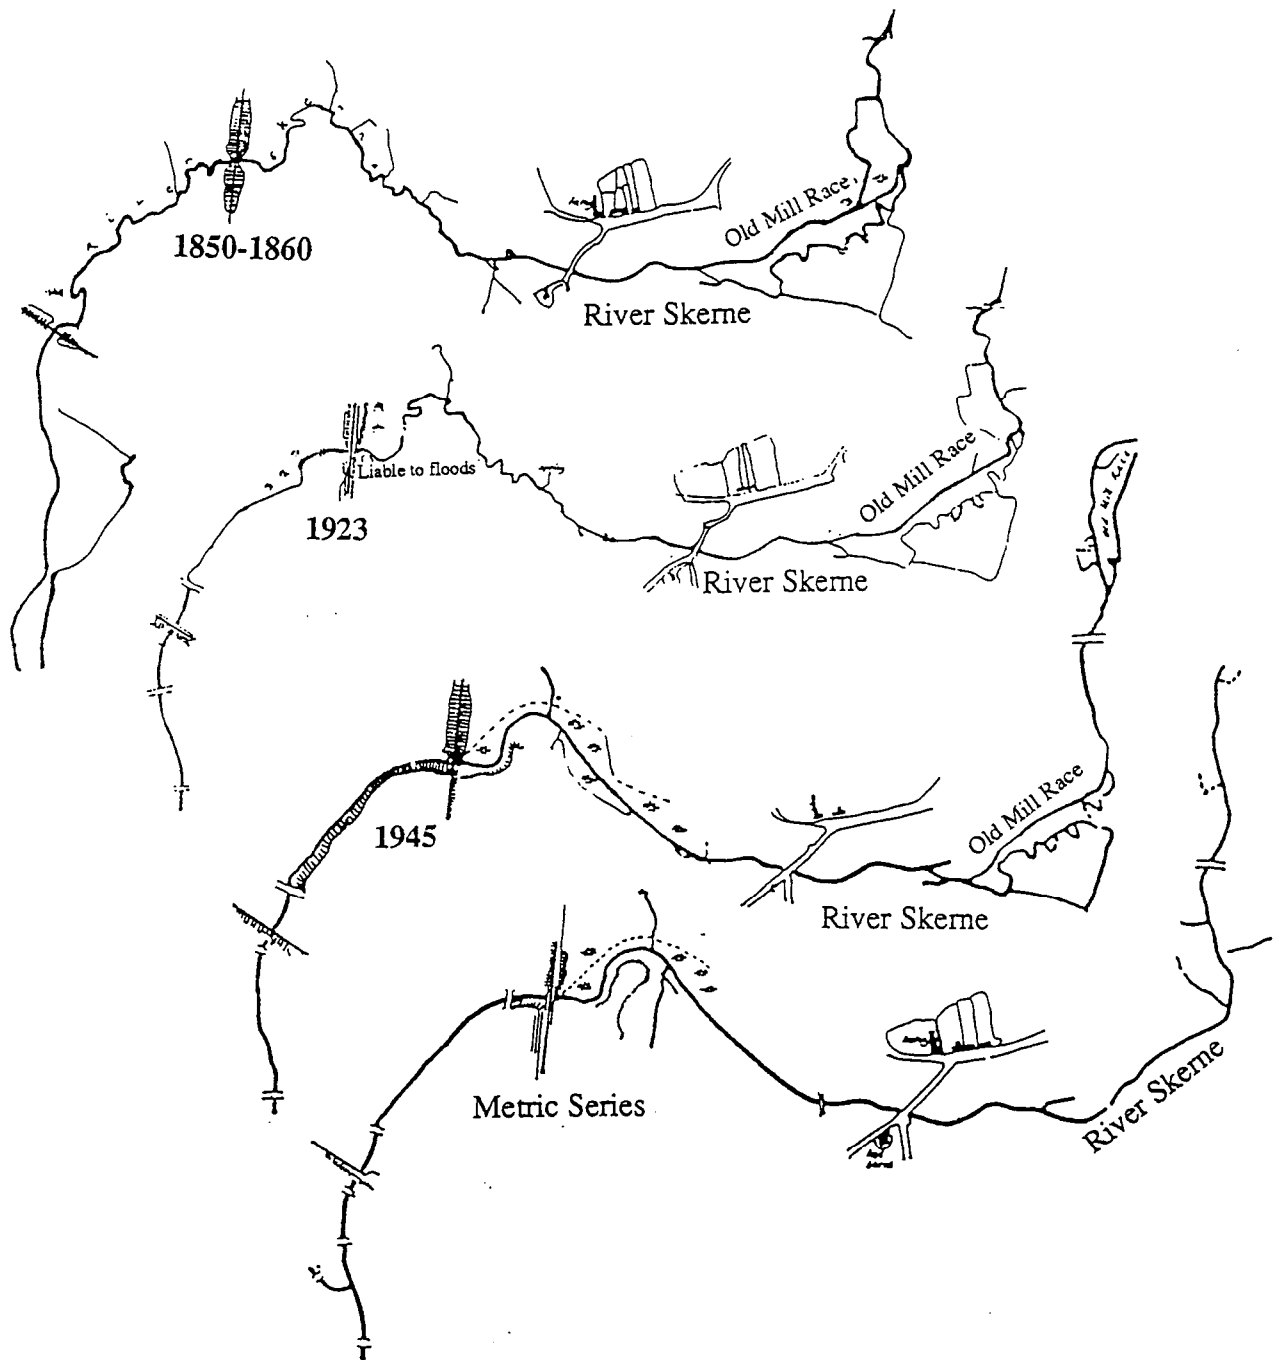
**Figure 13.2** Change in the planform of the Skerne in the restoration reach 1850-1960

The channel past Haughton Bridge was probably straightened prior to 1850, as it stands out when compared with sections up- and downstream at this time. The channel abandoned its natural course in favour of Haughton Mill Race, and artificial cut-offs and straightening occurred just downstream of Haughton Bridge.

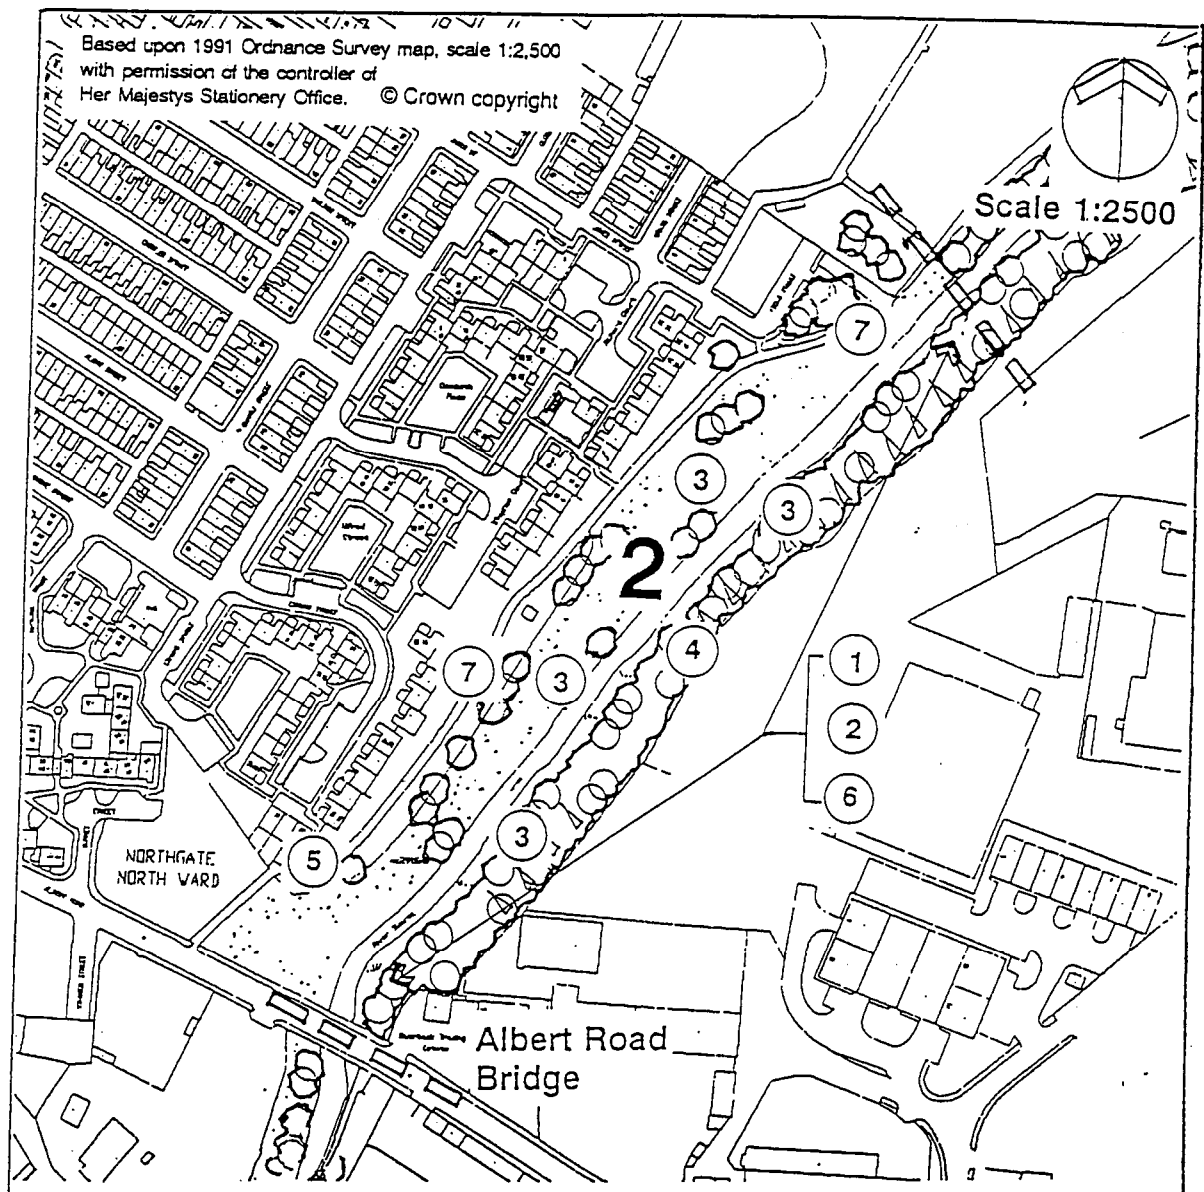
**Figure 15.1. Extract from Detailed Landscape Assessment. Section No.2. Albert Road Bridge to the Western Edge of the Allotments**

The right bank has a gentle slope with housing defining the visual envelope. This fronts onto a public open space which is largely mown grass with groups of mainly exotic trees and shrubs. Significant groups of trees, largely willow, are located on the bankside. The left bank has a steeply sloping embankment leading to an industrial plateau which consists of semi-natural planting. There is no formal river edge path although opportunity exists to provide a route from the top of the right bank along the river and under Albert Road Bridge, avoiding the crossing of a busy road and informal path on the left bank. The river has a smooth canalised channel and the water is discoloured.

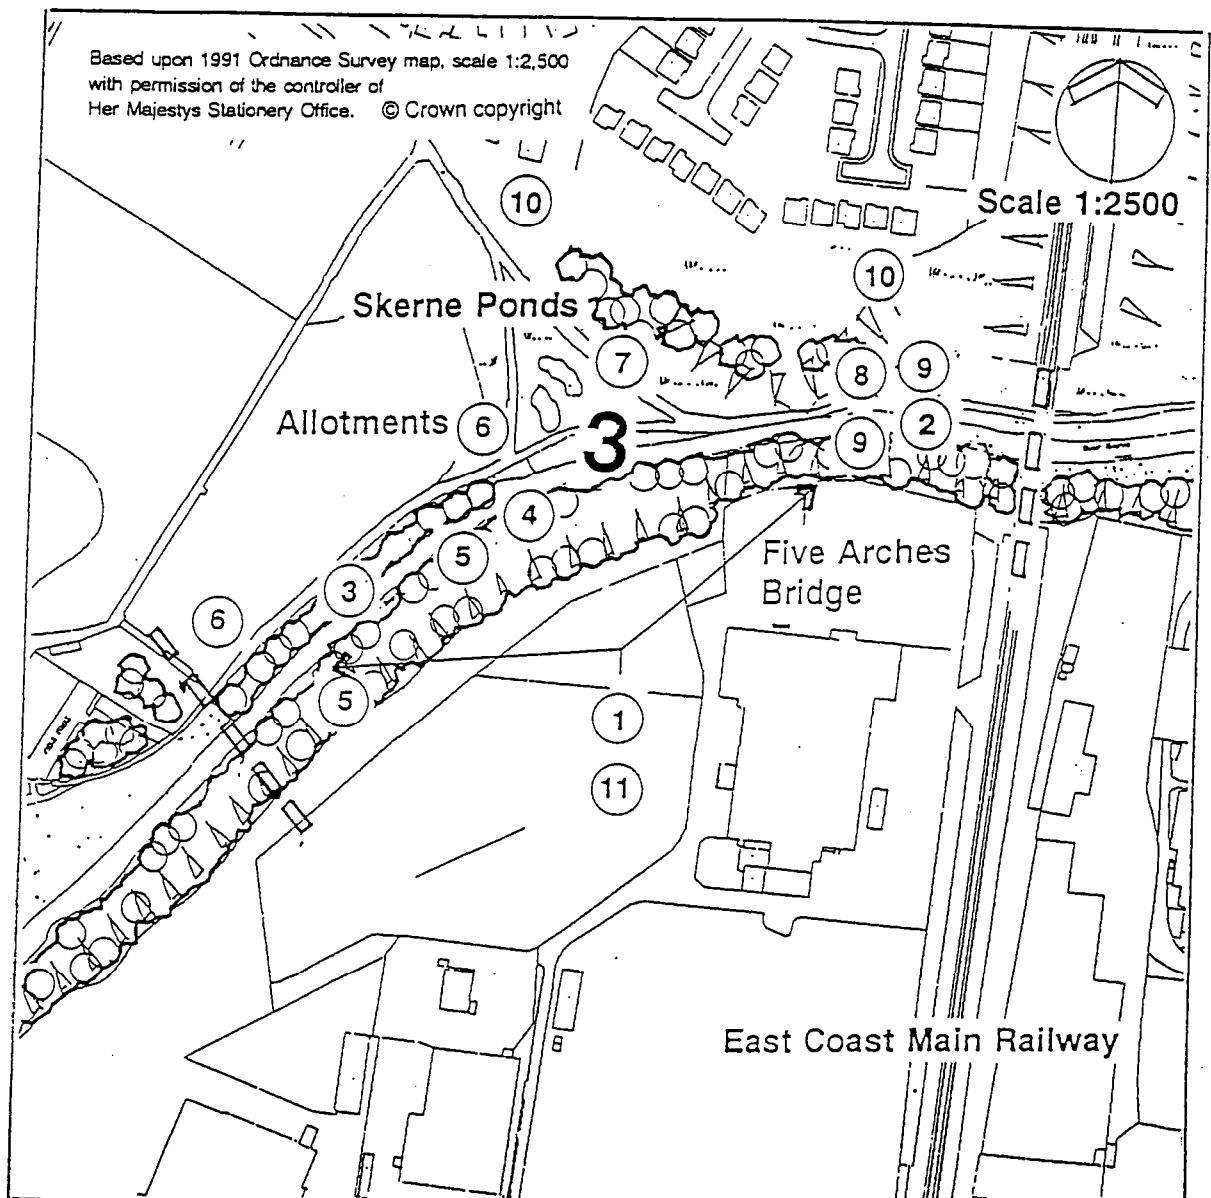
**Figure 15.2. Extract from Detailed Landscape Assessment.  
Section No.3. East Edge of Allotments to Five Arches Bridge**

This section contains a series of different spaces on the right bank with a fairly uniform appearance on the left bank. On the right bank, the path runs on an elevated route adjacent to allotments in a tight corridor dropping down to the culvert where the space opens to an informal area before tightening as the path approaches Five Arches Bridge owing to a major embankment and retaining wall. The left bank has semi-naturalised planting on a steep embankment leading to an industrial plateau. The river has a uniform profile with a canalised edge.

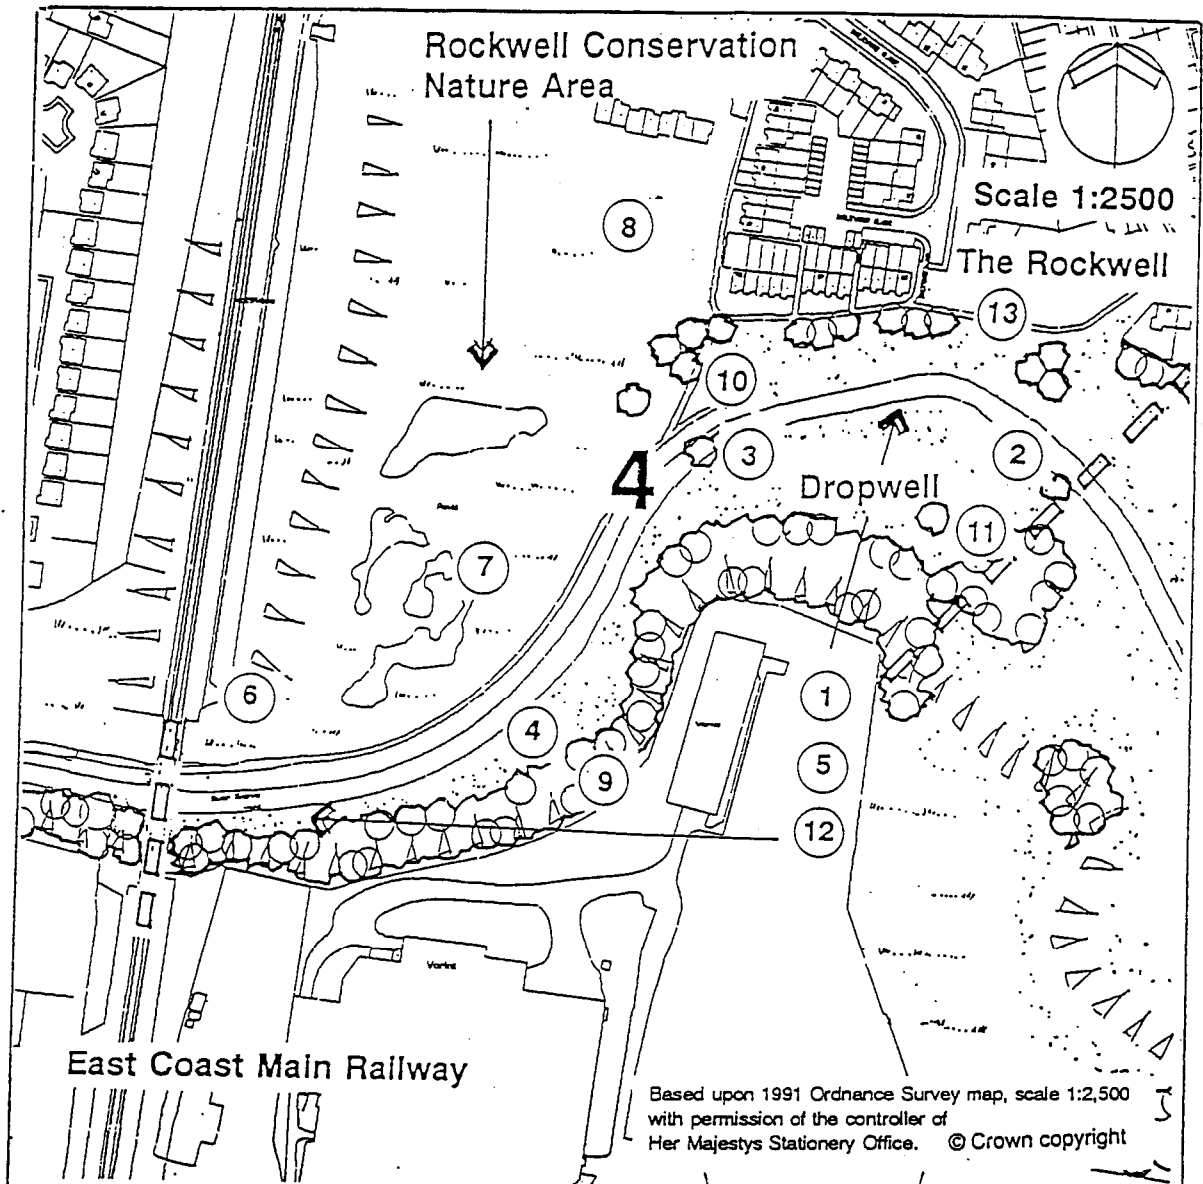
**Figure 15.3. Extract from Detailed Landscape Assessment.  
Section No.4. Five Arches Bridge to Rockwell**

The right bank has three major areas. Adjacent to housing there is a belt of trees and mown grass down to the river. Downstream is the Nature Conservation Area which contains a series of pools and rising from this is the railway embankment which provides spectacular views of the river corridor. The left bank consists of a steeply sloping embankment leading to an industrial plateau and contains a flat mown grass edge adjacent to the river. Although the river curves it is canalised with little evidence of marginal vegetation. There may be scope for restoration of the left bank to reunite it visually and ecologically with the right bank.

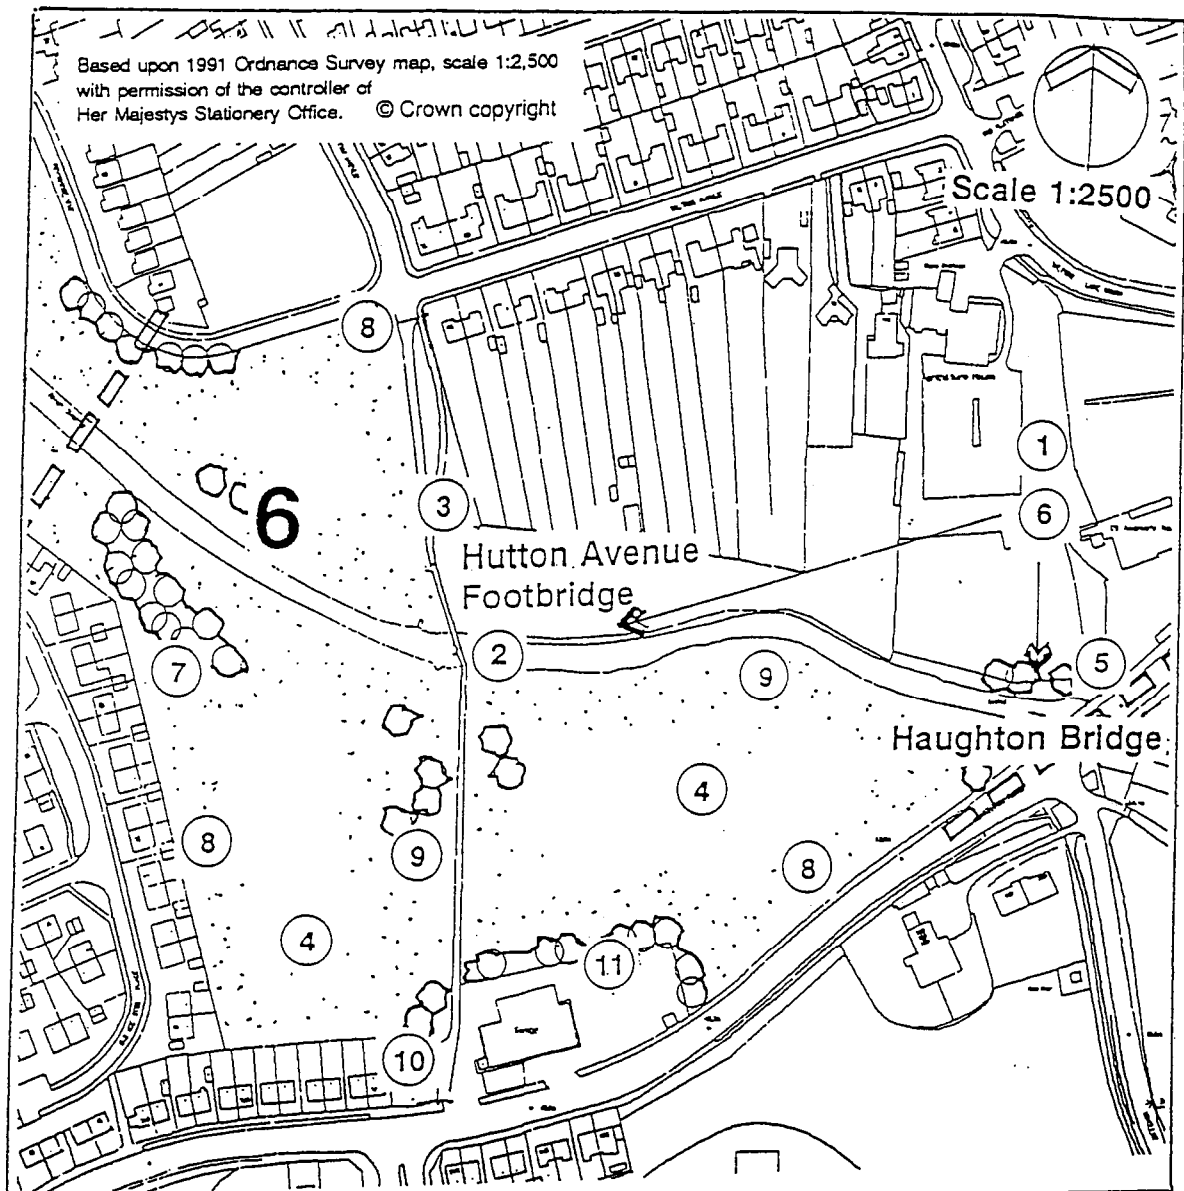
**Figure 15.5. Extract from Detailed Landscape Assessment. Section No.6.  
Old Hedgerow on the Southern Bank to Houghton Road**

The section has been subject to flood defence work and has a pronounced terrace on one side of the left bank. There is little evidence of marginal vegetation and no riverside trees. The left bank consists of a large area of gang mowed grass with occasional small trees. The housing and road edges are weak and impart a poor visual quality to this section. The right bank is largely in private ownership. Opportunities for river corridor restoration are severely limited by existing gas pipe and private ownership.

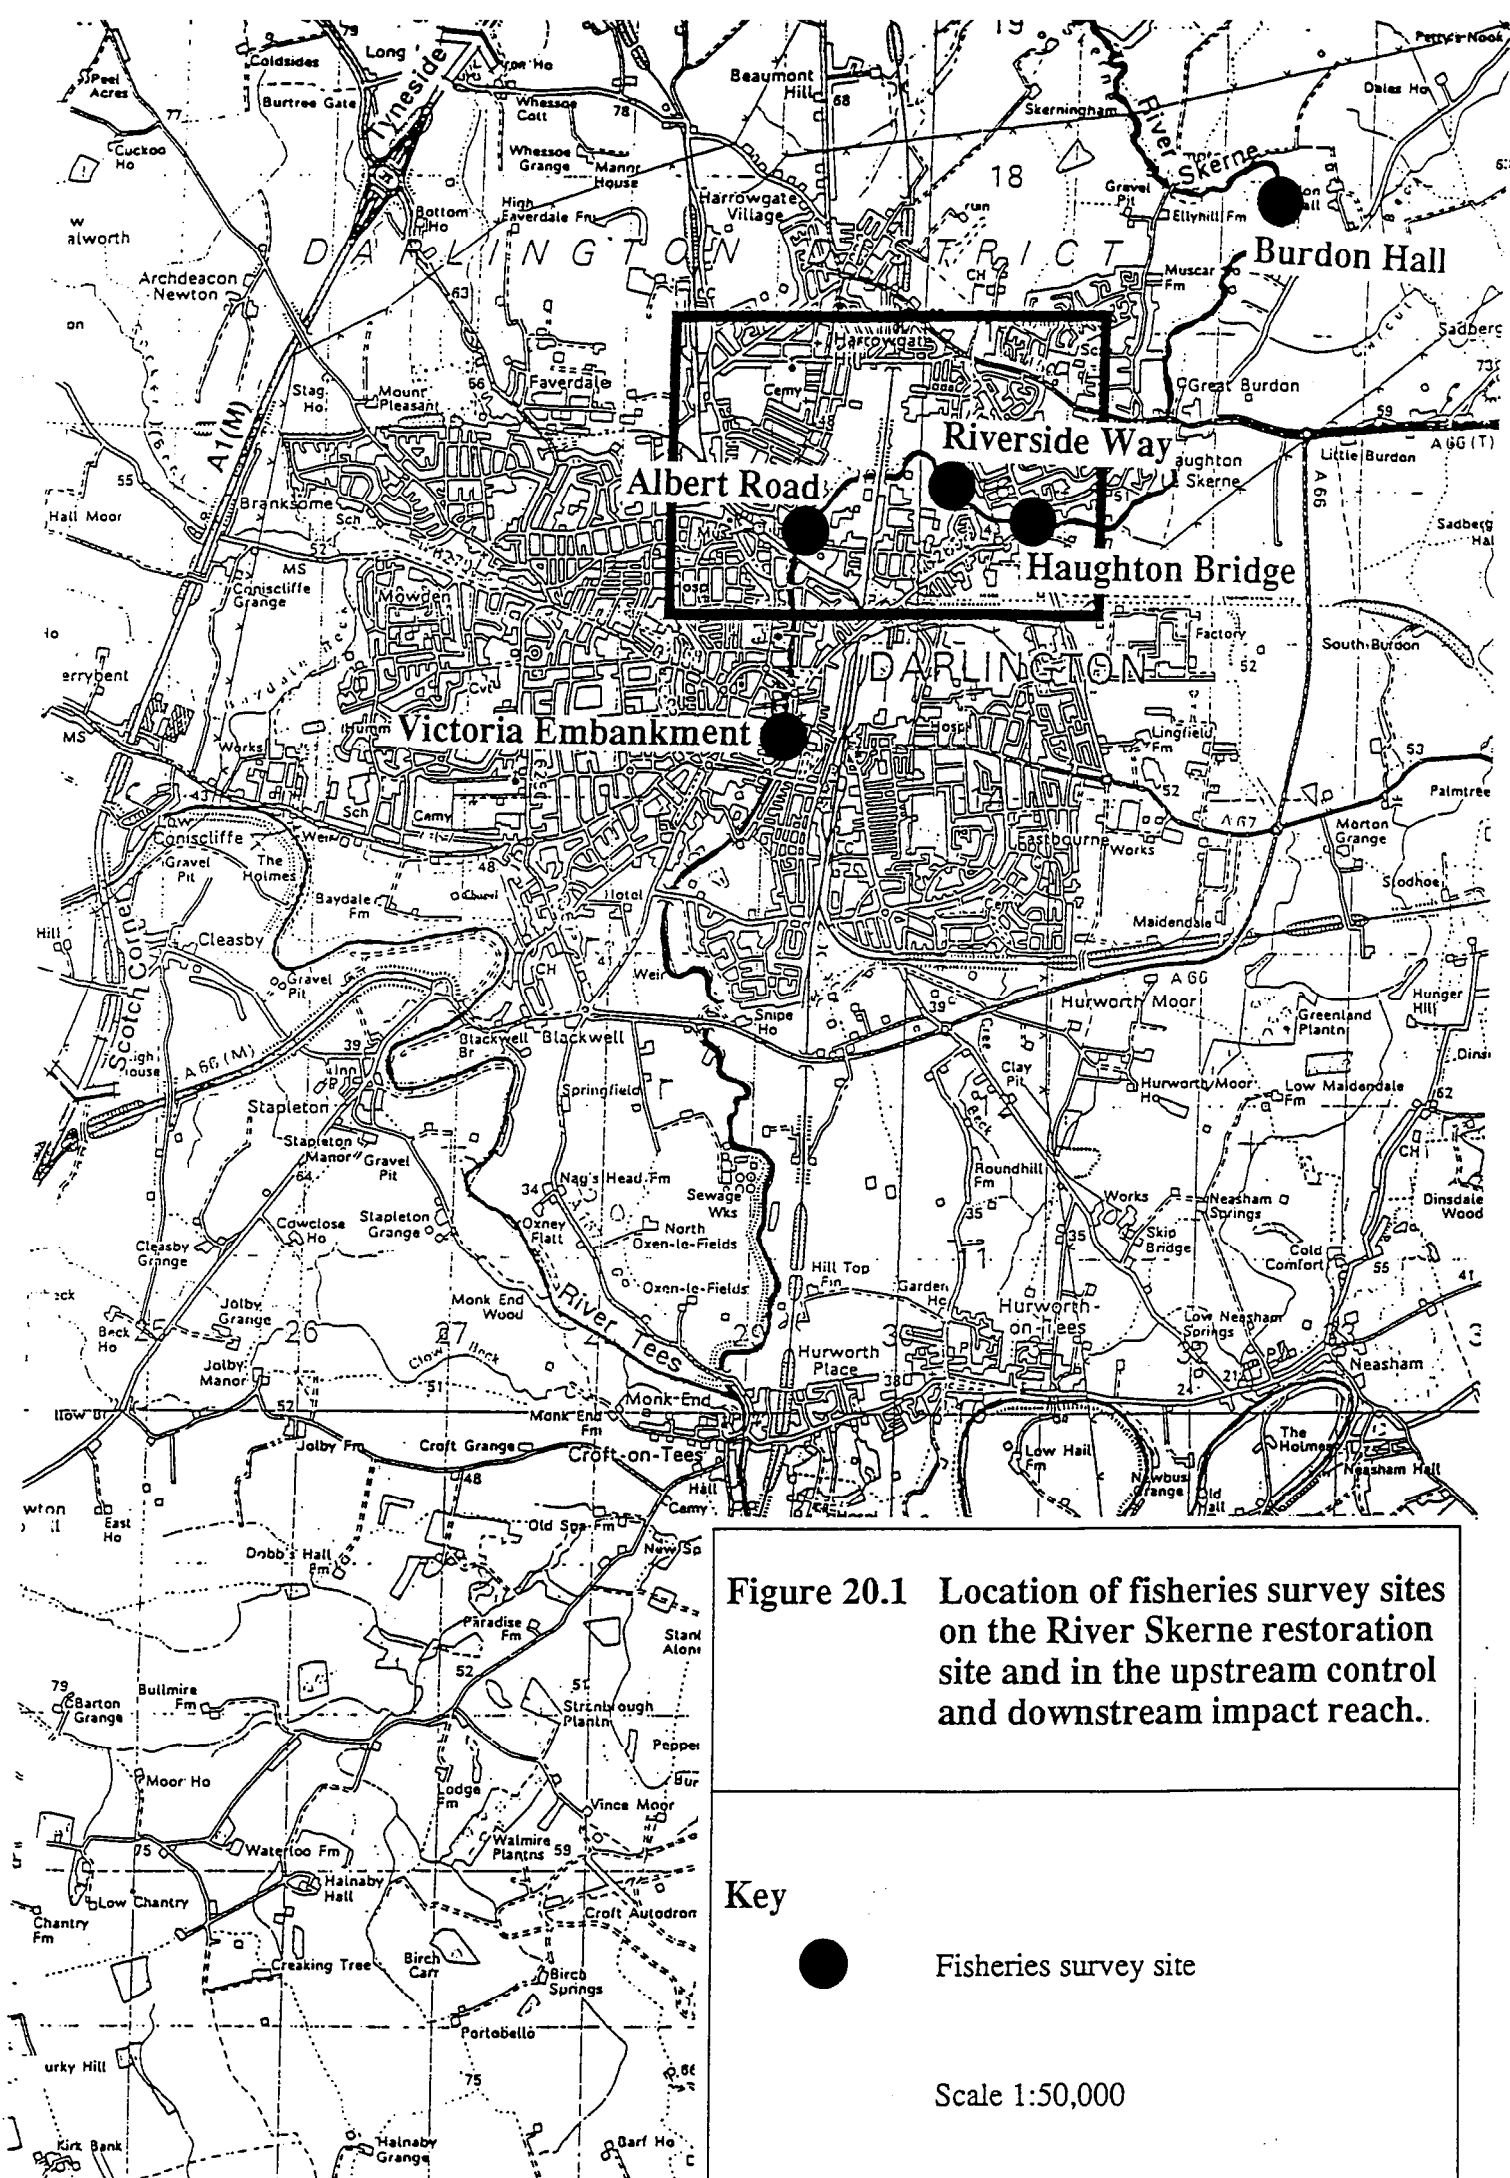
**Figure 20.1** Location of fisheries survey sites on the River Skerne restoration site and in the upstream control and downstream impact reach.
