Revetment Techniques Used on the River Skerne Restoration Project

The River Restoration Centre

R&D Technical Report W83

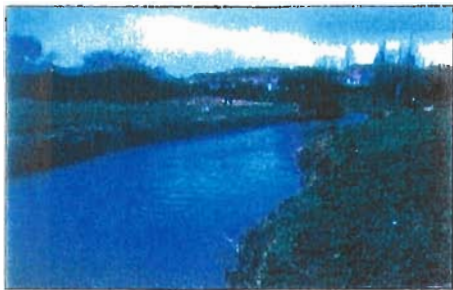
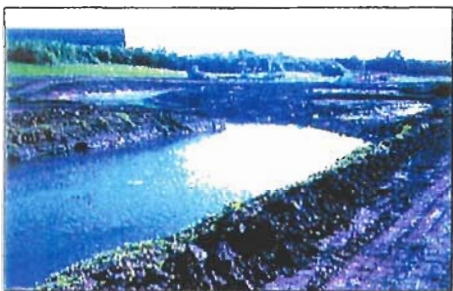
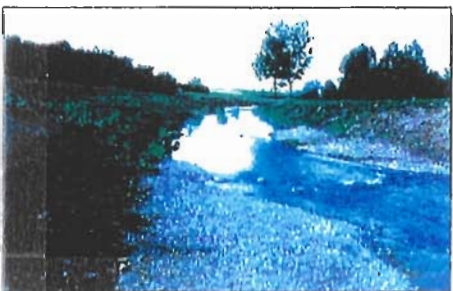
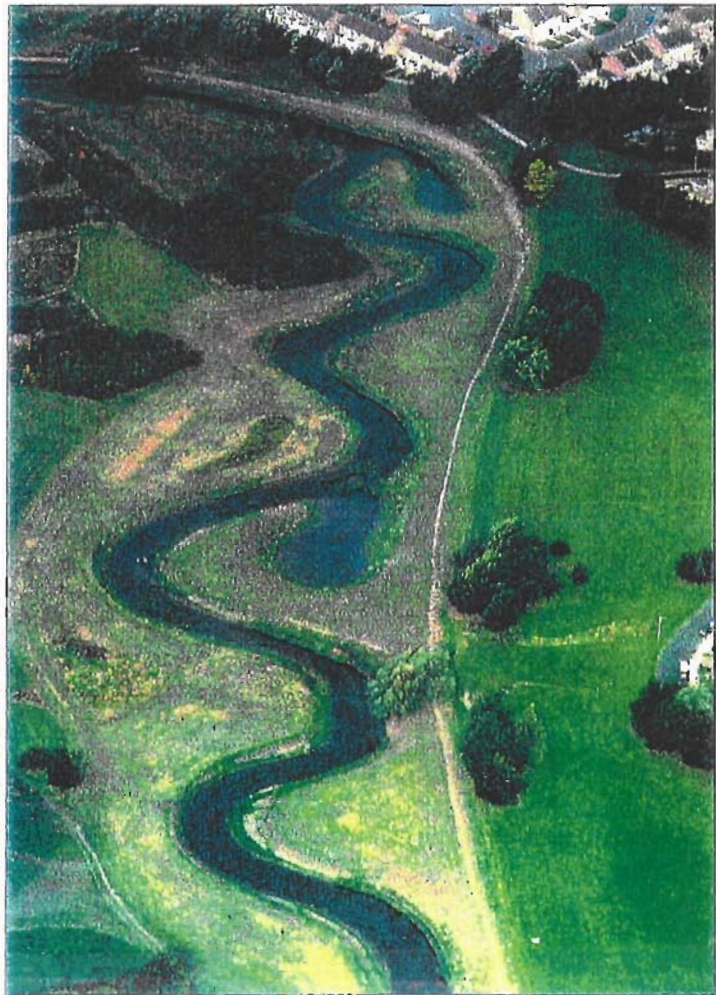
Figure 1.2 Site plan showing scope of works

Before meandering

Meanders being constructed

Riffle with deflectors in background

Aerial view showing meandering completed

The 2.1 km restoration reach is between Houghton Road Bridge NZ30701575 to Skerne Bridge NZ29151555. The river flows through an open amenity grassland over the upper half of the reach and in a 'ravine' of industrial landfill and development downstream. The reach where the revetments are located is shown in Figure 1.2.

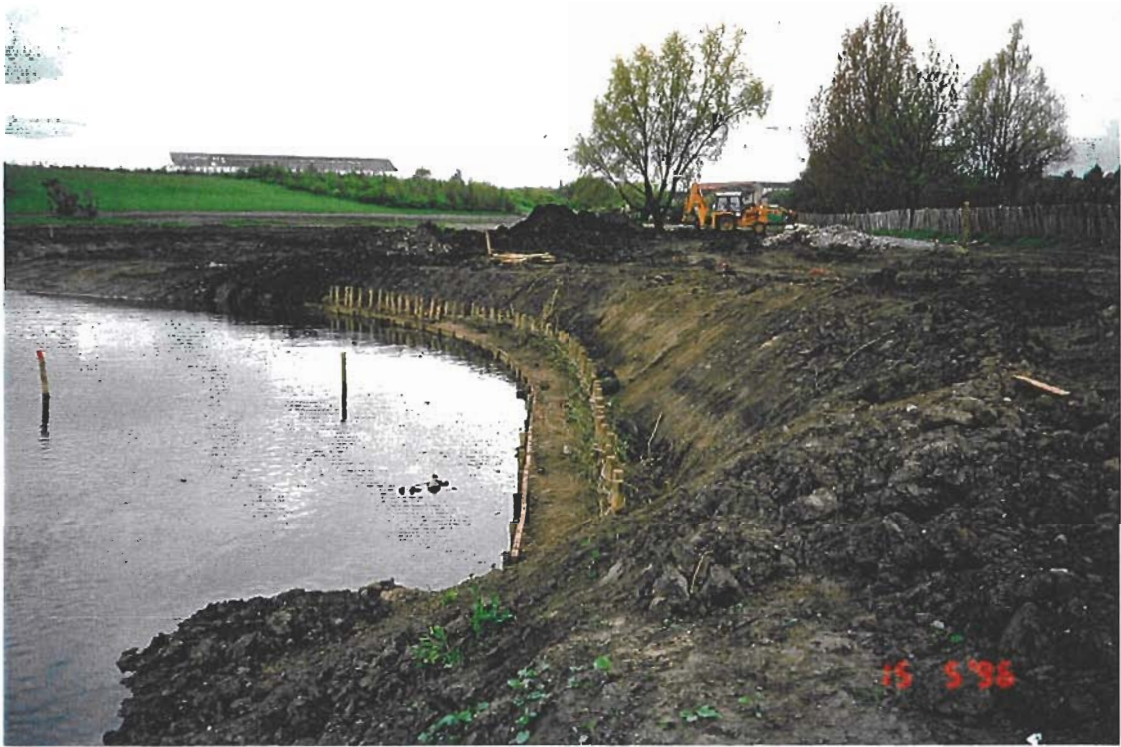
1. Entry spiling - spiling still to complete

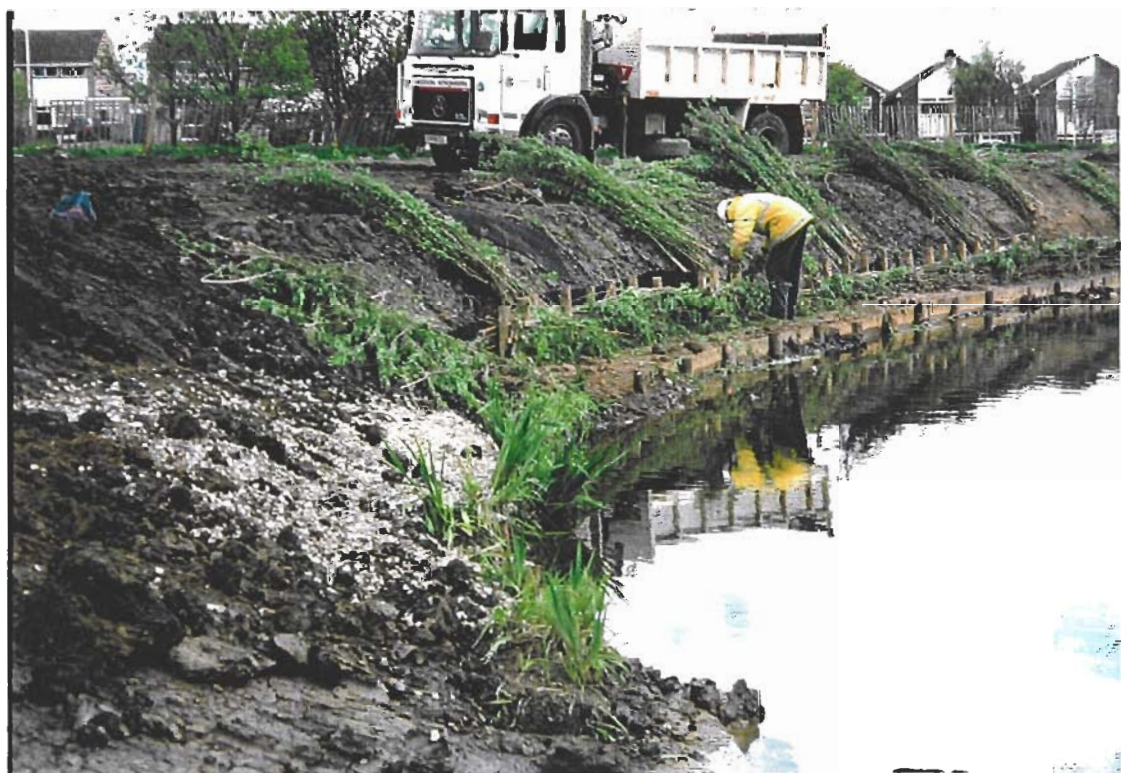
2. Entry spiling - weaving of osier

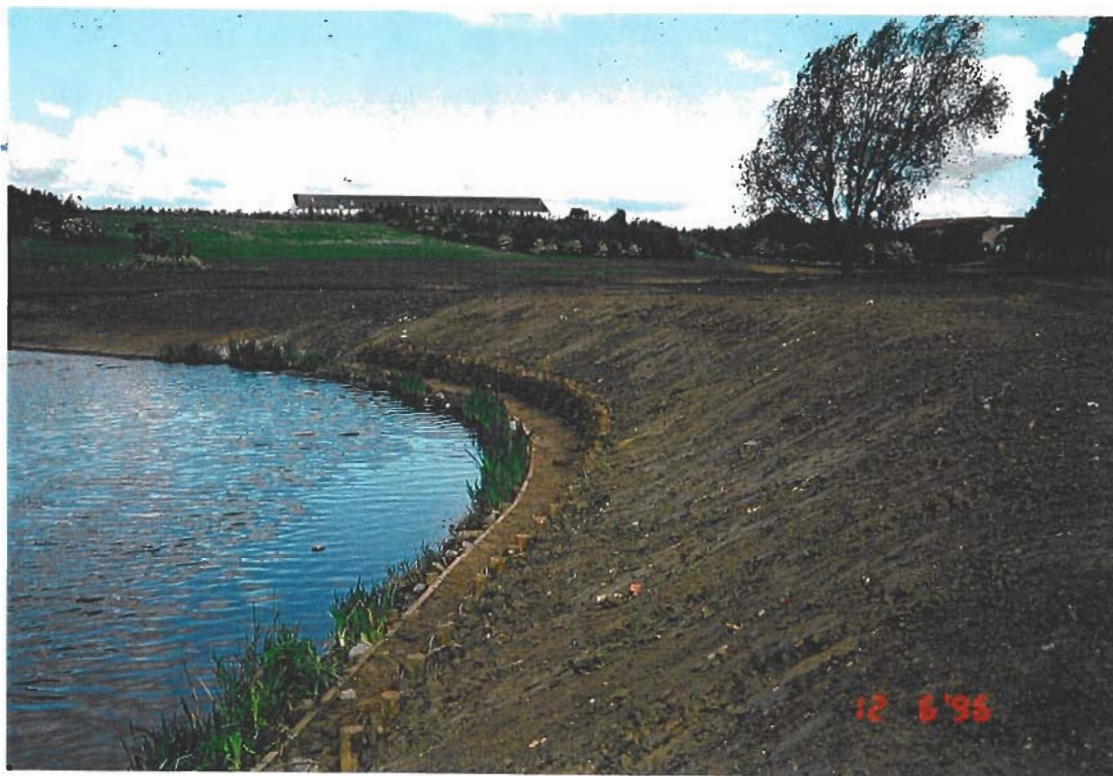
3. Entry spiling complete

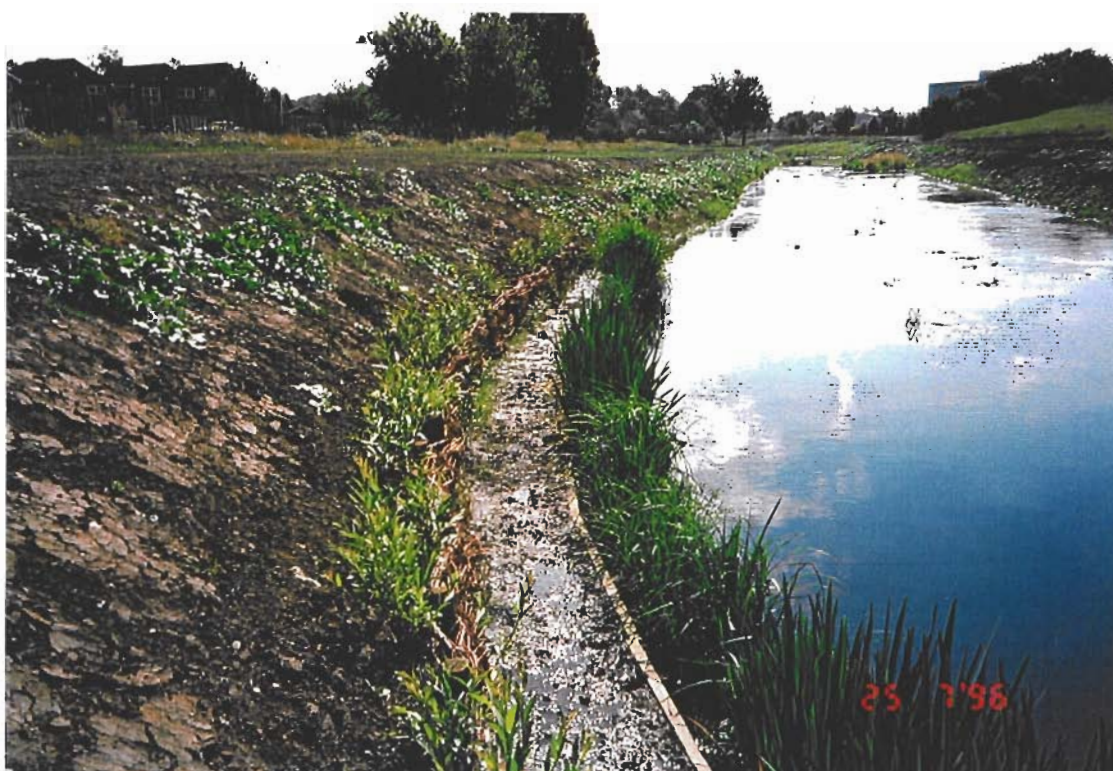
4. Entry spiling two months after installation

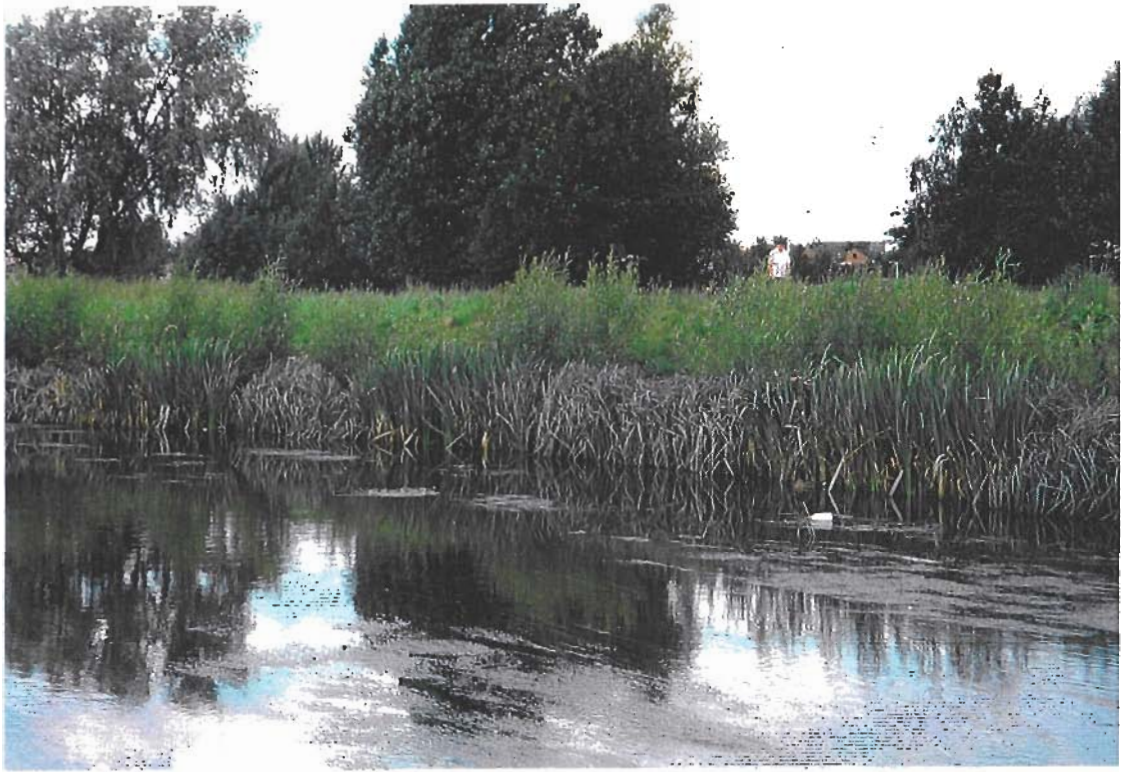
5. Entry spiling after one year

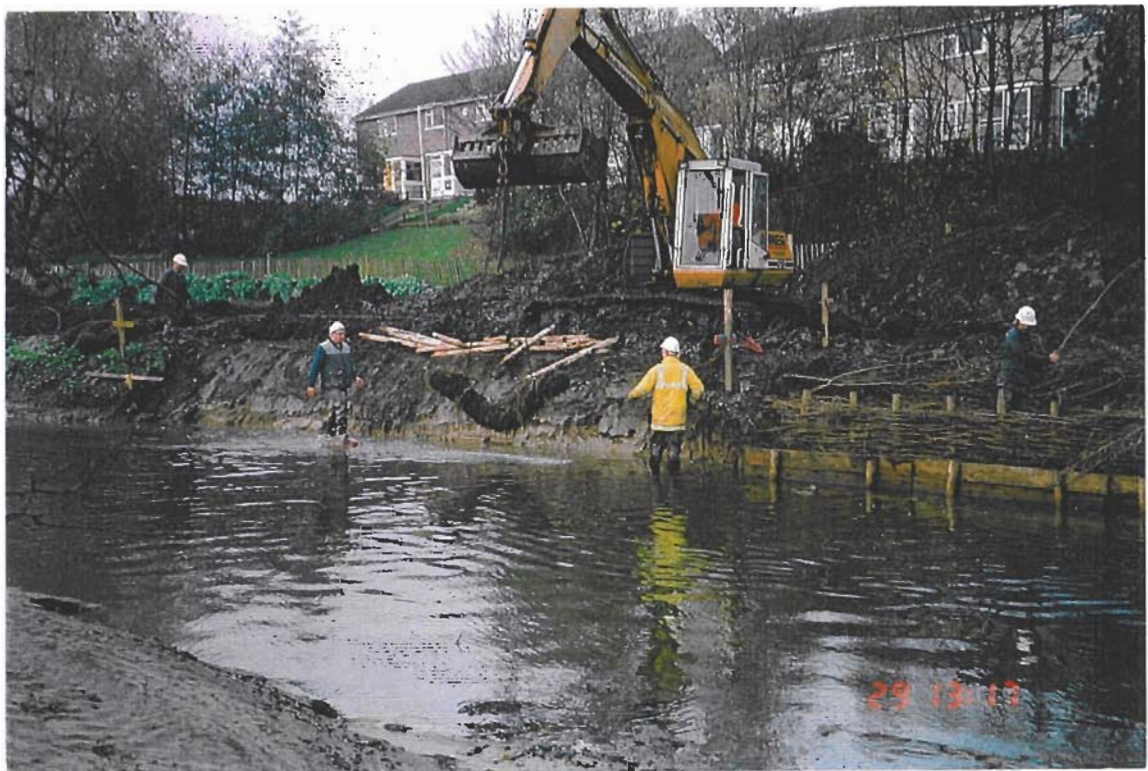
6. Exit spiling - positioning of plant roll

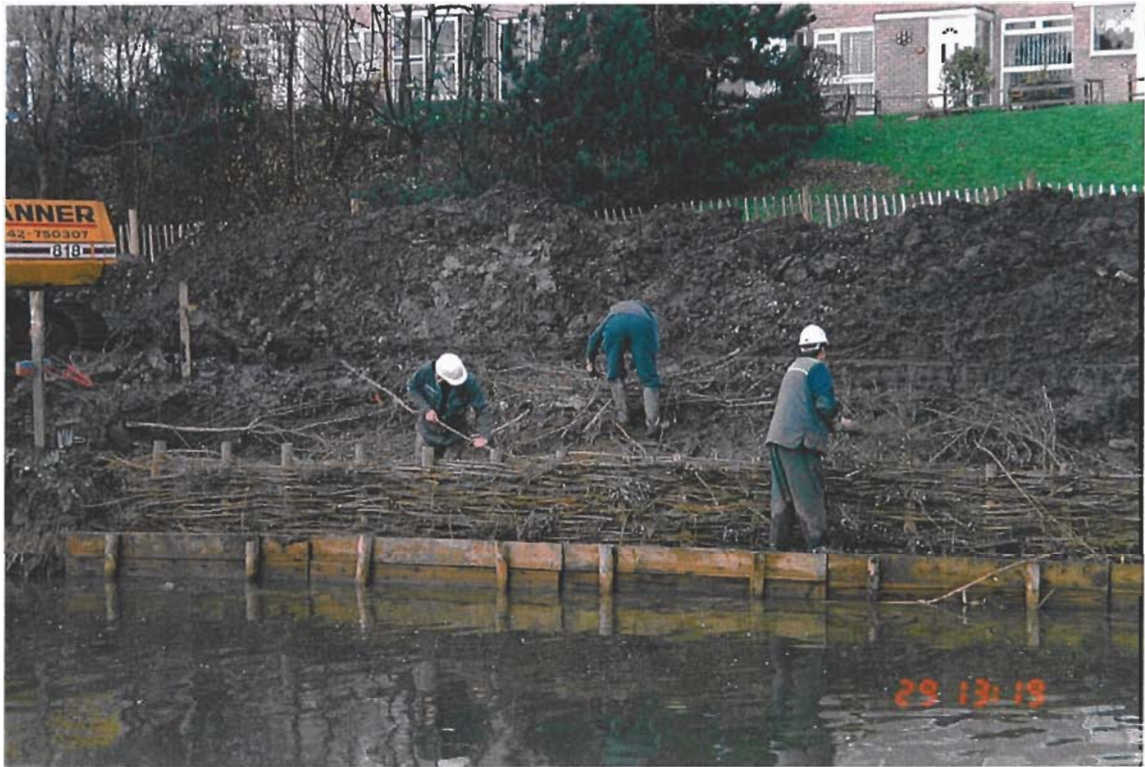
7. Exit spiling - weaving of spiling almost complete

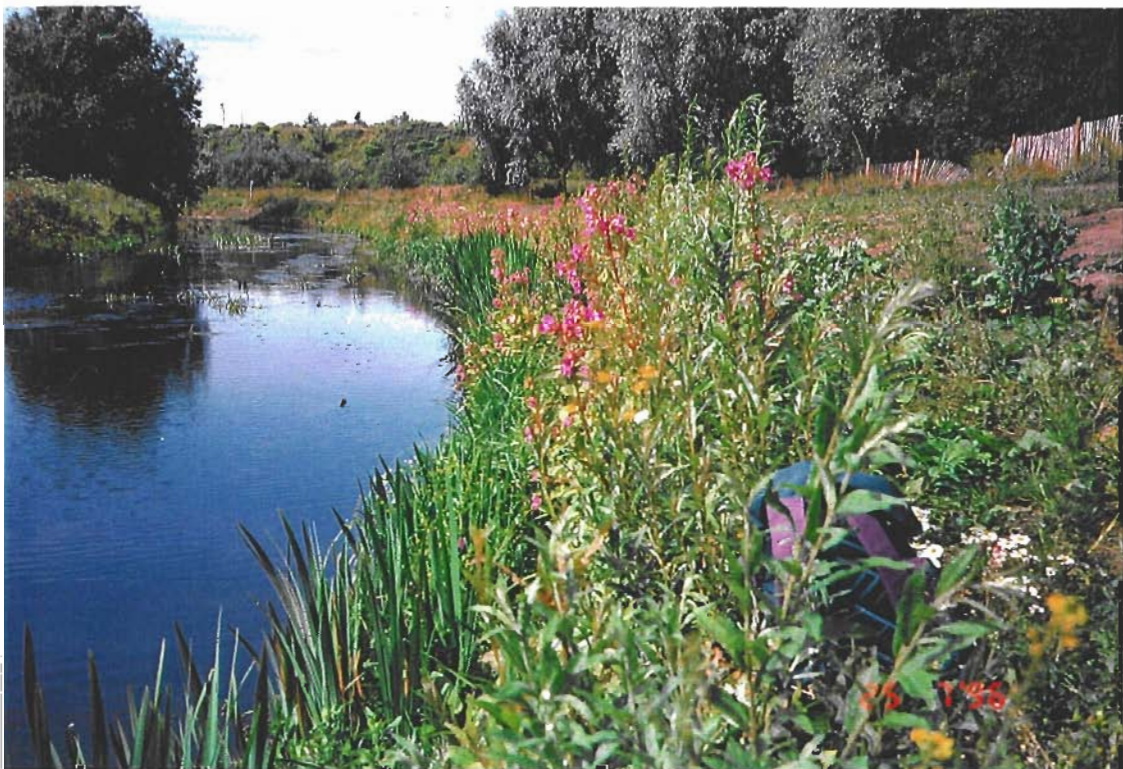
8. Exit spiling eight months after installation

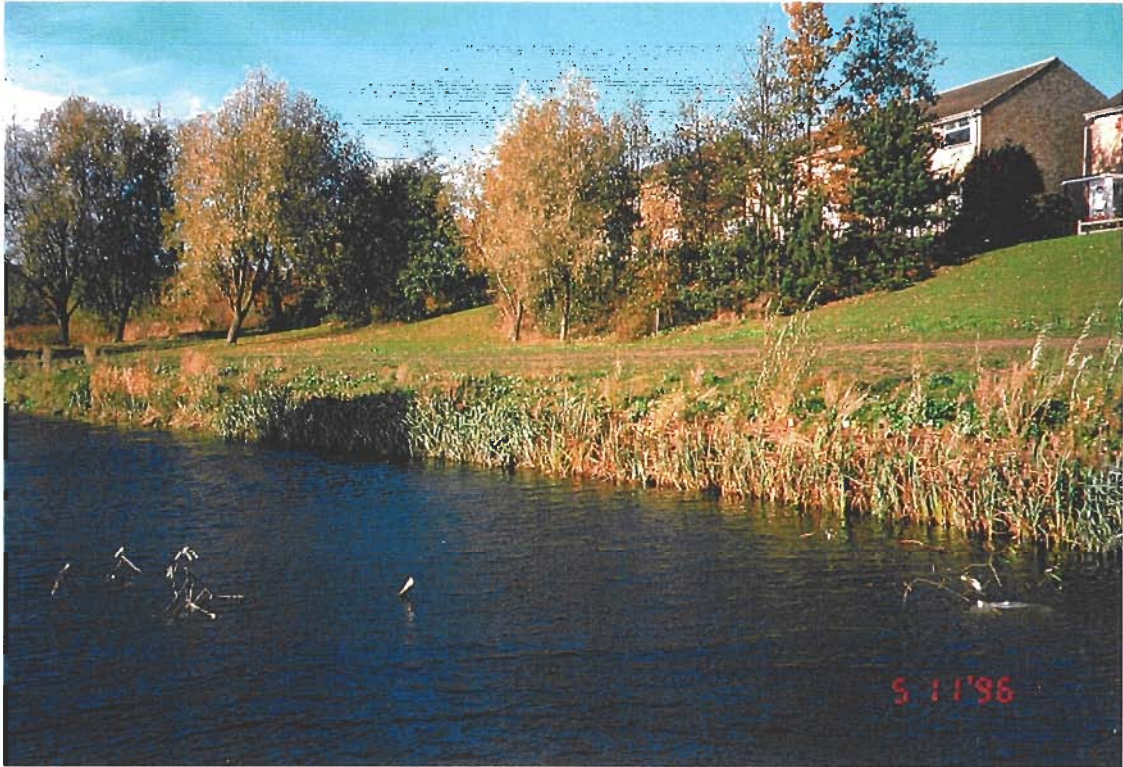
9. Exit after one year - downstream end where few willows have established

As site conditions do not appear to vary along the revetment, the differences in performance could be attributed to the fact that material for the exit revetment was harvested and stored in water for about six weeks before use. It is feasible that much of the material used at the downstream end of the exit was no longer viable at the time of installation. Only freshly harvested material should be used to ensure successful willow growth.

Willows and marginal plants on each revetment have grown vigorously with the exception of one length of spiling. The failure on this length highlights the importance of live willow being utilised while viable. If willow cover with the associated root development is required rapidly,

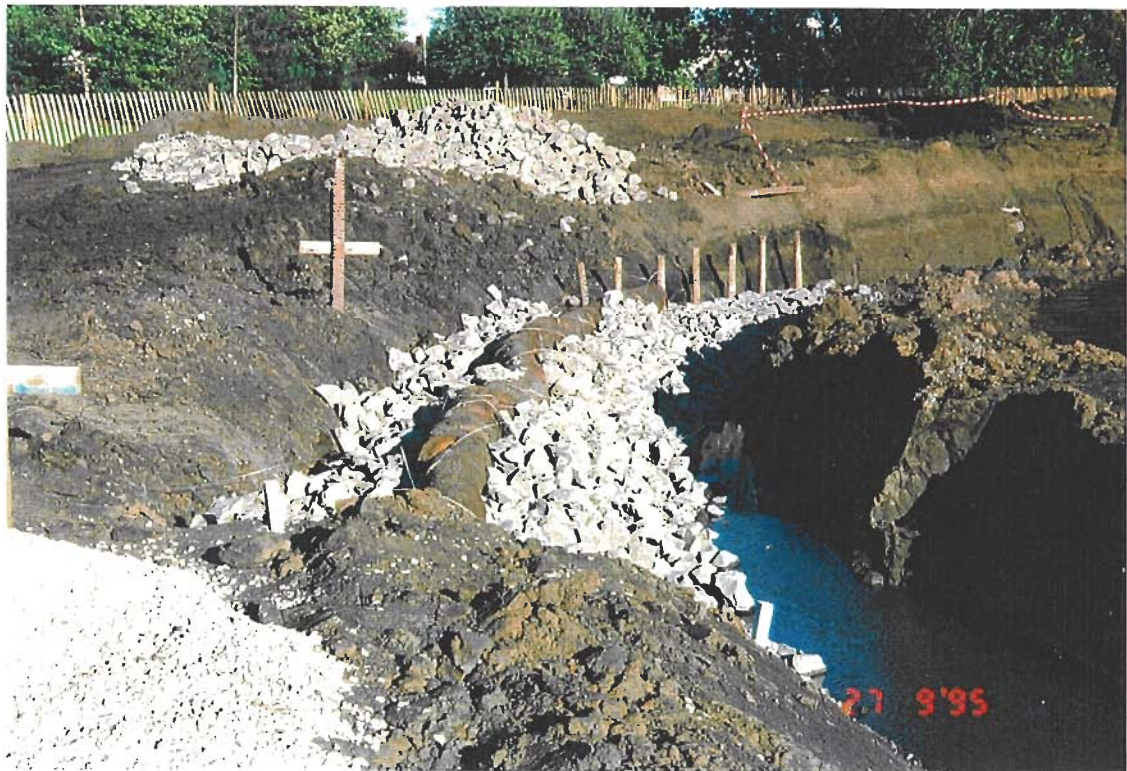
10. Log and geotextile during construction - logs wired over rock

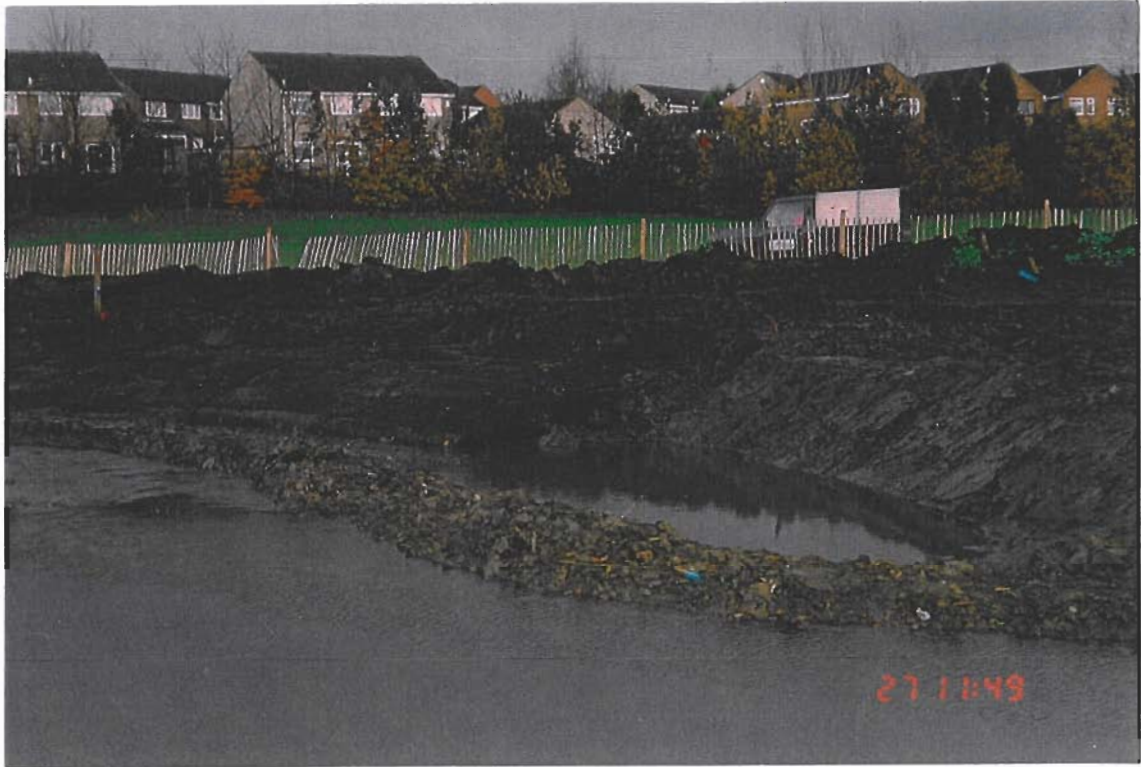
11. Log and geotextile (N3) - geotextile laid behind logs and covered with soil

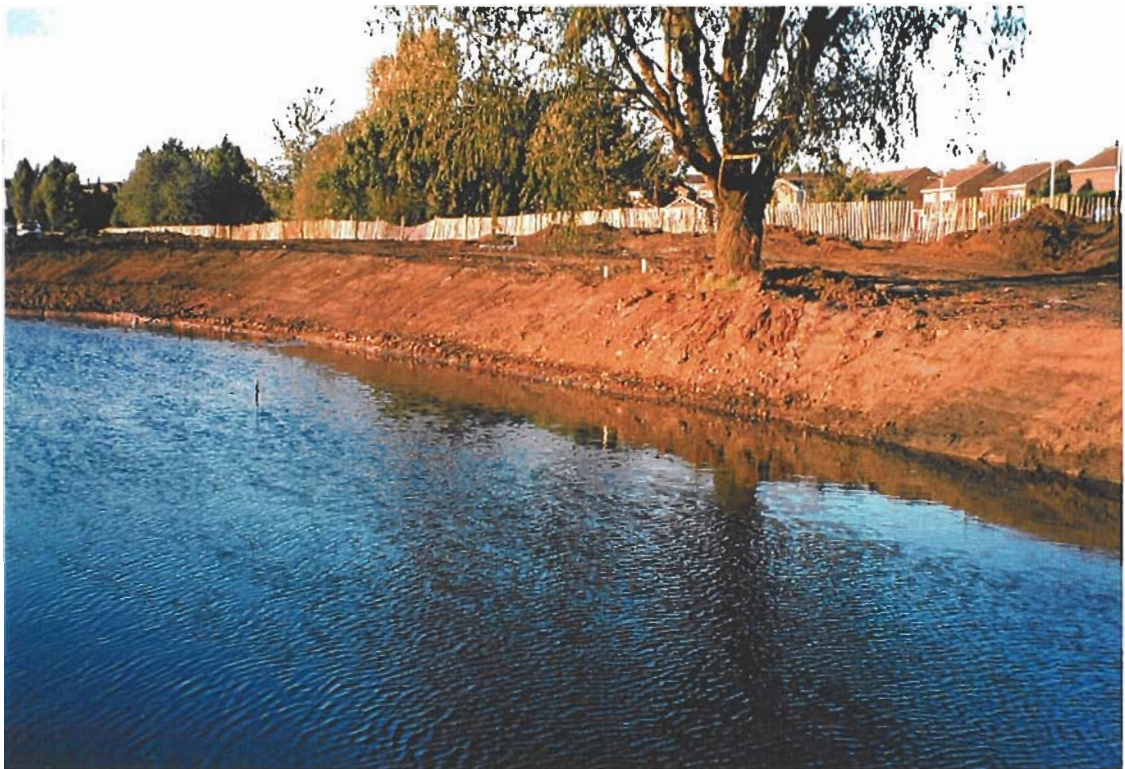
12. Log and geotextile (N1) prior to willow slip planting

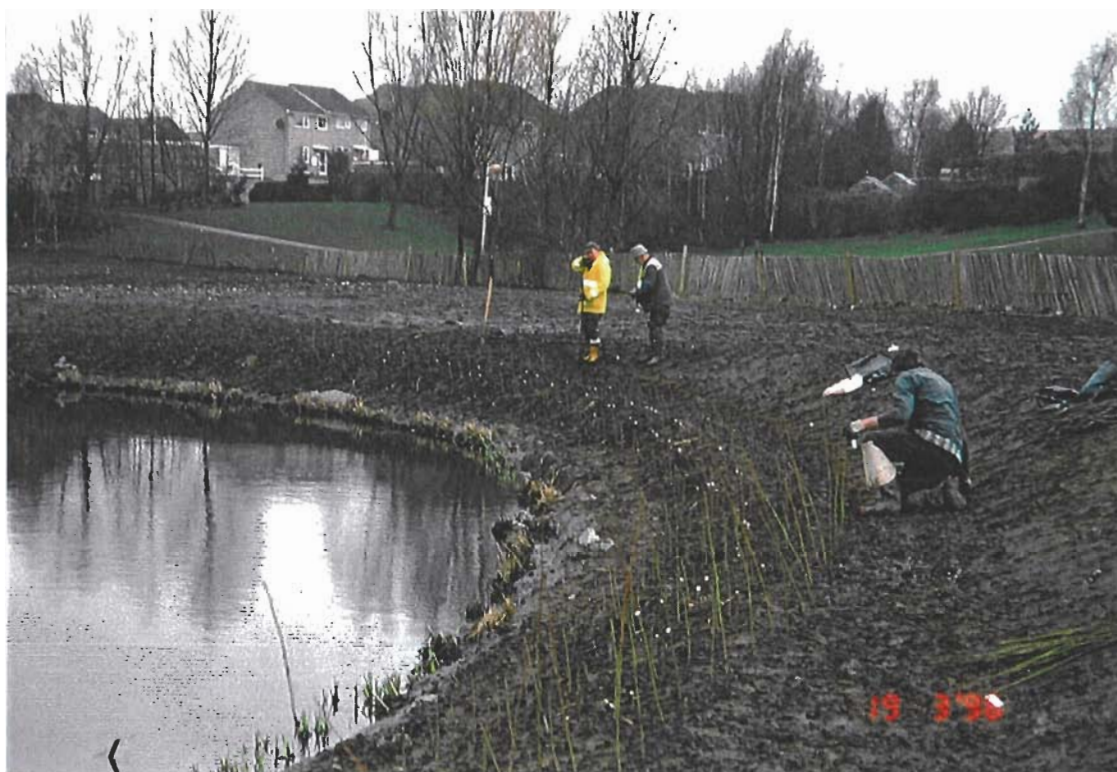
13. Log and geotextile (N3) with willow slips in position

Revetment N3 - The willow slips were planted in March 1996. Rooted goat willow has established in places but the growth rate has been very slow. After the first month some slips were missing particularly at the downstream end. Three months after planting, the rooted goat willow had grown 300 to 600 mm. By the end of the season there was little if any change in growth and the survival rate was only around 10%.

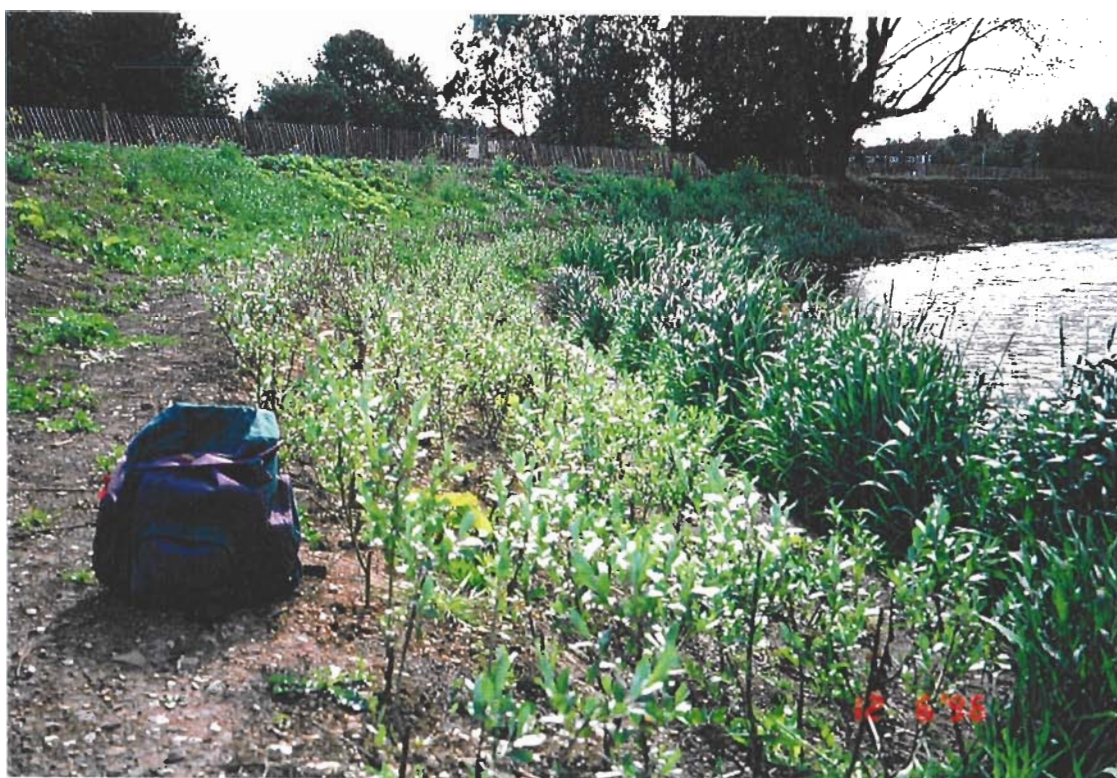
14. Log and geotextile (N1) four months after willows planted

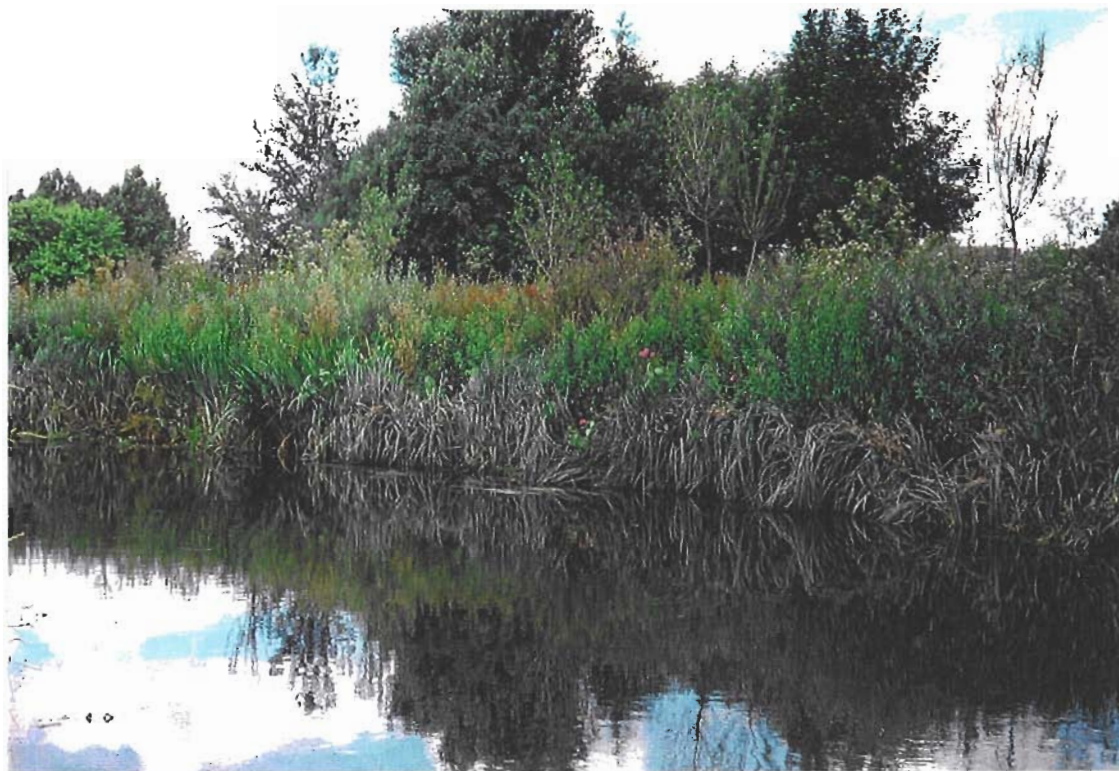
15. Log and geotextile(N1) after one year

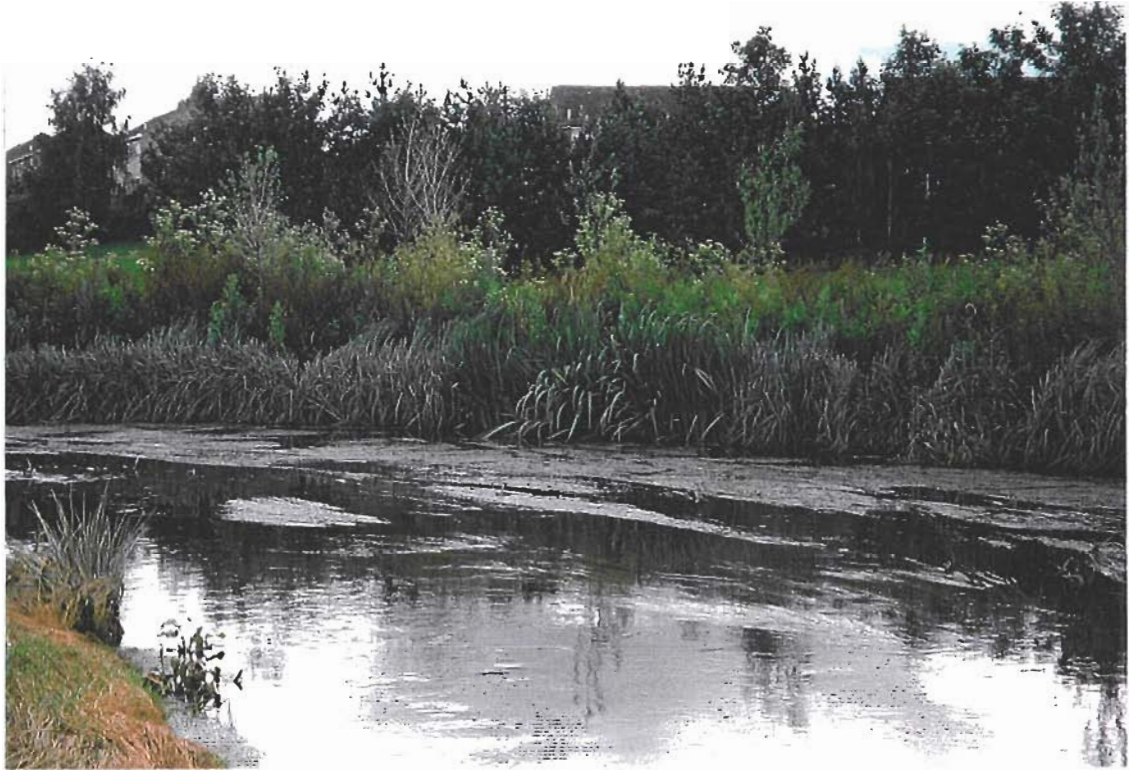
17. Log and geotextile(N3) after one year

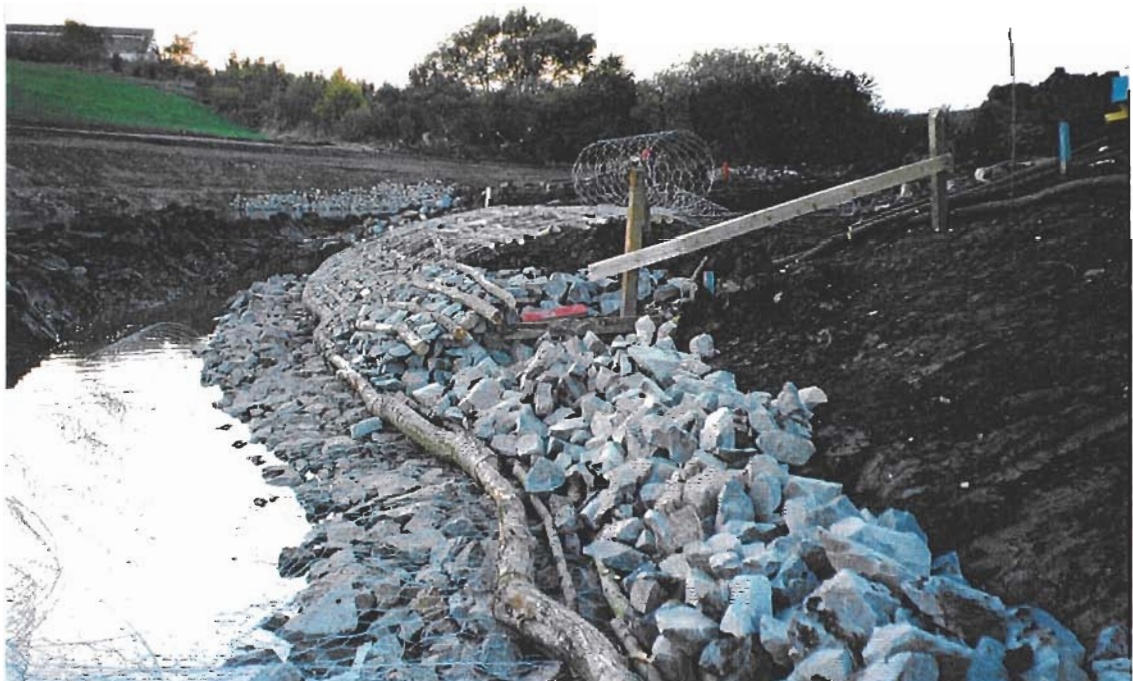
18. Willow mattress - one section under construction

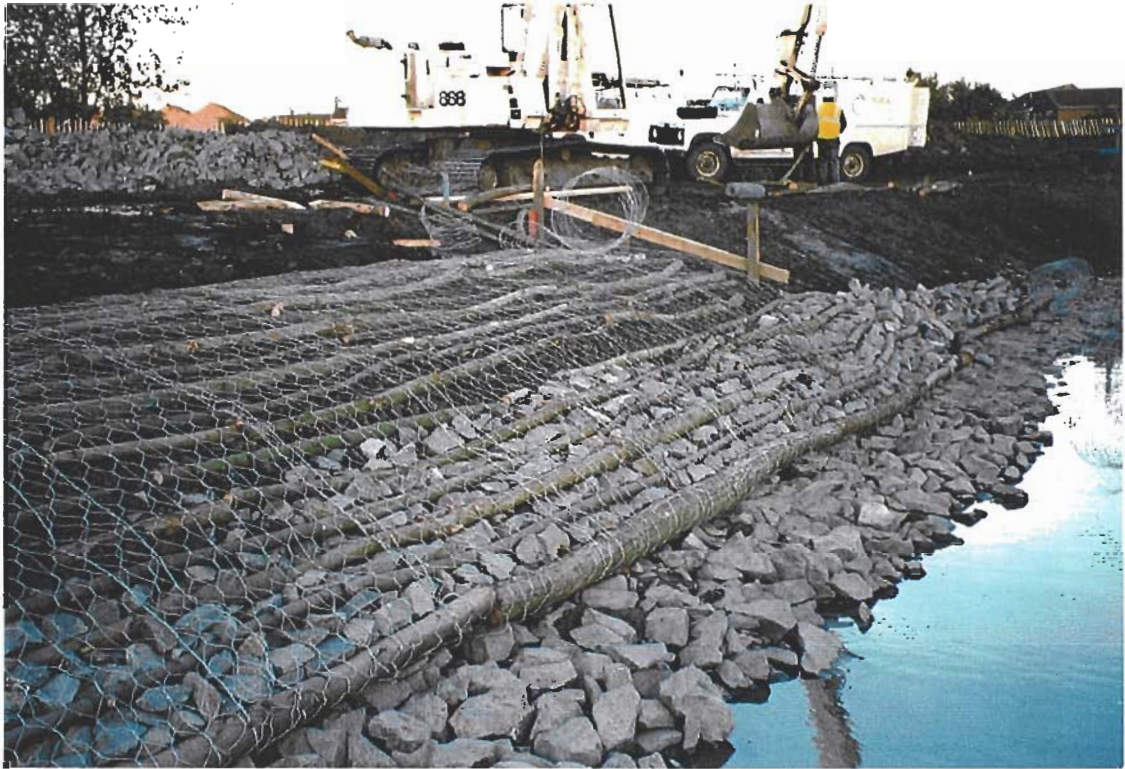
19. Willow mattress in progress

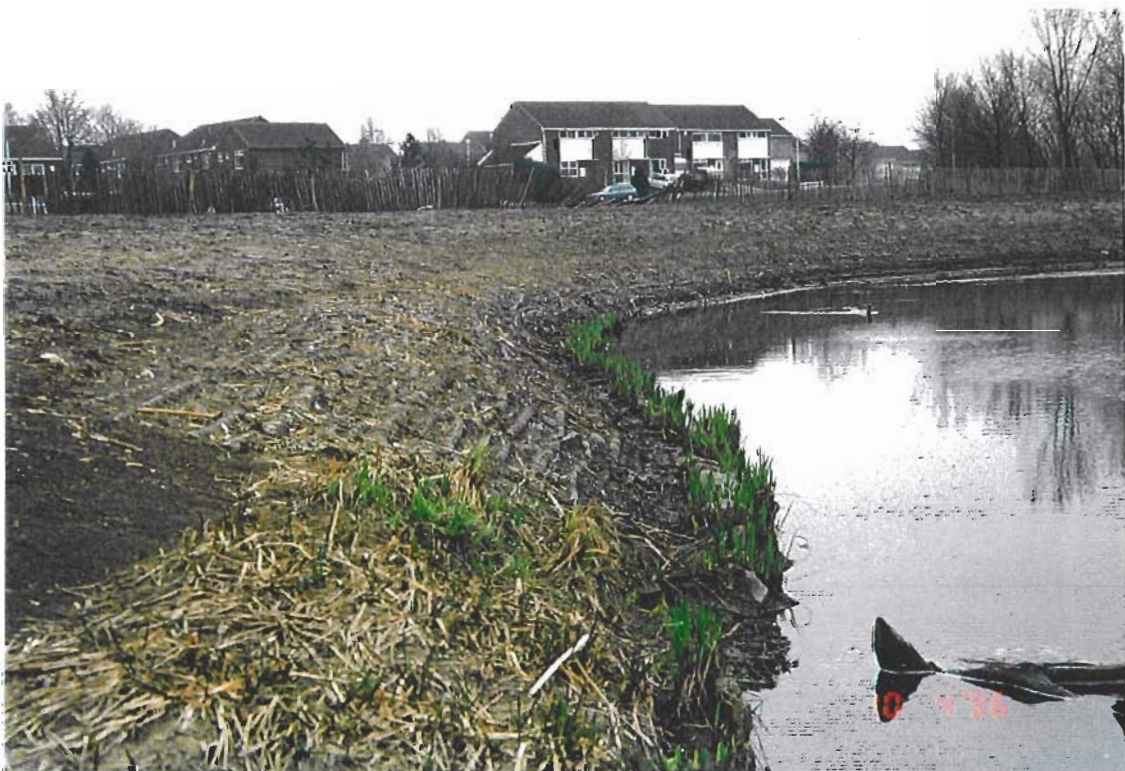
20. Willow mattress after the first winter

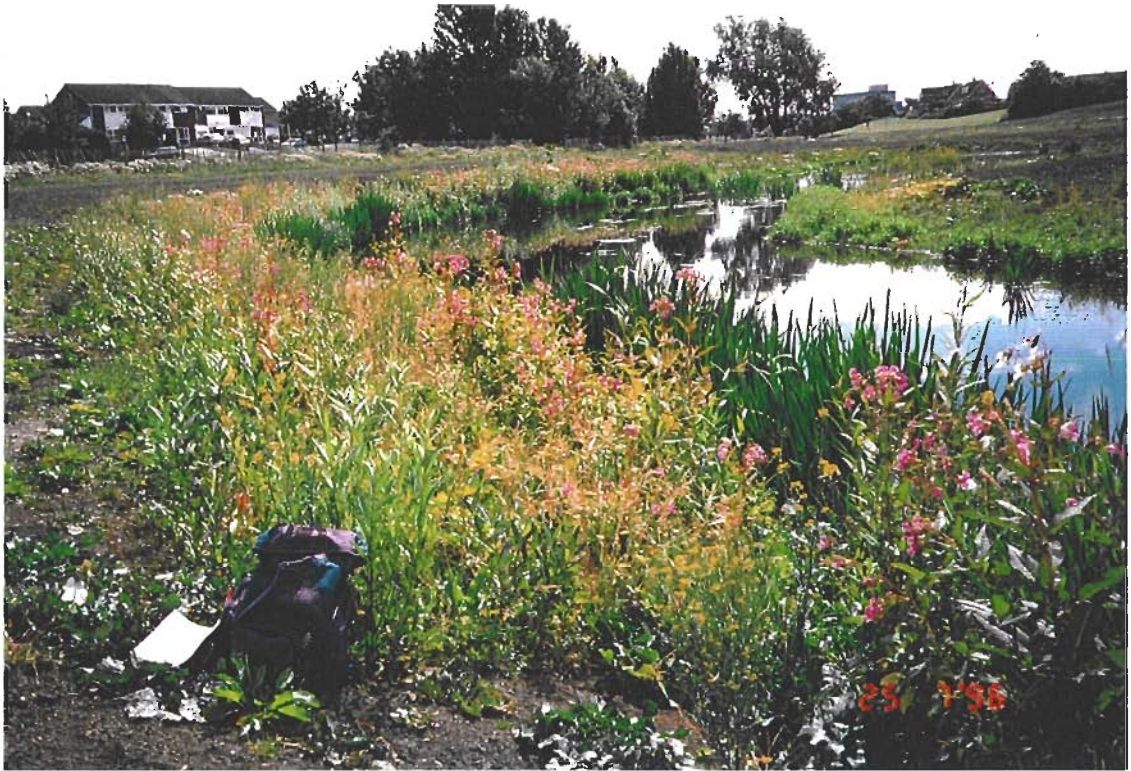
21. Willow mattress eight months after installation

Early in the first season, sprouting was most even at the downstream end; later the best growth was at the upstream end. This revetment was made using crack and white willow. The differences in uptake and growth rate may be accredited to this. By the end of the second season, the length with crack willow had grown 1500 to 2000 mm whereas the white willow reached 2500 to 3000 mm. The most vigorous growth was at the water's edge.

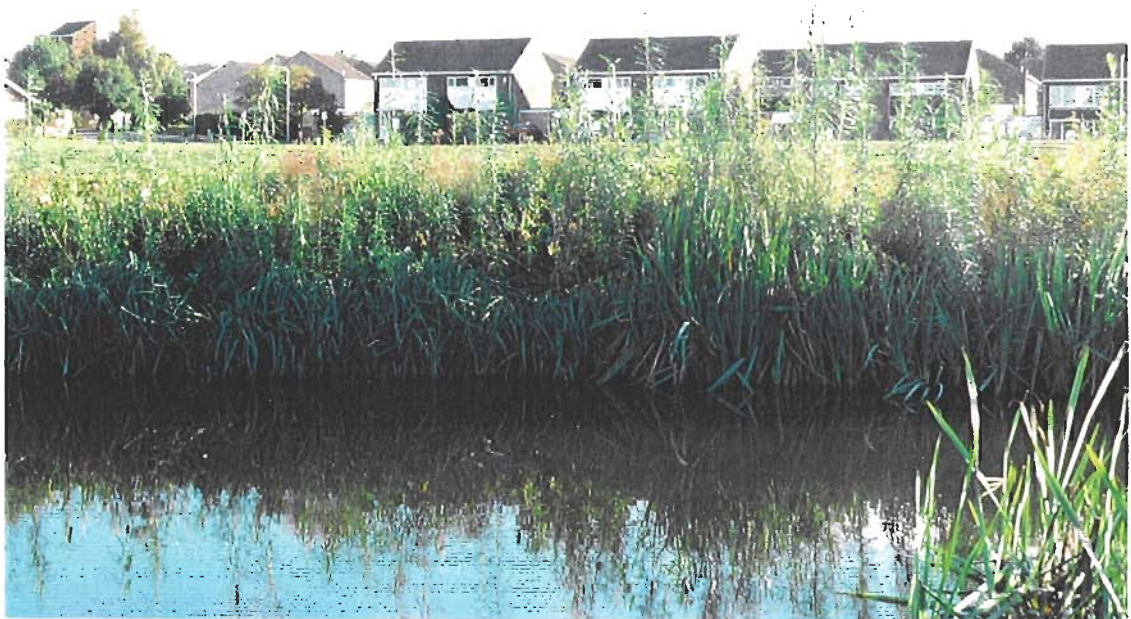
22. Willow mattress during the first summer

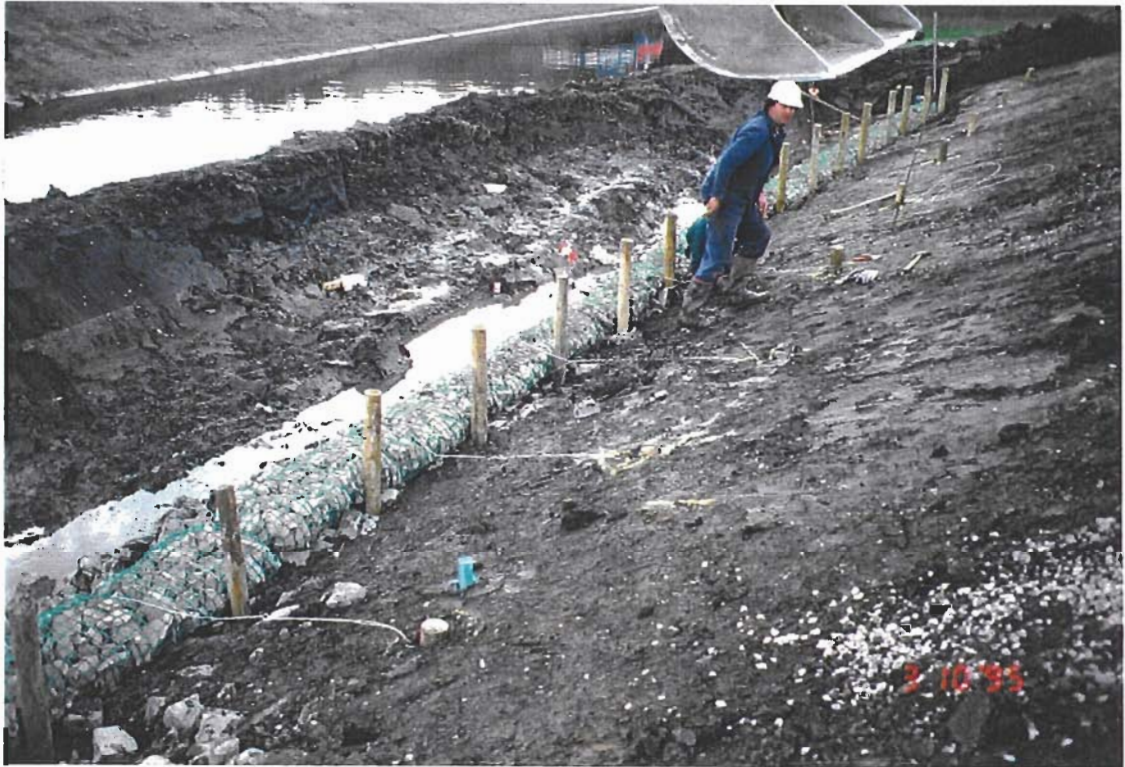
23. Transition rock rolls wired to posts

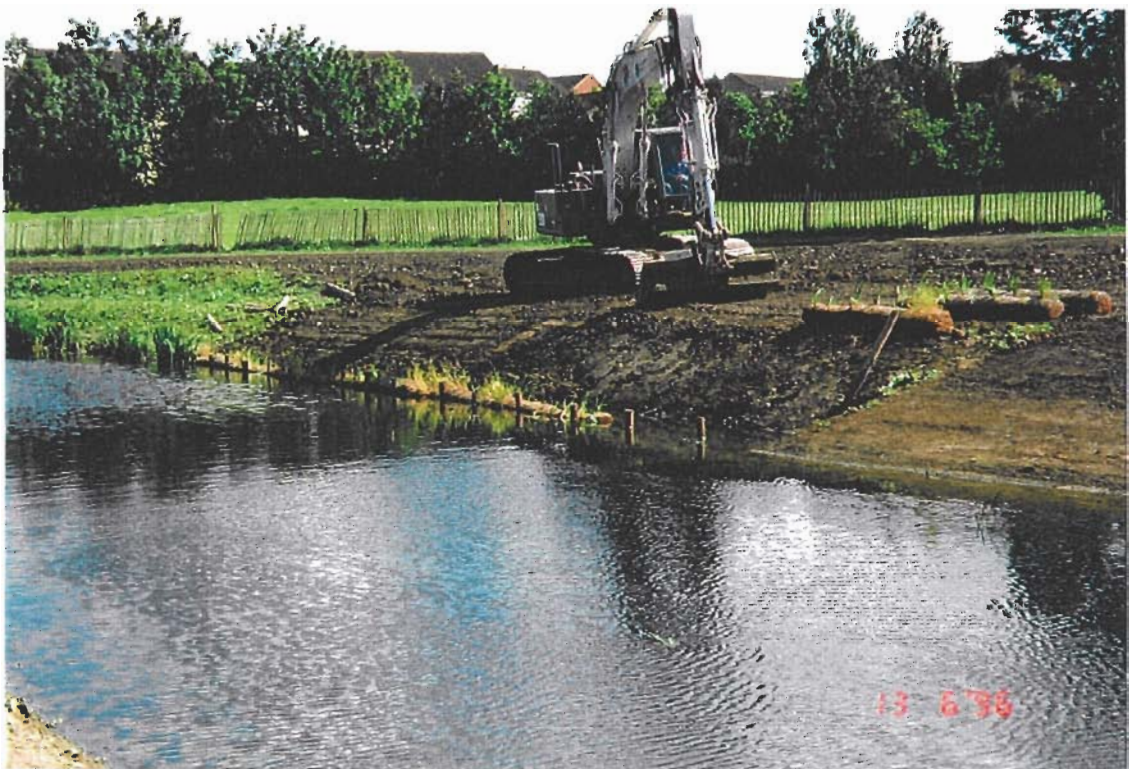
24. Transition plant rolls positioned behind submerged rock rolls
