**RIVER RESTORATION:
BENEFITS FOR INTEGRATED CATCHMENT
MANAGEMENT**

**RIVER SKERNE DARLINGTON
LANDSCAPE ASSESSMENT**

SGS Environment

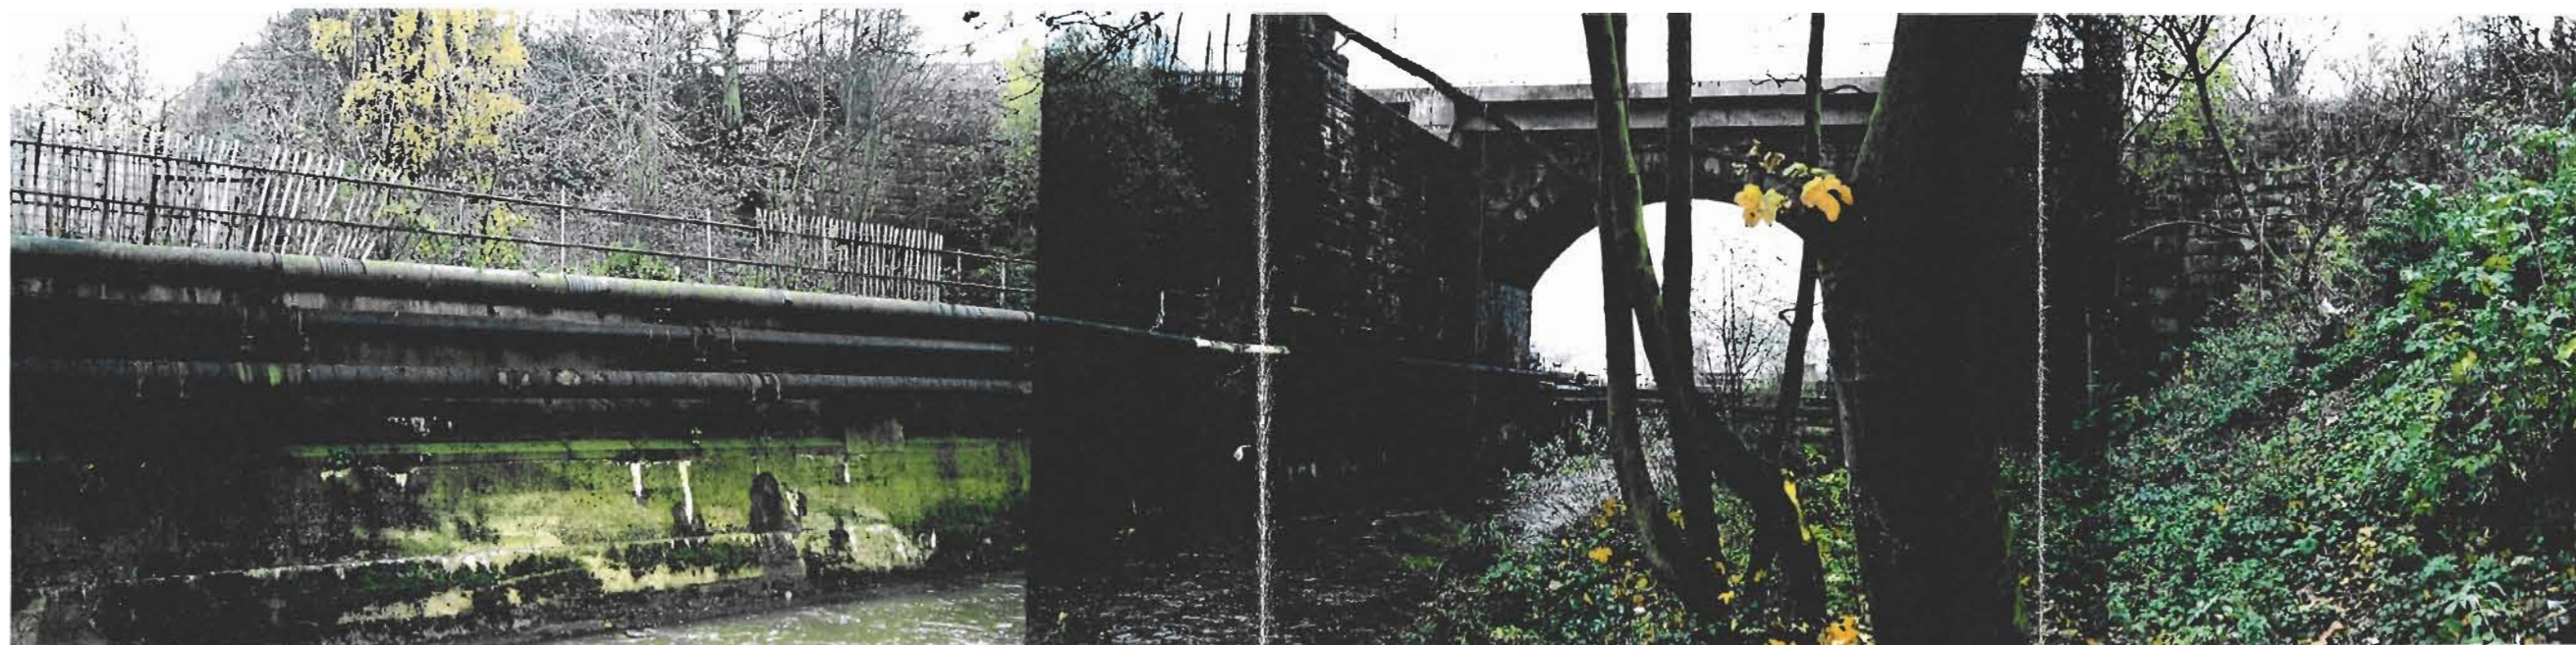
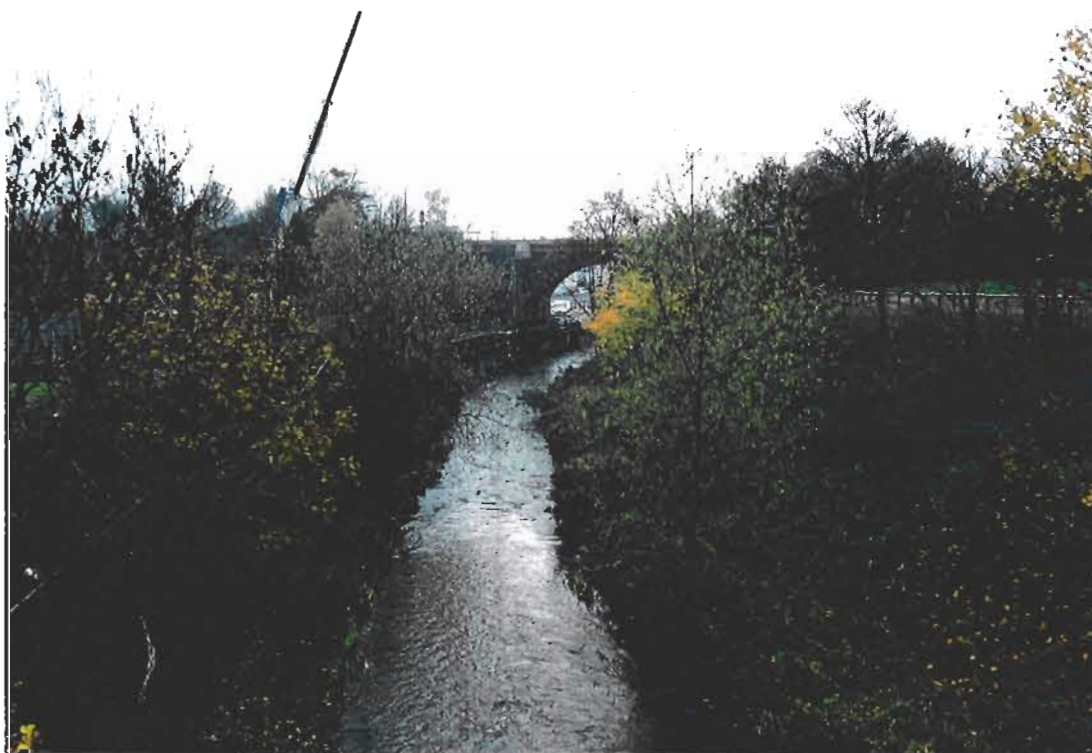
Fig. 18 - Photographs - Section 1

The area has a degraded industrial, urban enclosed character on the left bank with semi-natural vegetation enclosing the reclaimed right bank.

The existing vegetation is the only positive element within the degraded area. Opportunities for channel restoration are restricted by the existing retaining wall and topography to the creation of riffles and pools. Selective macrophyte control, planting and the creation of nesting platforms were suggested in the River Corridor Survey Report.

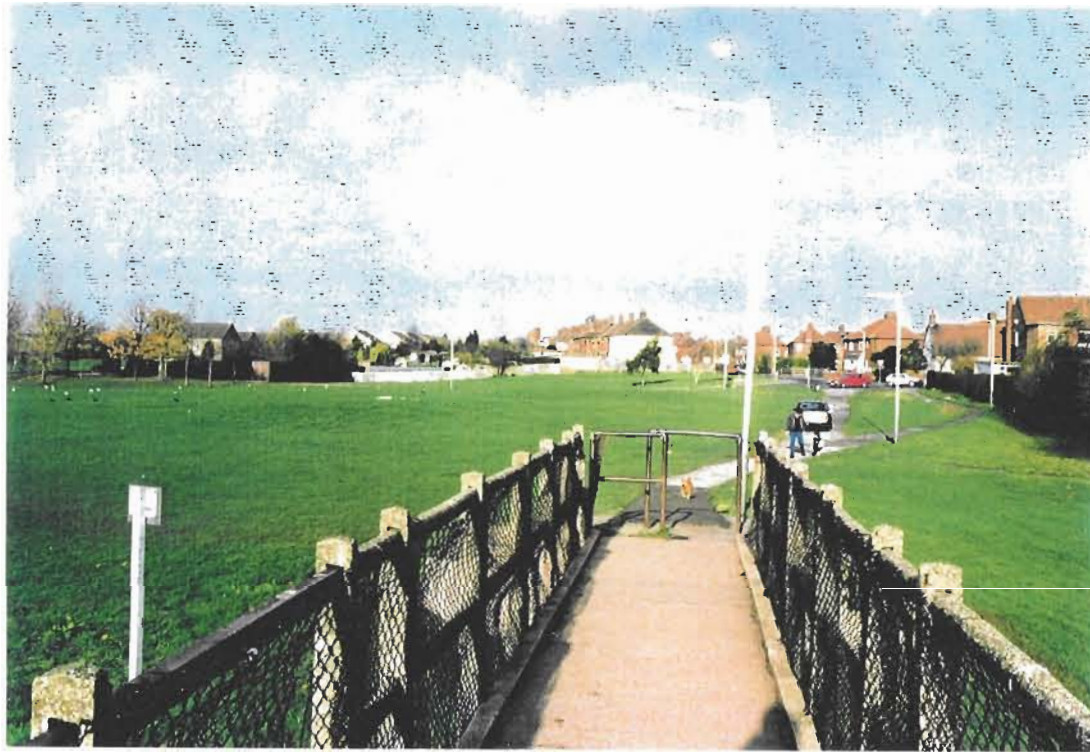
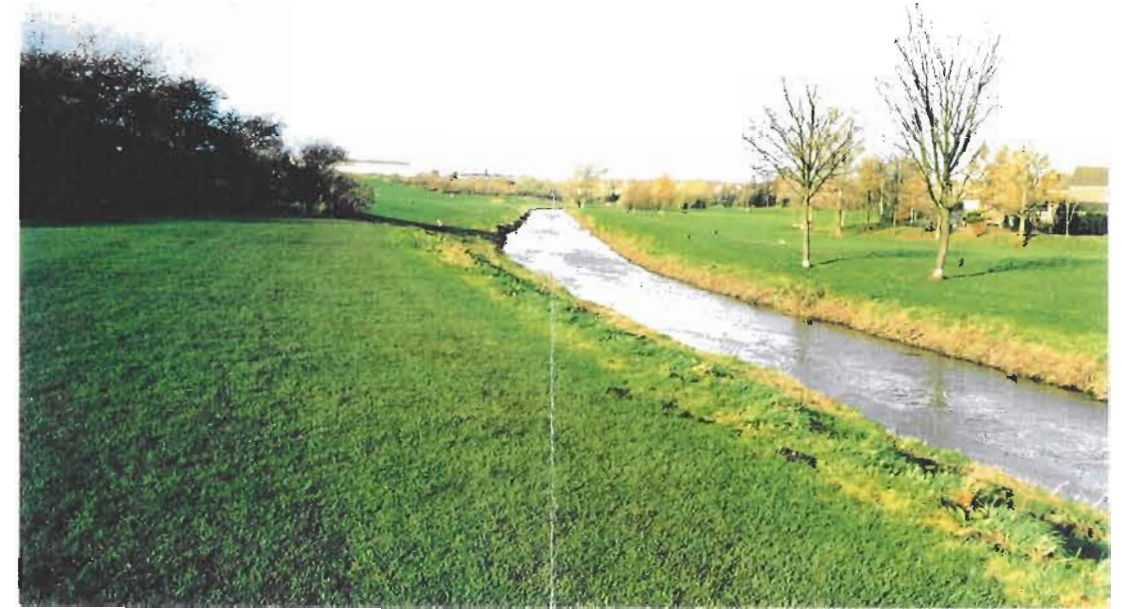
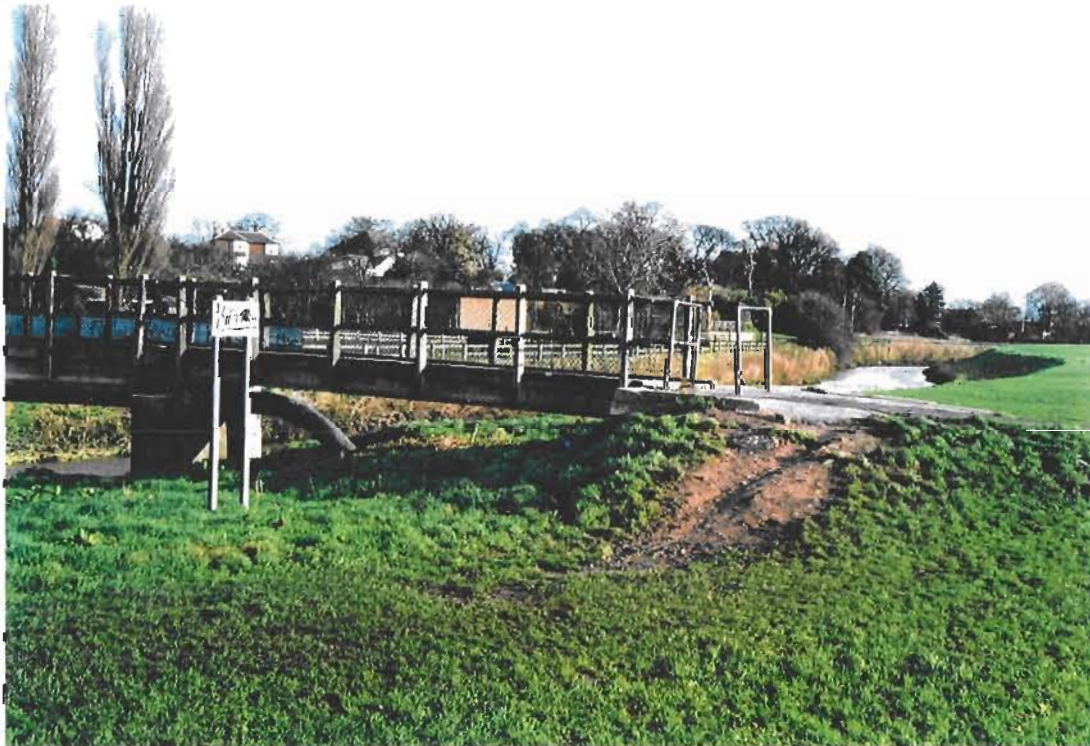
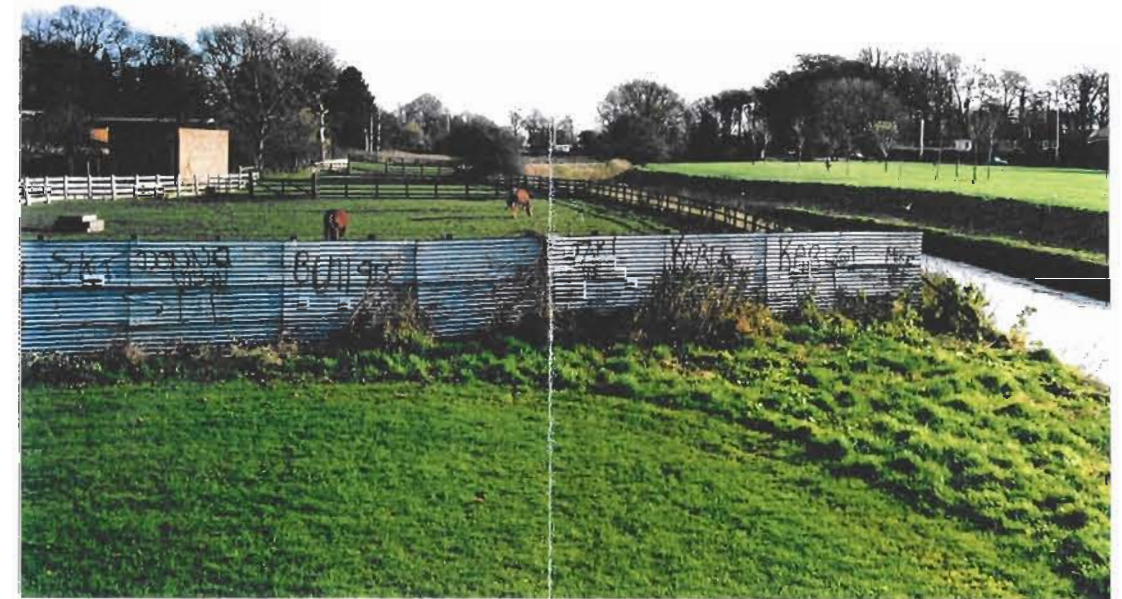
Fig. 26 - Photographs - Section 6

The character is one of degraded suburban parkland.
