RESTORING MEANDERS TO STRAIGHTENED RIVERS

I.7 Reconnecting remnant meanders

RIVER LITTLE OUSE

LOCATION - Thetford, Norfolk TL 870812 – TL 874816

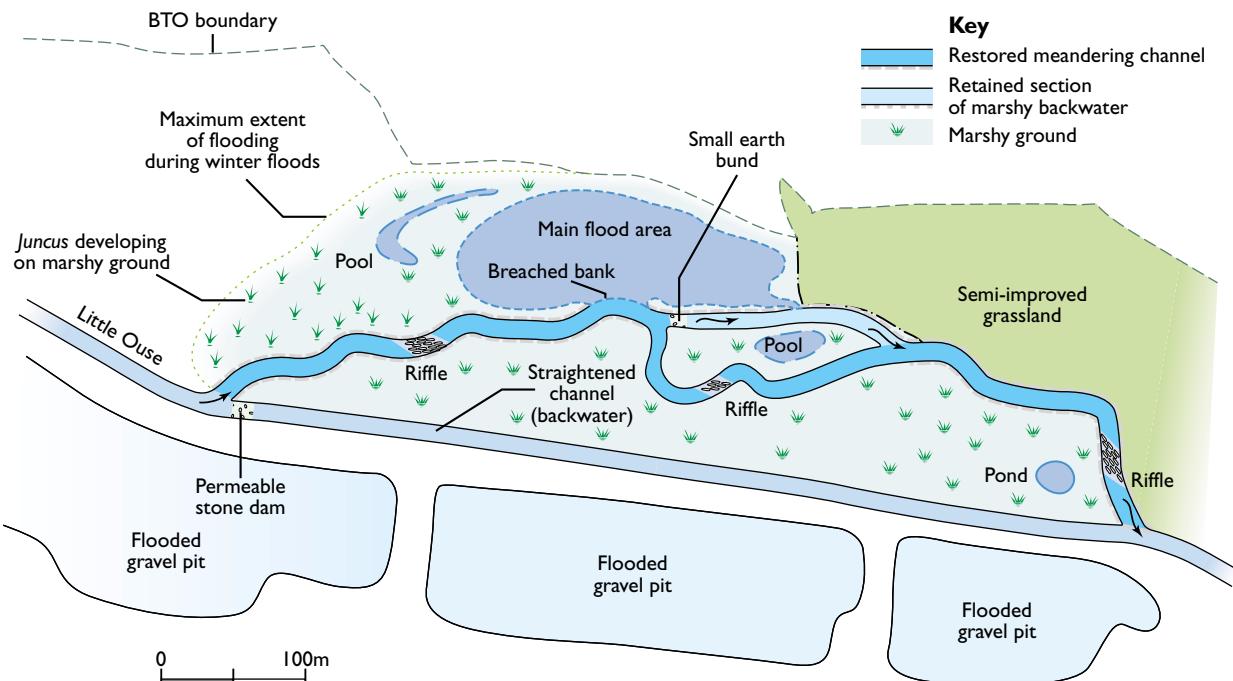
Figure I.7.1

PLAN OF MEANDERS

end of the canalised reach (permeable stone dam on figure 1.7.1), to raise the river level by 0.6m. This would ensure that approximately 90% of flow would be routed through the re-opened course.

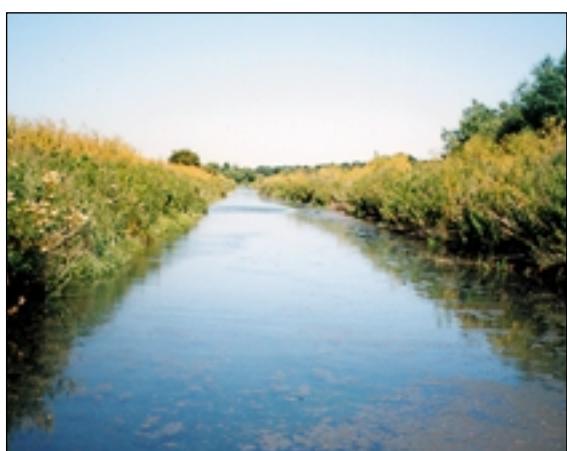
Canalised course of the Little Ouse

The new canalised course was straight, trapezoidal, c.6m wide and 1-2m deep, with 3m dry, steep banks dominated by tall ruderals and grass. In-stream habitat was poor, macrophytes were confined mainly to the shallow margins, and the substrate was dominated by sand with some silt and gravel.

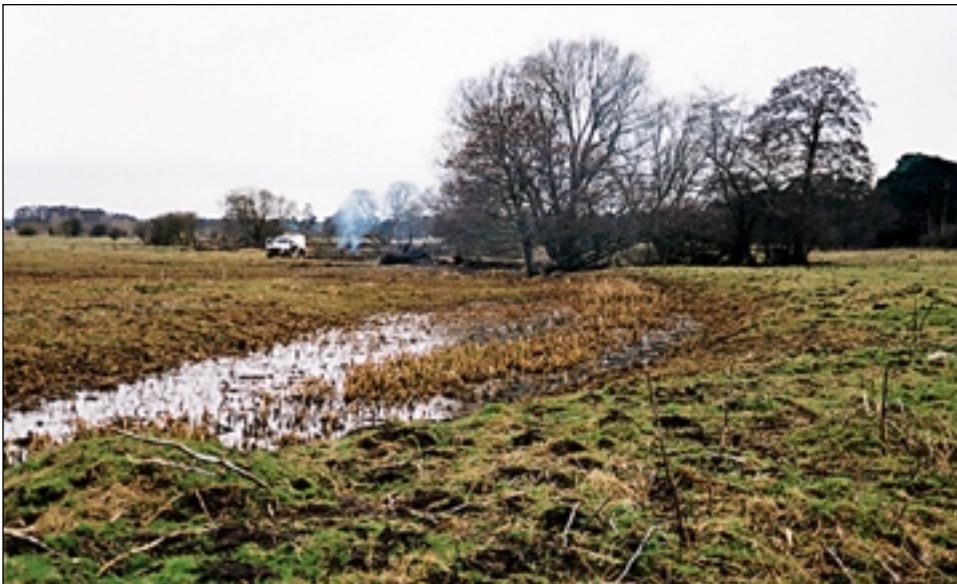
The old meandering channel remained as a damp depression, merely infilled at each end during the excavation of the new cut. By restoring flows to the old channel 900m of diverse river habitat incorporating deep pools, runs and riffles would be regained, in contrast to the uniform, slack and deep water of the canalised section. Additionally, the landowner was keen to see the land adjacent to the meanders flood, restoring the lost hydrological connection between river and floodplain.

Looking downstream along the old meanders

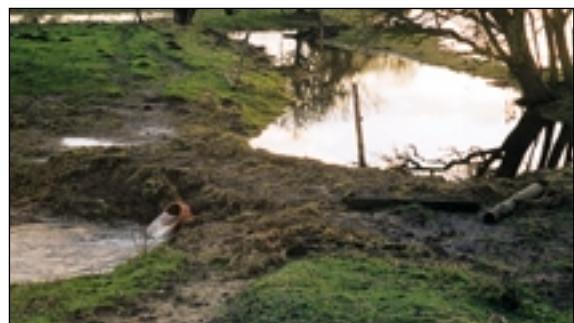
In the middle of the meandering reach a marshy backwater section was isolated with a bund at the upstream end to protect the habitat from high velocity flood flows.

Sluice, bund and upstream flooding area

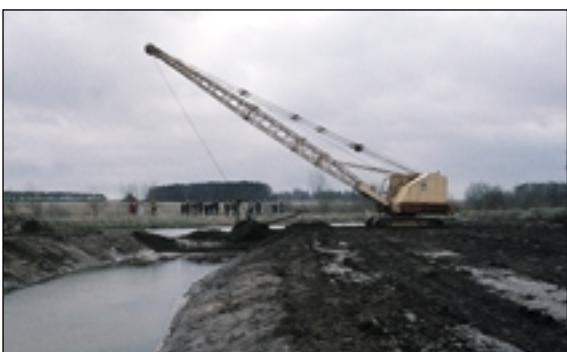
The old course was reopened by excavating the 'plug' material from the upstream and downstream ends of the meanders. Some tree work and minor regrading was carried out along the remaining length of the original course where necessary. The very small amount of spoil was spread within the immediate reach of the excavator. The restored Little Ouse now has an average channel depth and width of 1m and 8m, respectively.

The meanders needed to be 'unplugged' at both ends

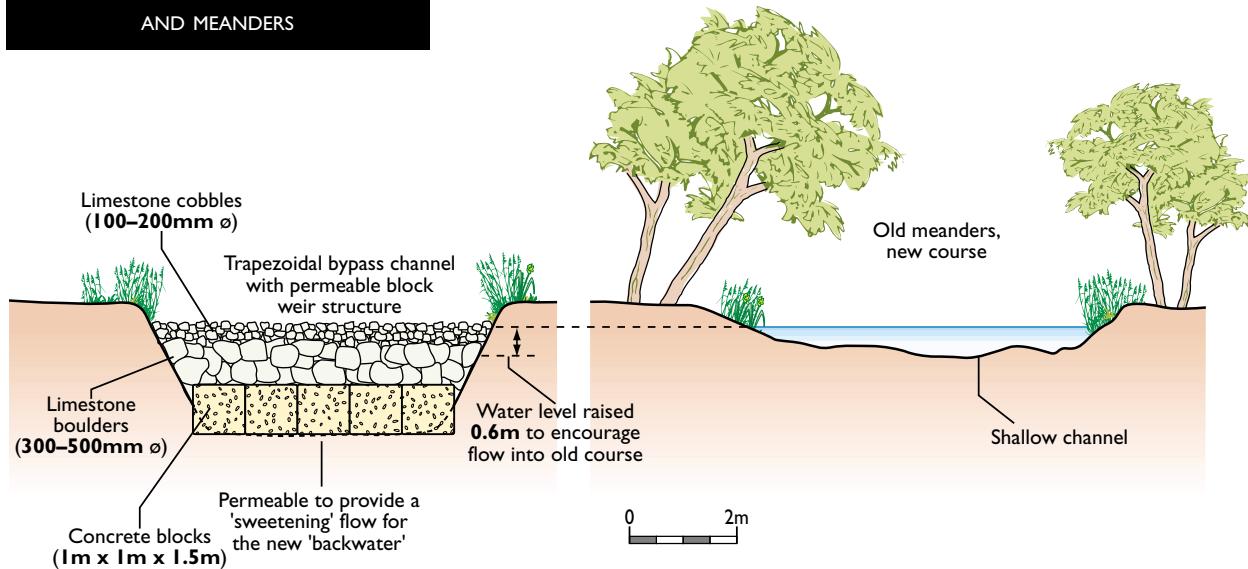
Figure 1.7.2

The structure, 6m wide by 10m long by 2m high, was constructed using 1.5 by 1m prefabricated concrete blocks below a 0.75m depth of boulder sized limestone, surfaced with 0.25m of cobble sized limestone. The 'weir' was designed to be permeable to provide a sweetening flow to the canalised channel. Flows, where levels exceed the 2m crest, will overtop and discharge through the retained canalised 'flood relief' backwater channel.

SECTION THROUGH STONE DAM AND MEANDERS

Using a 50 foot reach dragline, a boulder and stone structure was placed into the river at the upstream

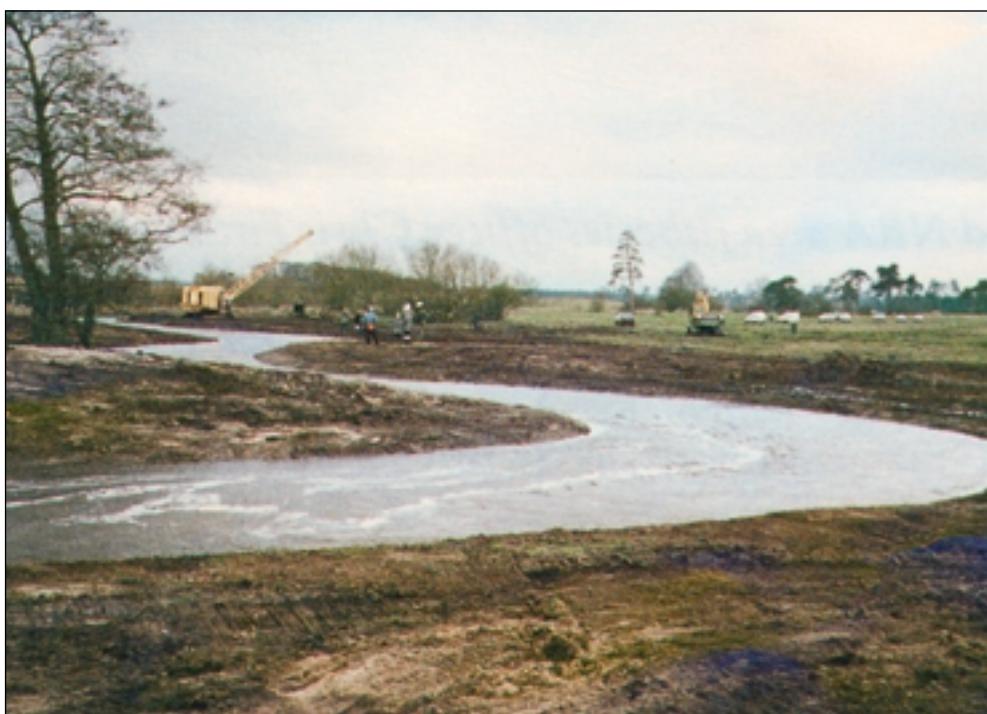
Surveys show that the meandering channel is sustaining a diverse aquatic invertebrate community, with stonefly, mayfly and snail species which are not present in the canalised section. Fish species such as chub and dace, also not found in the straight section, are using the reconnected reach as spawning and nursery habitat.

The re-establishment of marshland plants on this site has taken longer than originally anticipated. This may be due to a combination of factors, including an inadequate seed-bank, build-up of silt deposits, and prolonged inundation. However, wildfowl and waders have not been slow to use the greater areas of shallow standing water, including nesting pairs of lapwing.

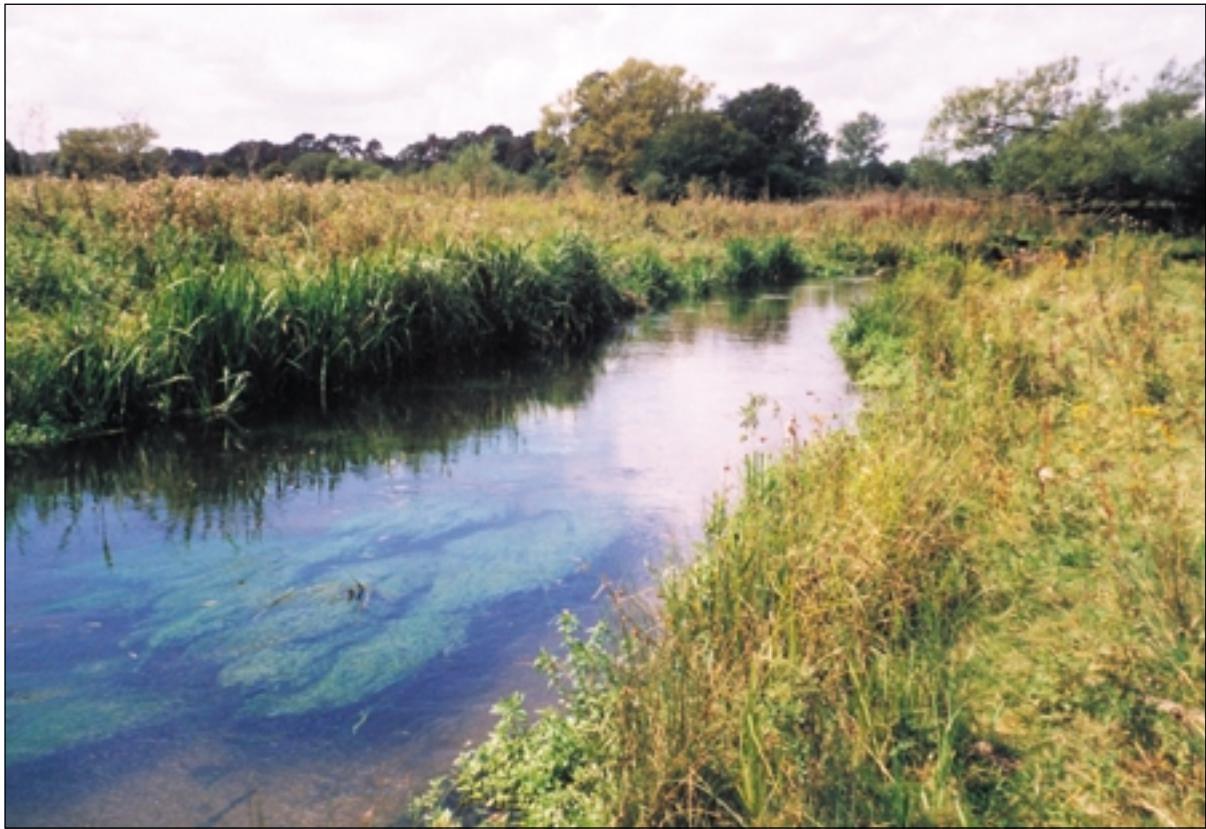
The restored Little Ouse

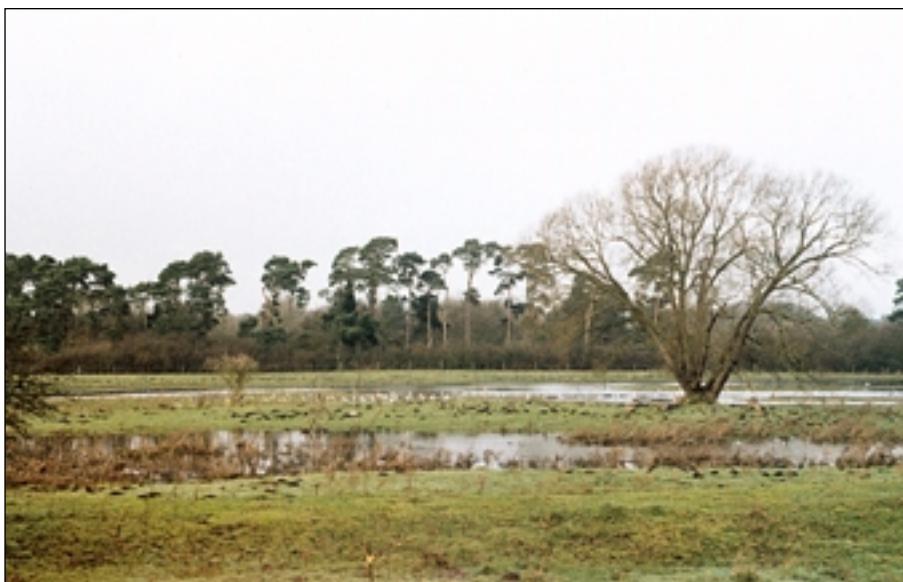
Flooding along meanders,
Spring 1999
