ENHANCING STRAIGHTENED RIVER CHANNELS

3.4 Radical re-design from uniform, straight channel to a sinuous, multi-channel river

RIVER ALT

LOCATION – Knowlesley, Liverpool, Merseyside SJ 435927

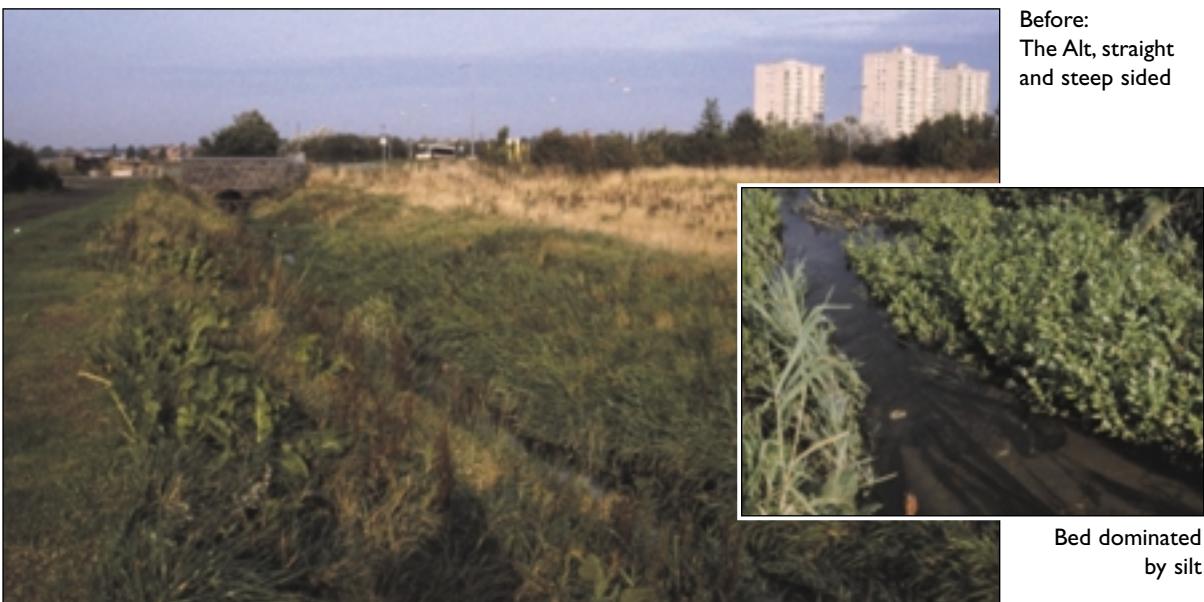
Trees, shrubs and marginal plant species

Trees at 2m centres	Shrubs at 1m centres	Marginals at ~ 4/m ²
White willow	Common osier	Purple loosestrife
Ash	Goat willow	Yellow flag
Oak	Hawthorn	Water plantain
Alder	Blackthorn	Common club-rush
Gean	Hazel	Common reed
Bird cherry	Dog rose	Water mint
Eating apple varieties	Honeysuckle	Gypsy wort
	Dogwood	Water forget-me-not
	Bramble	Brooklime

Trees and shrubs all 1+1 bare root transplants 600-900mm, ratio of 2:1 shrubs to trees. Random species groups of 3-5 trees and 5-7 shrubs.

The shallow berms separating the braids and main course were planted with various riparian species

rather than relying on natural recolonisation, as there was little natural seed source upstream. In addition on some of the higher berms willow was planted to provide extra cover. A native grass and wildflower mix was used for the banks.

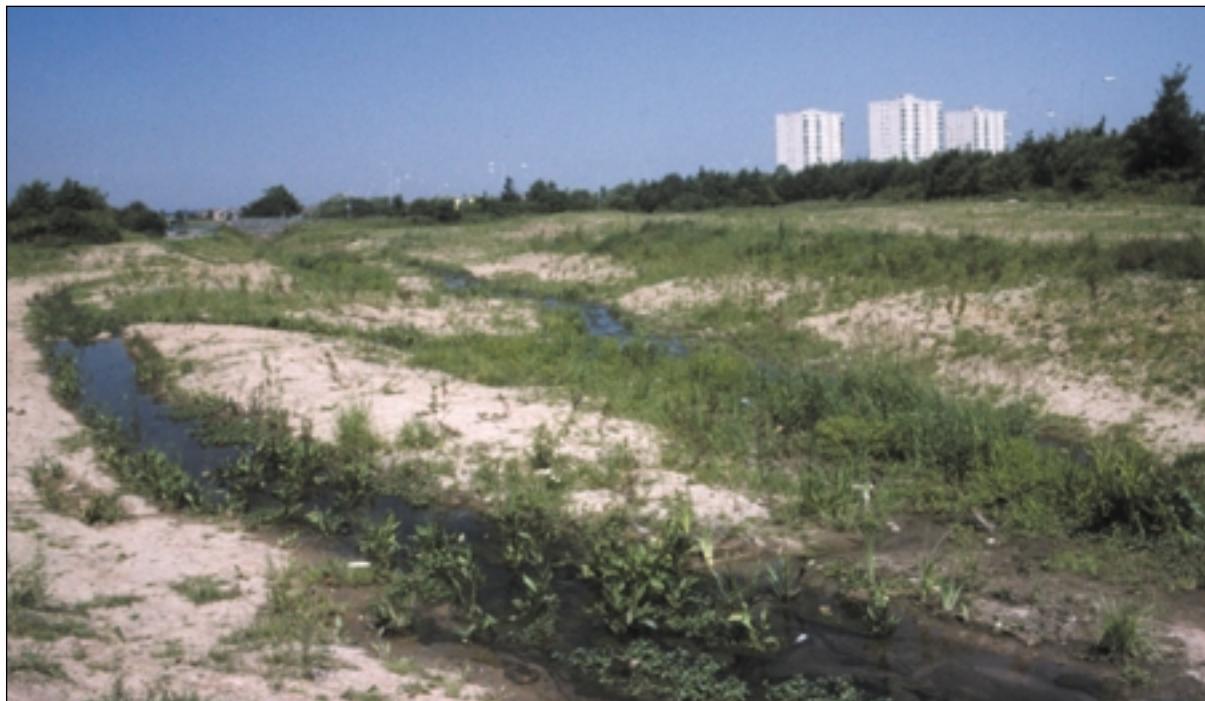
The excavated 'floodplain' area

Spoil disposal had to be addressed at an early stage to permit such a large (9000m^3) 'floodplain' excavation. The nearby school planned to build an earth bank to prevent illicit vehicle access to its playing fields. By using 6000m^3 from the enhancement works to help the school achieve this, the project avoided a potential doubling of costs.

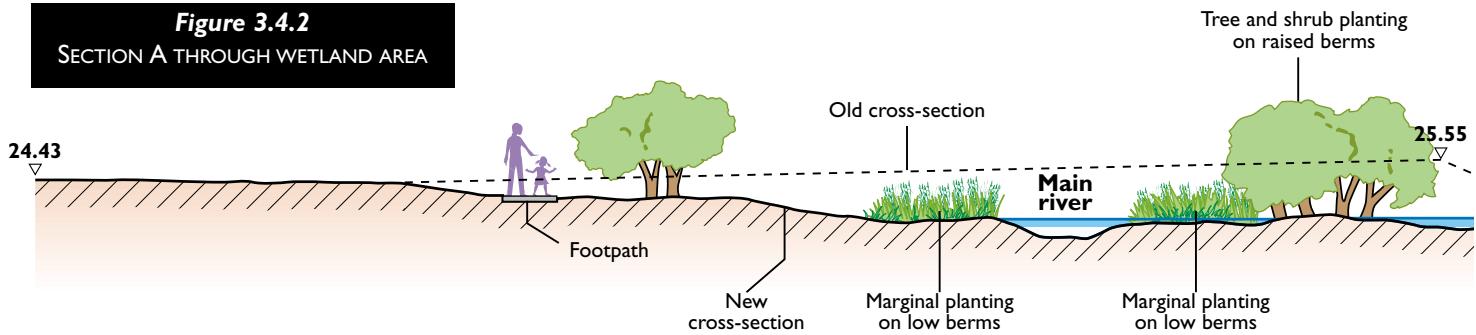
Figure 3.4.2

SECTION A THROUGH WETLAND AREA

The final bank profiles were as shallow as 1:25, connecting the low lying adjacent land by removing the existing raised edge. For a length of 50m the redirected footpath now cuts across the shallow bank slope bringing the public closer to the watercourse.

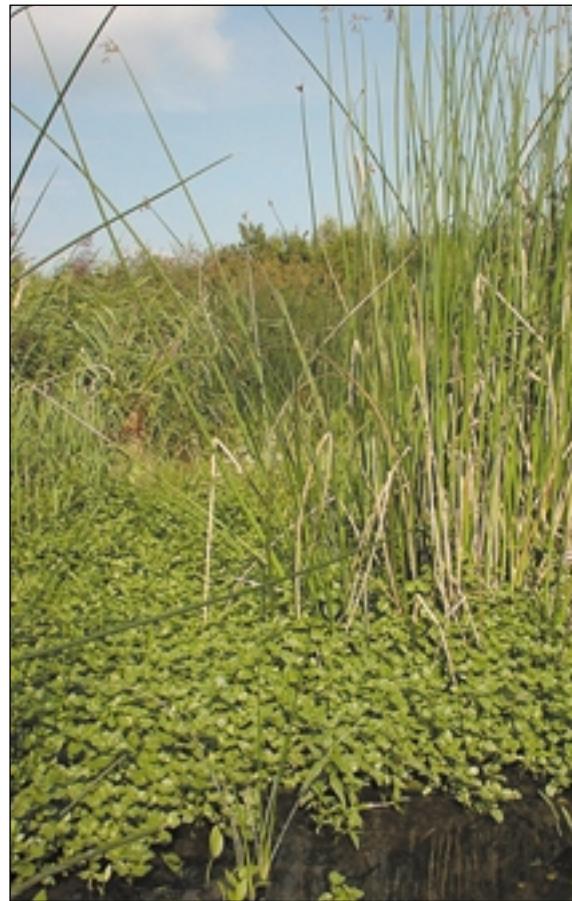
A good diverse vegetation structure has developed along and between the channel threads

The planting has been successful, with the exception of some of the shrubs on the riverbank which were removed.

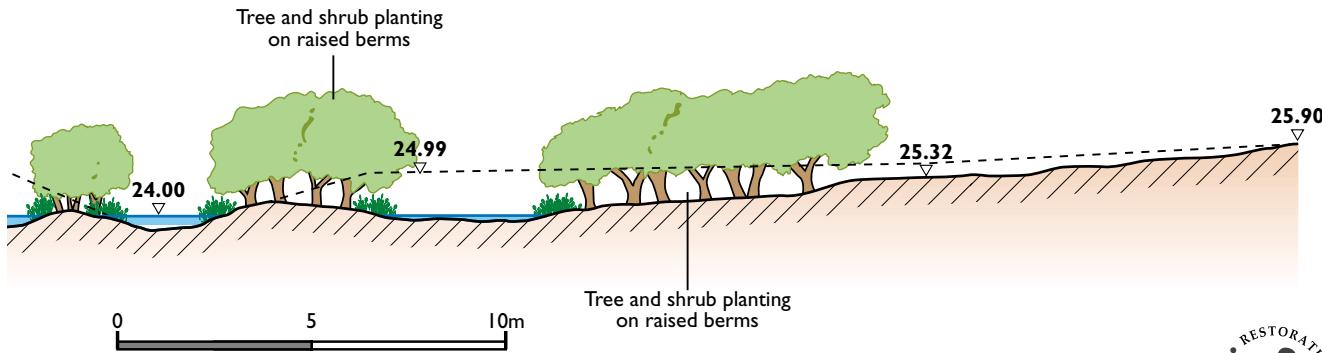
Wetland Area
