REVETTING AND SUPPORTING RIVER BANKS

4.2 Willow mattress revetment

RIVER SKERNE

LOCATION – Darlington, Co Durham, NZ 301160

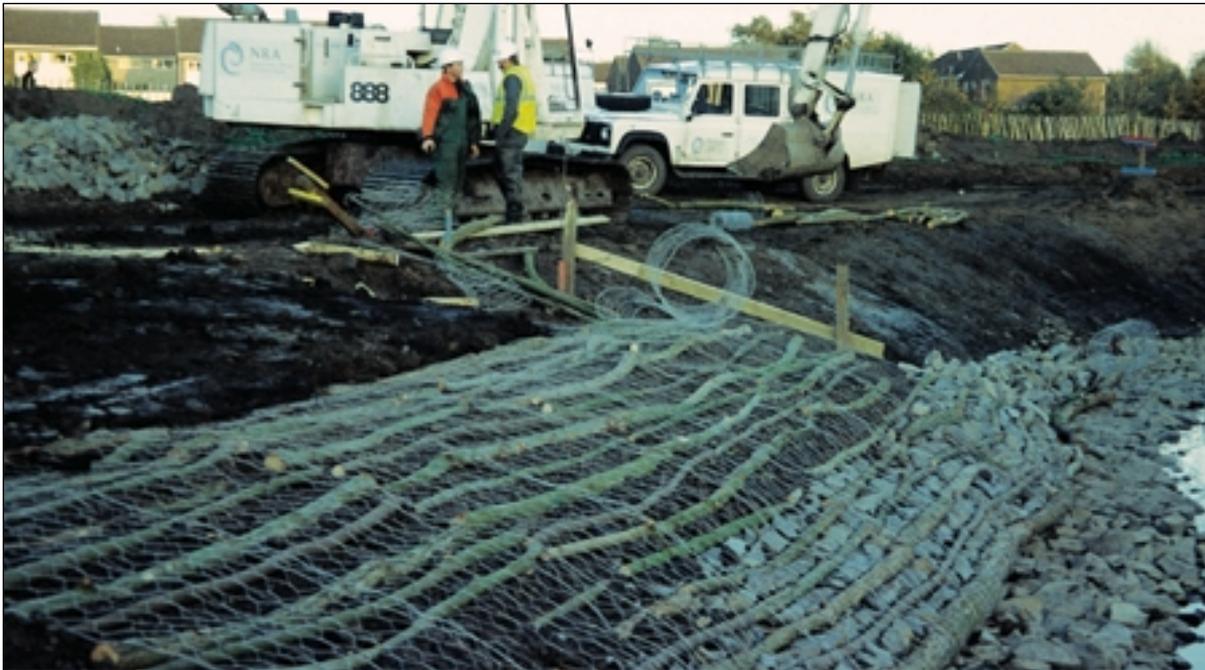
Mattress revetment under construction – October 1995

NOTE: Additional poles inserted to close up spacing after photo taken

Selected live crack and white willow poles, 50-100 diameter, were then laid horizontally all along the face of the fill and pressed into it. Finally the free ends of the netting were drawn tightly over the poles and secured to stakes driven well back in the fill. Due to the shortage of willow locally, up to 30 % non-regenerative sycamore was incorporated intermittently. The netting was stapled to the poles to create a structurally integral unit.

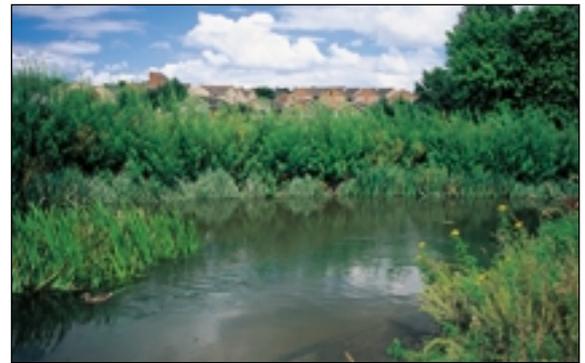
Matress revetment after 2 years

The revetment has remained stable, and dense willow growth up to 3m high covers the bank. Marginal sedge and iris complete what is a most desirable habitat niche favoured by water voles and birds.

Due to autumnal installation, no growth of willow occurred for the first 6 months, when winter floods washed out some soil. Since then the situation has reversed and silts are accumulating within the willow whilst roots extend into underlying soils and rock.

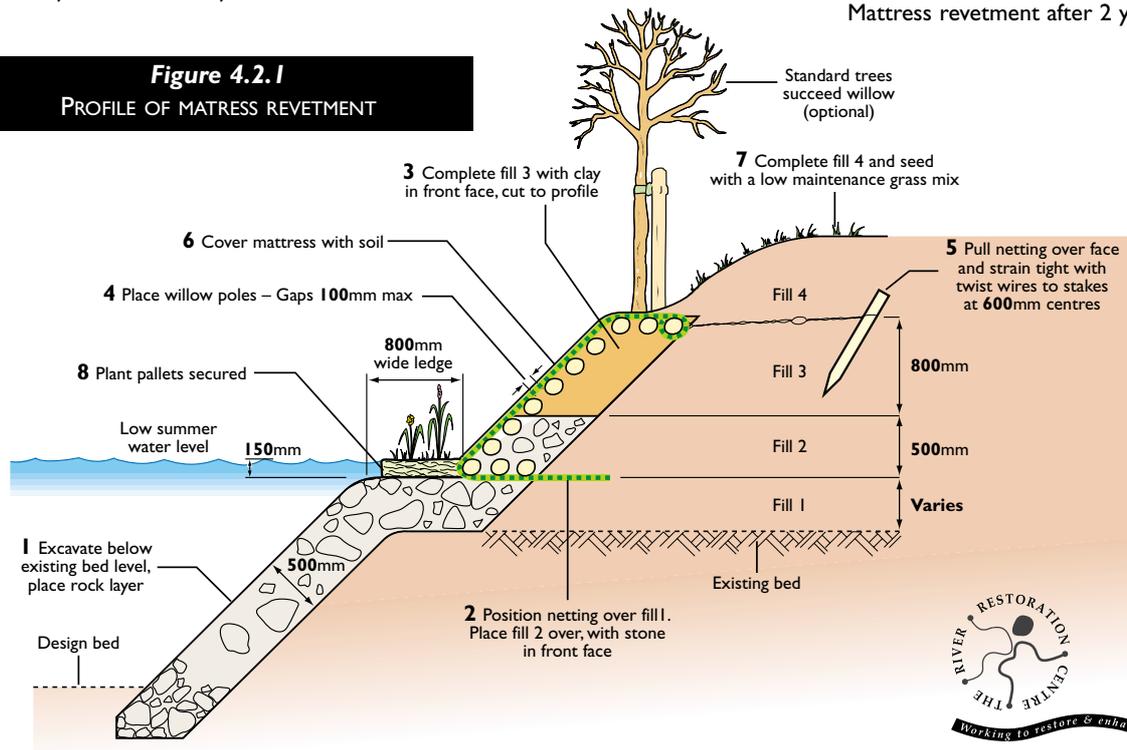
Figure 4.2.1
PROFILE OF MATRESS REVETMENT

The newly aligned and graded river bank was formed to about two thirds height by filling on top of the underwater zone described above. Rolls of sheep netting, cut to length, were incorporated under the fill as shown.

Crushed rock was used to line the newly excavated channel around a sharp bend, as well as the initial infill of the redundant channel (fill 1). Few alternatives to rock were practical in this urban situation, but rock does form a flexible revetment which tree roots and aquatic flora/fauna will colonise. Most importantly, the rock used was mixed at the quarry to provide a densely graded '300mm down' matrix to the following specification:

This was made up with fill, leaving a ledge, and seeded with grass.

As a final measure, pre-planted coir pallets were fixed along the water's edge to provide visual amenity and variety of habitat. The following year, standard trees were planted along the upper ledge. These may outgrow the revetment willow as they mature, provided the latter is regularly coppiced.
