# REVETTING AND SUPPORTING RIVER BANKS

## 4.4 Plant roll revetment

### RIVER SKERNE

LOCATION – Darlington, Co Durham, NZ 301160

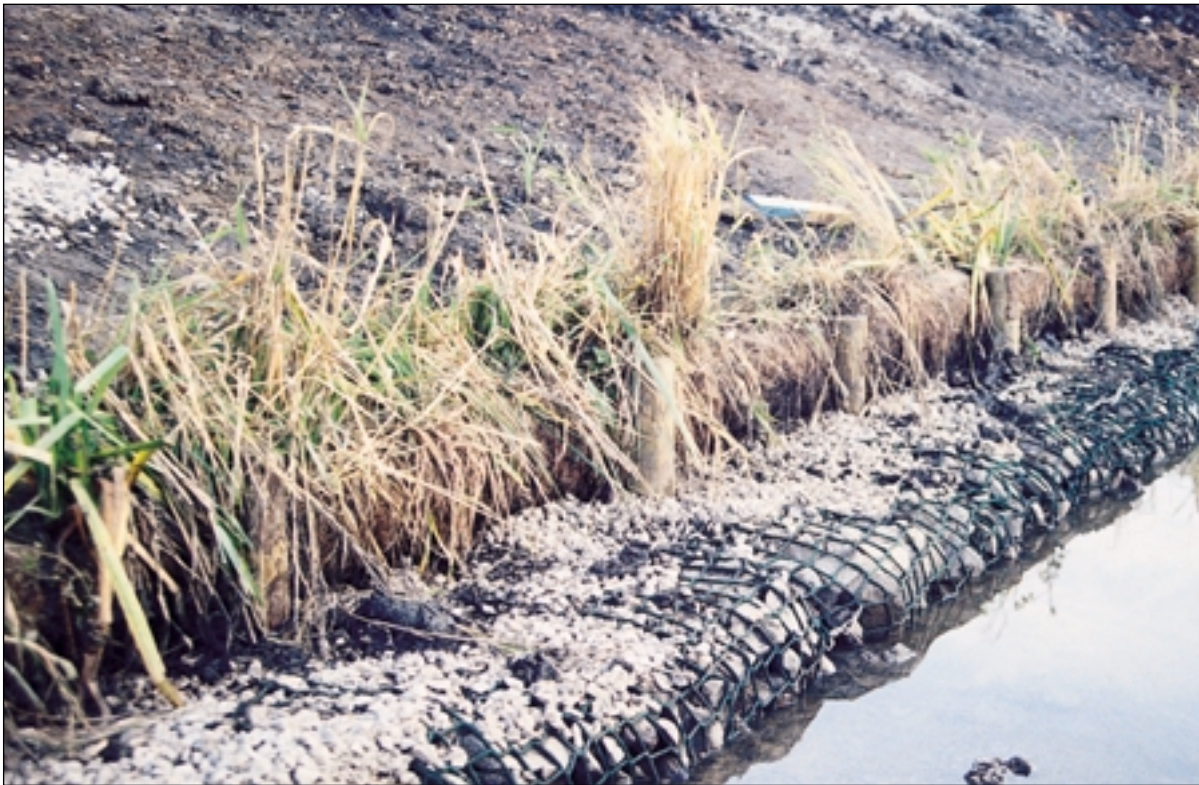
Transitional revetment at installation (water level artificially low in photo)

Rock rolls are set out below water on ledges cut to suit and secured by driving posts through the netting. Long term stability and flexibility is achieved by pulling the rolls tight against the posts using twist wires anchored to stakes set well back.

Plant rolls are set out at low water level and wedged tight up against the rock rolls by driving stakes at a suitable angle along the rear of these.

Pre-planted flat pallets of coir were added above the plant rolls to increase the extent of marginal vegetation although this is largely an aesthetic measure.

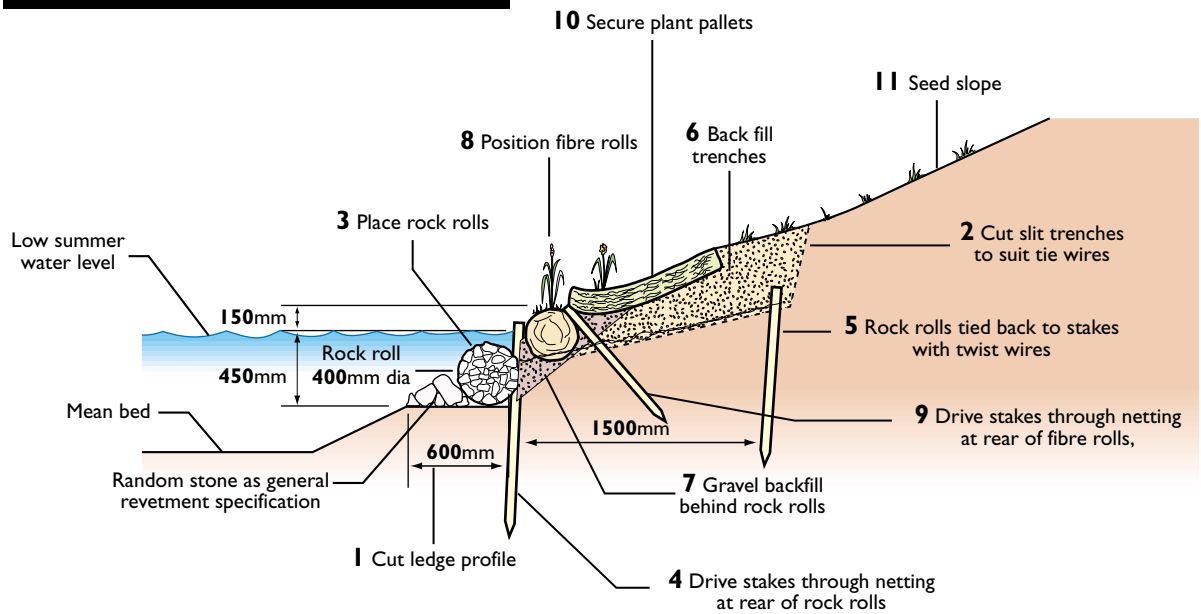
**Figure 4.4.1**  
PROFILE OF TRANSITIONAL REVETMENT

Rock rolls are flexible 'sausages' of crushed rock contained within nylon netting, whereas plant rolls are of dense coir within which selected marginal aquatic species can be pre-grown. Plant rolls fixed over rock rolls will become homogeneous as roots penetrate downwards into the rock and the adjacent soil. The design provides inbuilt flexibility

whilst allowing the plants to develop in stable conditions.
